# Enhancing ecological connectivity and safe passage for wildlife on highways between the southern Santa Cruz Mountains, Gabilan Range, and Diablo Range in California

Diamond, TD, A Sandoval, NP Sharma, ME Vernon, PD Cowan, AP Clevenger, and SC Lockwood. 2022. *Enhancing ecological connectivity and safe passage for wildlife on highways between the southern Santa Cruz Mountains, Gabilan Range, and Diablo Range in California*. Pathways for Wildlife and Peninsula Open Space Trust, Palo Alto, CA.

AUGUST 2022

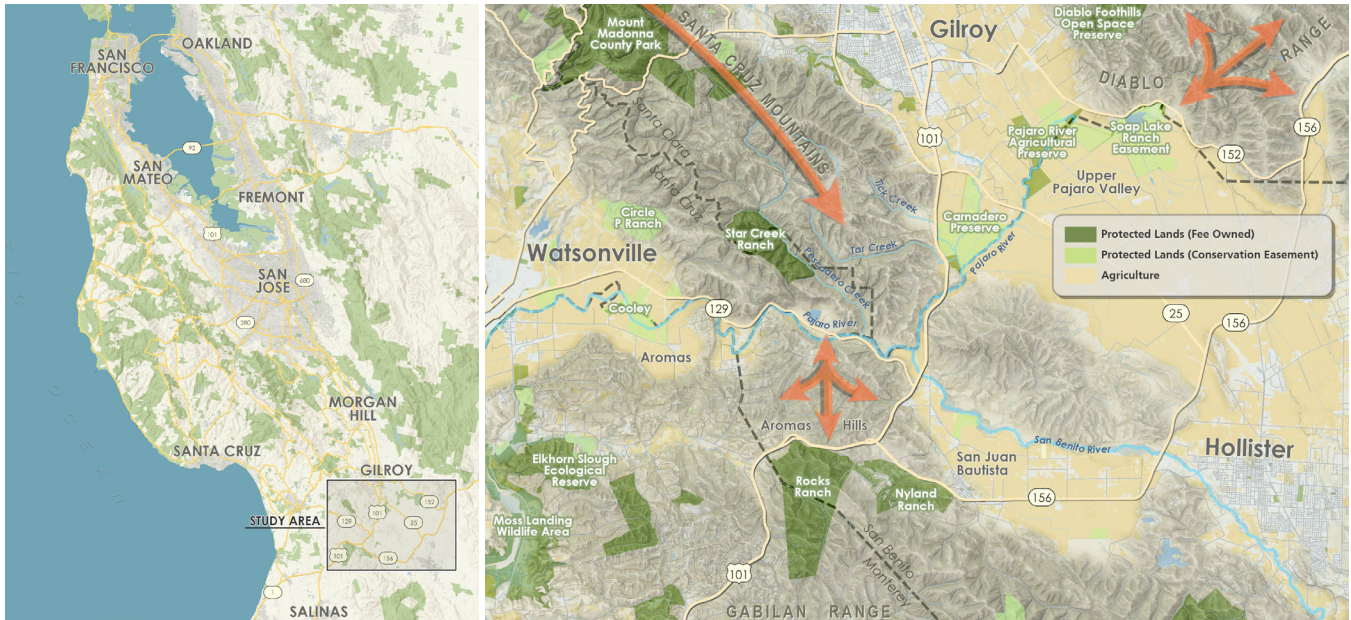
**Figure 1.1.** The area for this study includes lands in Santa Clara, San Benito, Santa Cruz, and Monterey counties, Caltrans Districts 4 and 5 (including US 101, SR 129, SR 156, SR 152, and SR 25), and CDFW Regions 3 and 4. Arrows denote proposed ecological connectivity through the Aromas Hills connecting the Santa Cruz Mountains to the Gabilan Range and through the Upper Pajaro Valley connecting the Santa Cruz Mountains to the Diablo Range. Agricultural land use is denoted in yellow to illustrate its prominence as a regional land use, though other land uses are also present.

Transportation corridors, along with human development and agriculture, have important influences on ecological connectivity and wildlife movement in both the Aromas Hills and Upper Pajaro Valley (CDFW 2015). Of particular relevance to ecological connectivity in the study area are the interactions between wildlife and US and state highways, which are the primary focus of this study. Understanding the impact of these highways on connectivity is essential to regional biodiversity conservation and climate resilience efforts. Highways in the study area include US Highway 101 (four to five lanes, depending on location), State Route (SR) 152 (spanning two or three lanes, depending on location), SR 25 (two lanes), SR 129 (two lanes) and SR 156 (four lanes) (Figure 1.1). Vehicular traffic on the five highways of interest is significant, though traffic is heaviest on US 101 at SR 25 and lightest on US 129 at Rogge Lane (Figures 1.1 and 1.2).

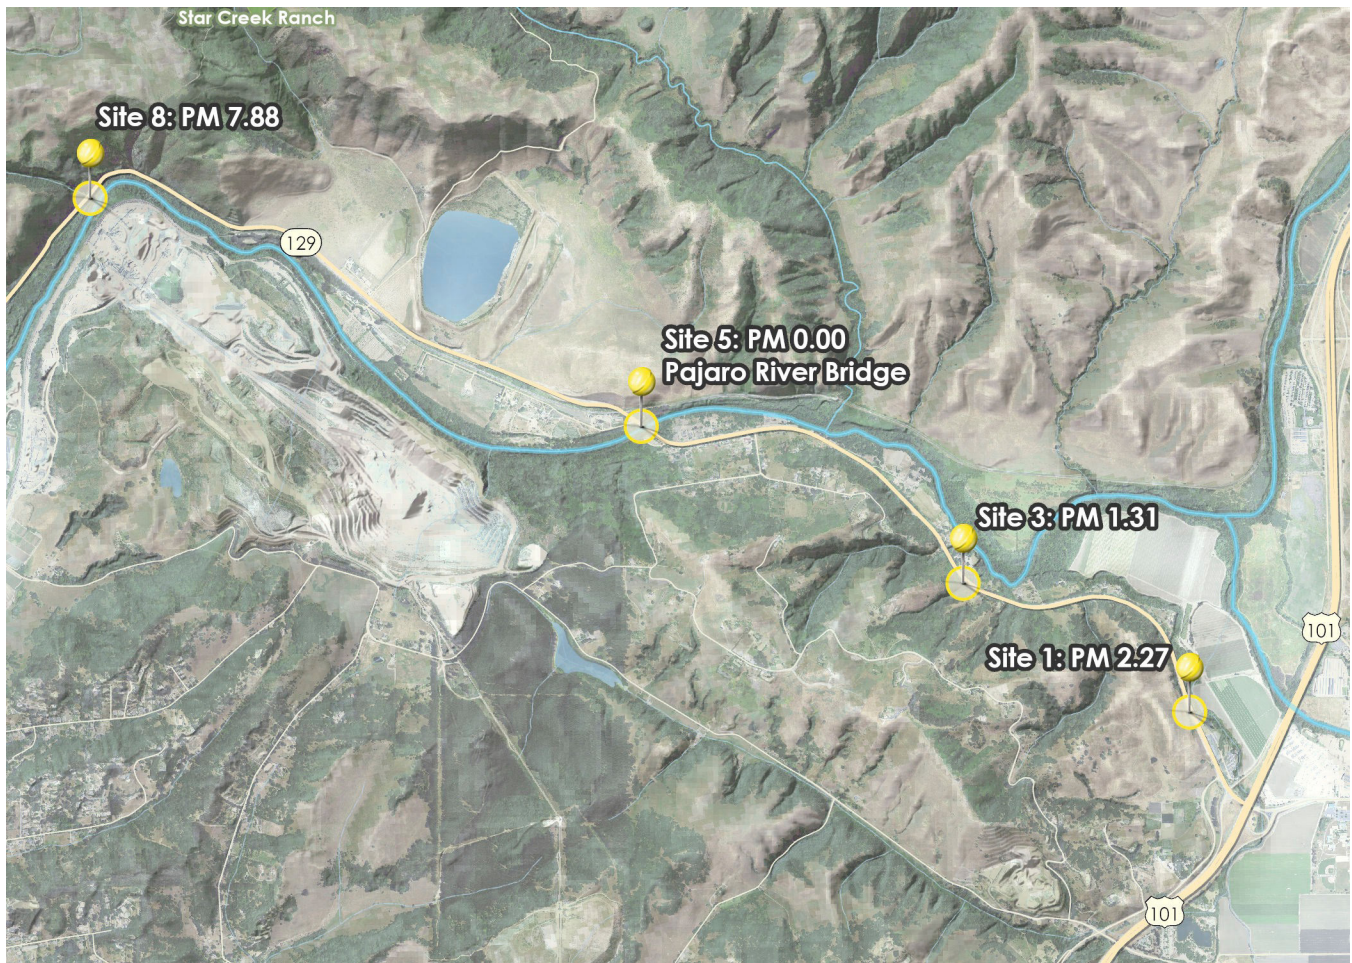
**Figure 2.10.** Map of camera monitoring sites in the SR 129 section.

The SR 129 section has four undercrossings, including three culverts and the Pajaro River Bridge underpass (Figure 2.10). These undercrossings were all monitored for the same number of trap nights. We recorded a total of 984 native species passages across all trap nights in this section, with seven native species detected. When standardized, this section recorded a total of 270 native species passages, with an average of 67 passages. The species with the highest passage rates when standardized were bobcat (164), raccoon (84), and opossum (55) (Figures 2.11 and 2.12). Notable species detected included gray fox (Sites 1, 5, and 8) and long-tailed weasel (Site 8). We also recorded a female bobcat traveling with a juvenile at the SR 129 Site 8 culvert and a bobcat with severe mange at the SR 129 Site 3 culvert. Domestic cats were detected at SR 129 Sites 1, 3, and 5 (Figure 2.12).

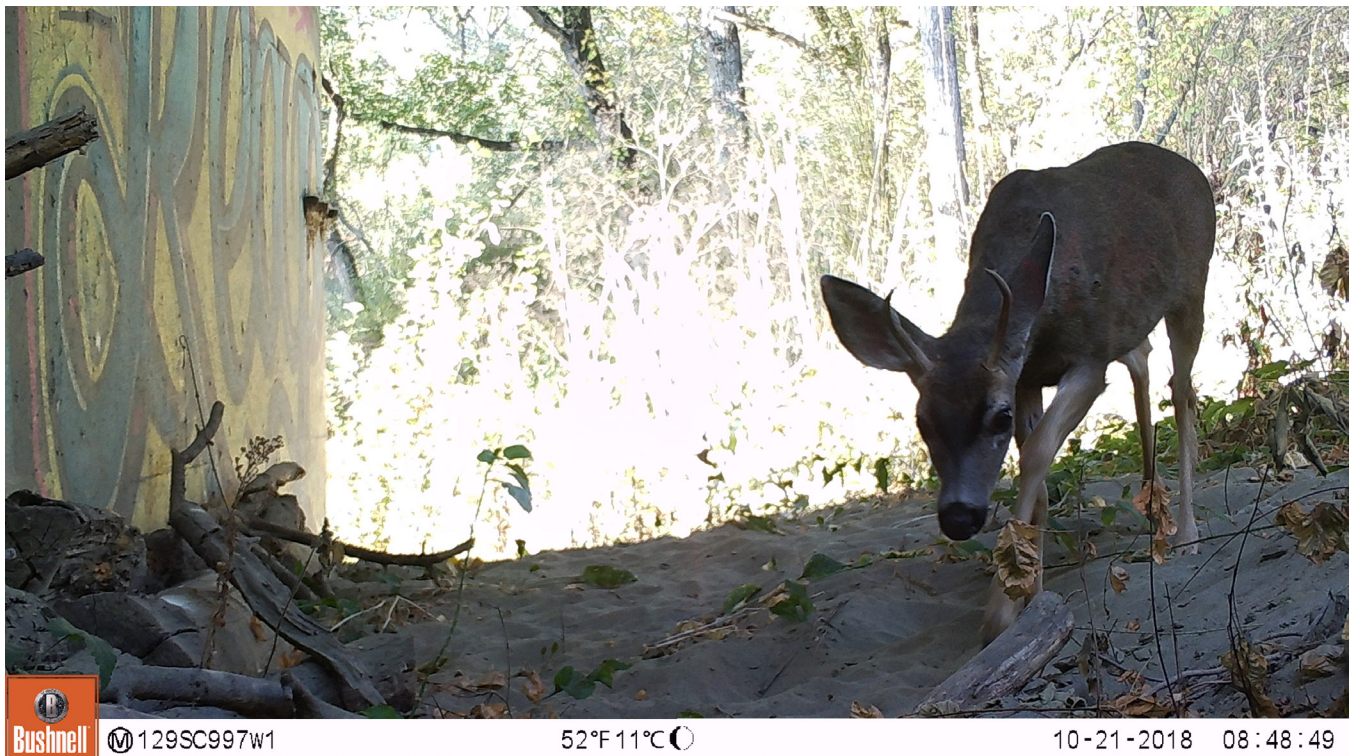
Male deer traveling under SR 129 Site 5, the Pajaro River Bridge.

SR 129 Site 5 Pajaro River Bridge is the only undercrossing beneath SR 129 big enough to facilitate passage of large animals such as deer and mountain lions, though mountain lions were not detected. This site had five native species detected, but also had the lowest number of native species passages in this section when standardized in the 100 trap night analysis (19) (Figure 2.11). Domestic cats and opossums were also recorded at this site (Figure 2.12). A juvenile male deer investigated, but did not pass through, SR 129 Site 3, which is a box culvert that is likely too small for deer passage. This indicates the need for additional structures in this highway section (besides SR 129 Site 5 Pajaro Bridge) that can facilitate passage by large mammals.

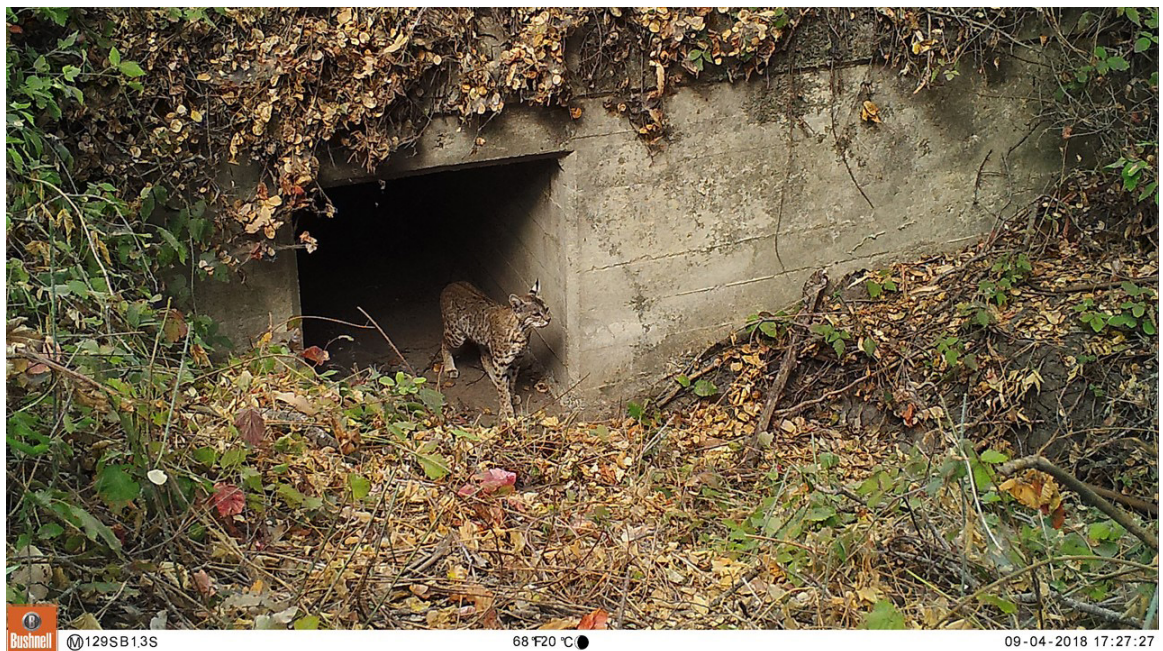
Bobcat traveling through the SR 129 Site 3 culvert on September 4, 2018.

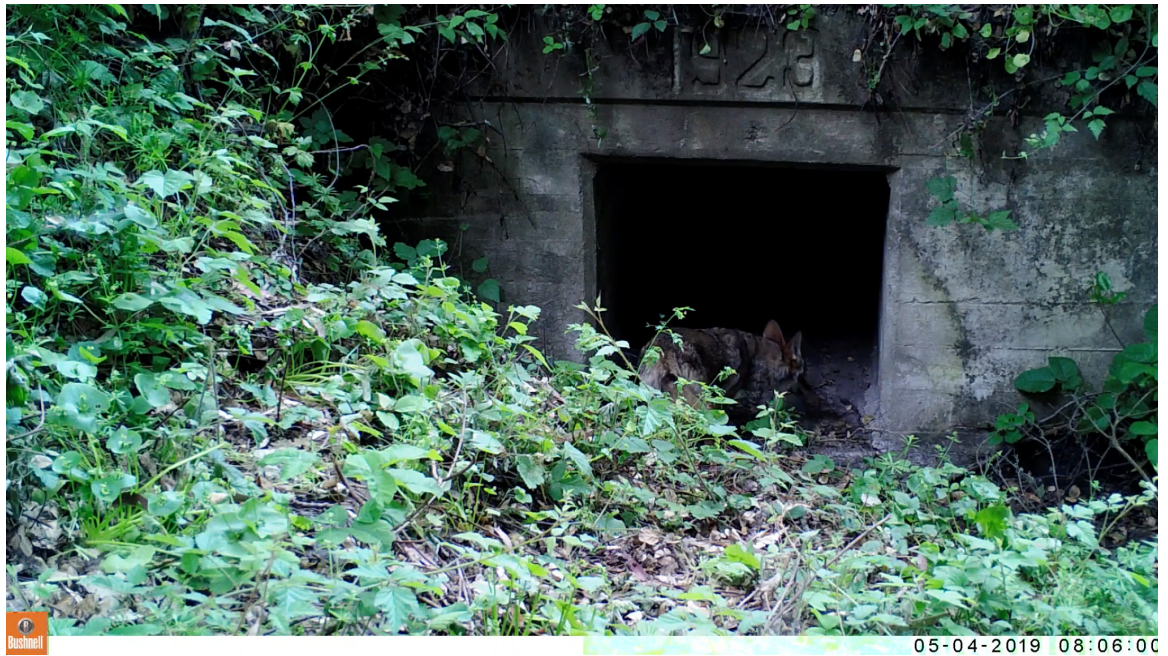
Coyote traveling through the SR 129 Site 3 culvert on May 4, 2019.

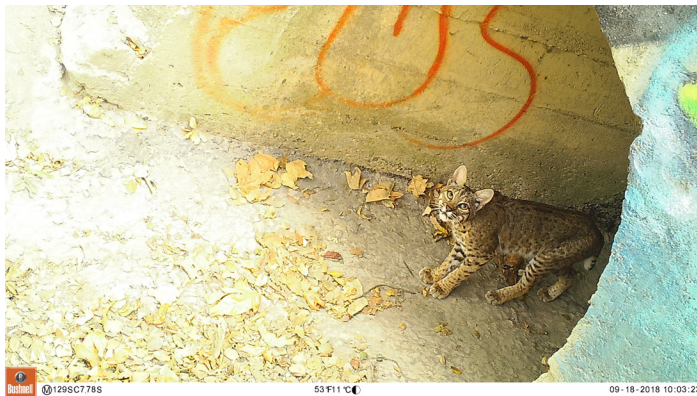
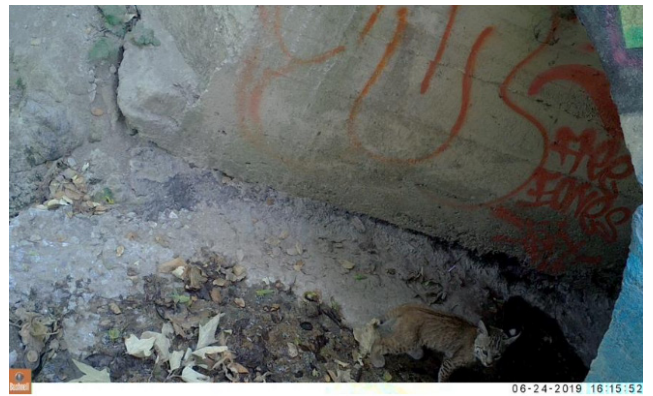
Adult (left) and juvenile (right) bobcats traveling through the SR 129 Site 8 culvert on September 18, 2018 and June 24, 2019, respectively.

SR 129 Site 8 had the highest number of native species passages in this section when standardized in the 100 trap night analysis (118) (Figure 2.11), with five species detected. This may be because of the presence of riparian habitat on both sides of this culvert, including on the north side which leads to the Pajaro River. The three culverts (SR 129 Sites 1, 3, and 8) consistently facilitated movement of medium-sized mammals throughout the study period.

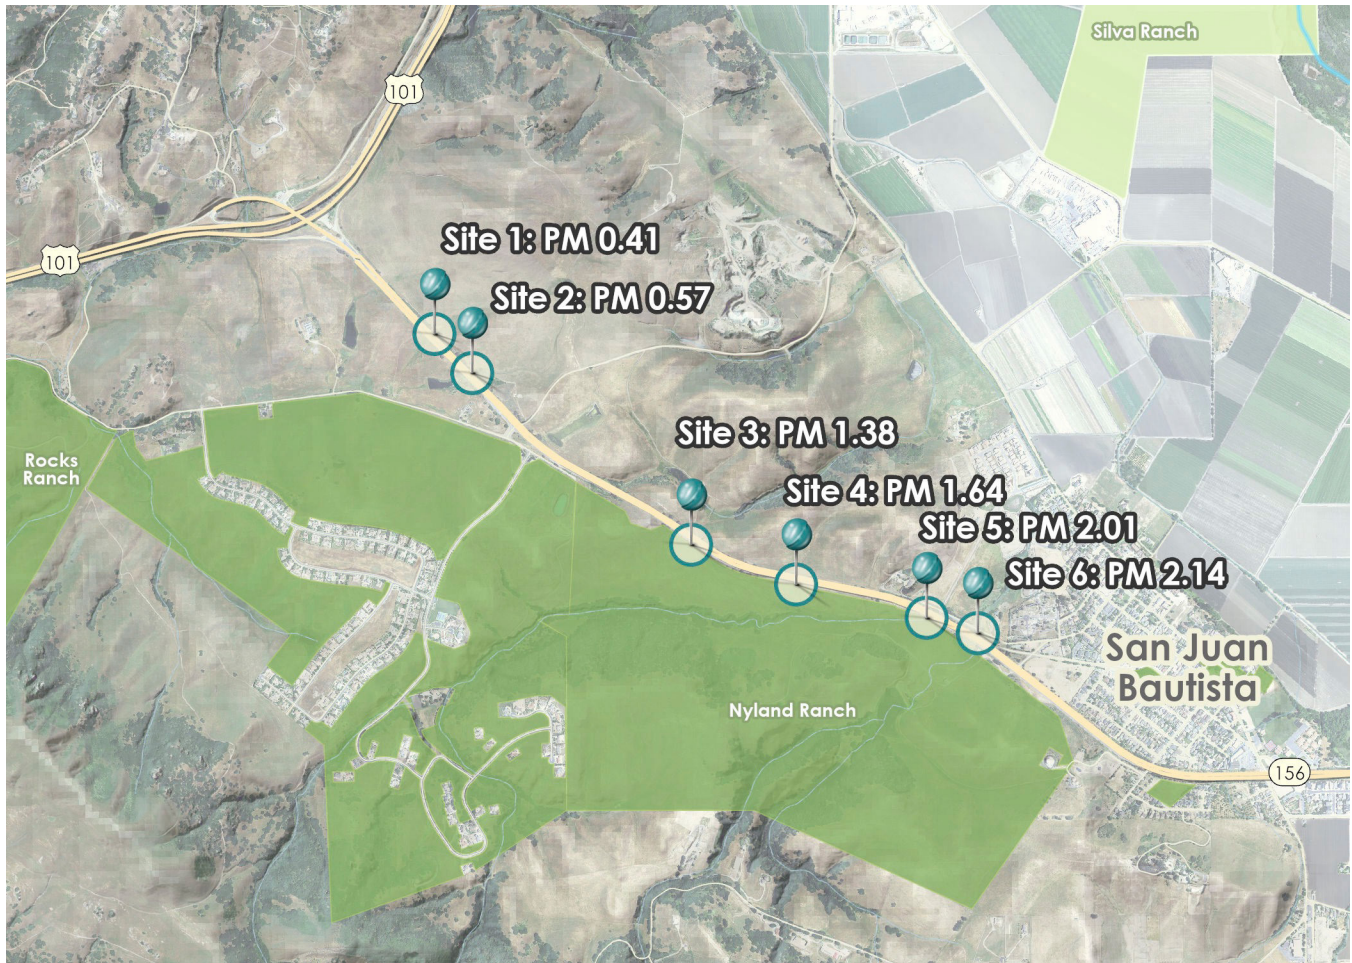
**Figure 2.13.** Map of camera monitoring sites in the SR 156 section.

We had six monitoring sites along SR 156, all culverts (Figure 2.13). Across the six sites, we recorded a total of 606 passages by native species, with a total of five native species detected. When standardized, this site recorded a total of 182 native species passages, with an average of 30 passages. The native species with the highest passage rates when standardized were skunk (93), raccoon (42), and coyote (43). We also detected passages by non-native red fox at Sites 5 and 6 (Figure 2.14). Opossums were detected at all sites in this section.

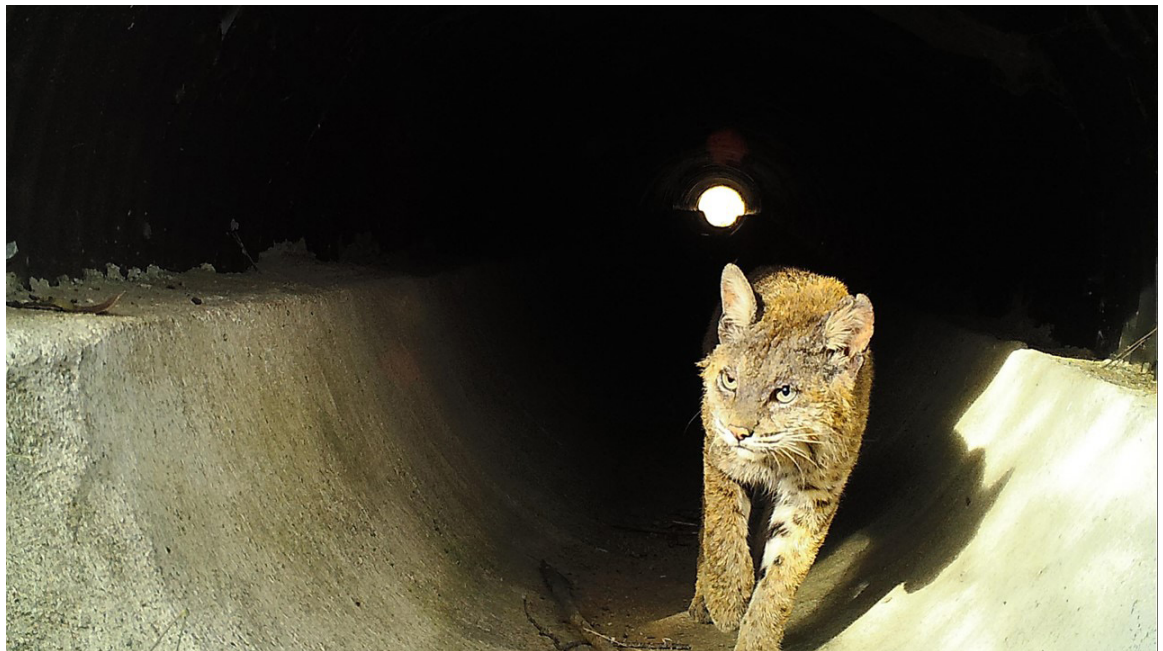
Bobcat with mange traveling through SR 156 Site 2.

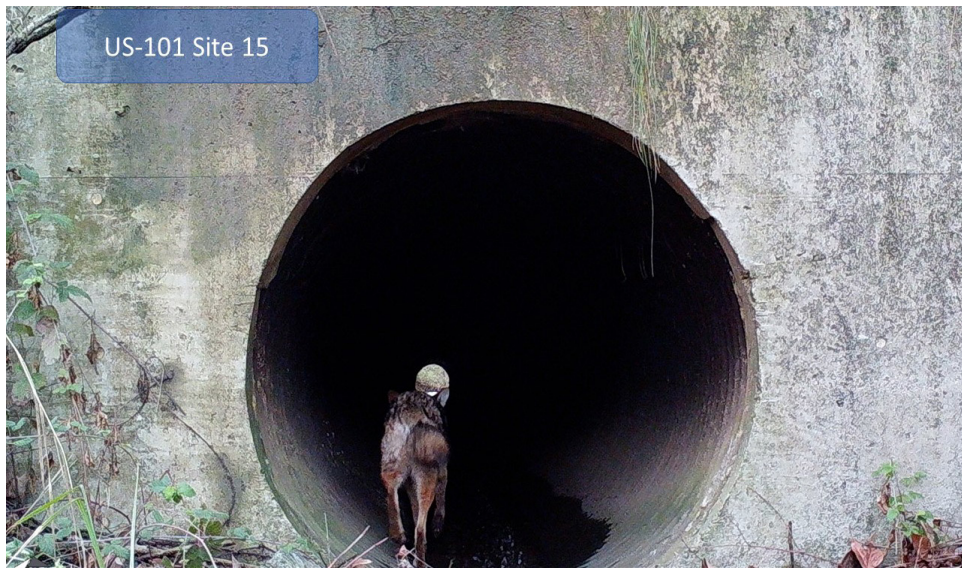
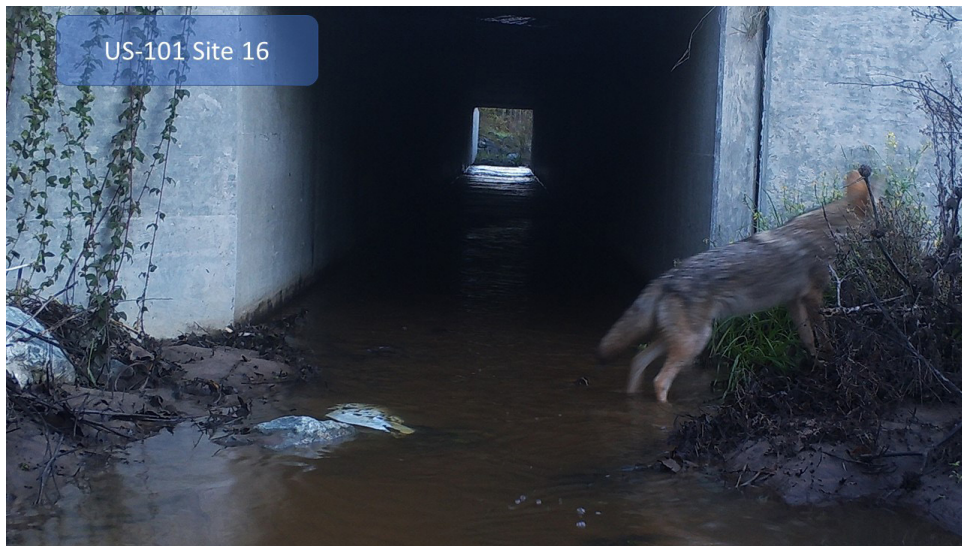
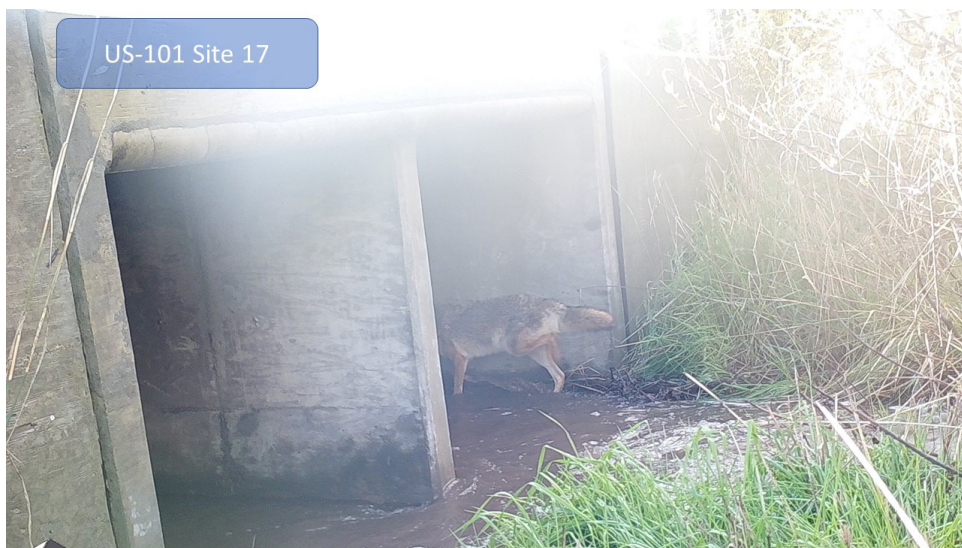
Coyotes traveling through US 101 Sites 15, 16, and 17.

The Eucalyptus Grove culverts (US 101 Sites 9–11), had a very low rate of passages compared to the Habitat Island culverts (US 101 Sites 15–17) (Figure 2.18). Though cameras detected the same native species at both the Eucalyptus Grove culverts and the Habitat Island culverts, the total number of passages by native species was much higher at the Habitat Island culverts (Figure 2.18). Passages through the Eucalyptus Grove culverts were mainly by domestic cats (Figure 2.19).

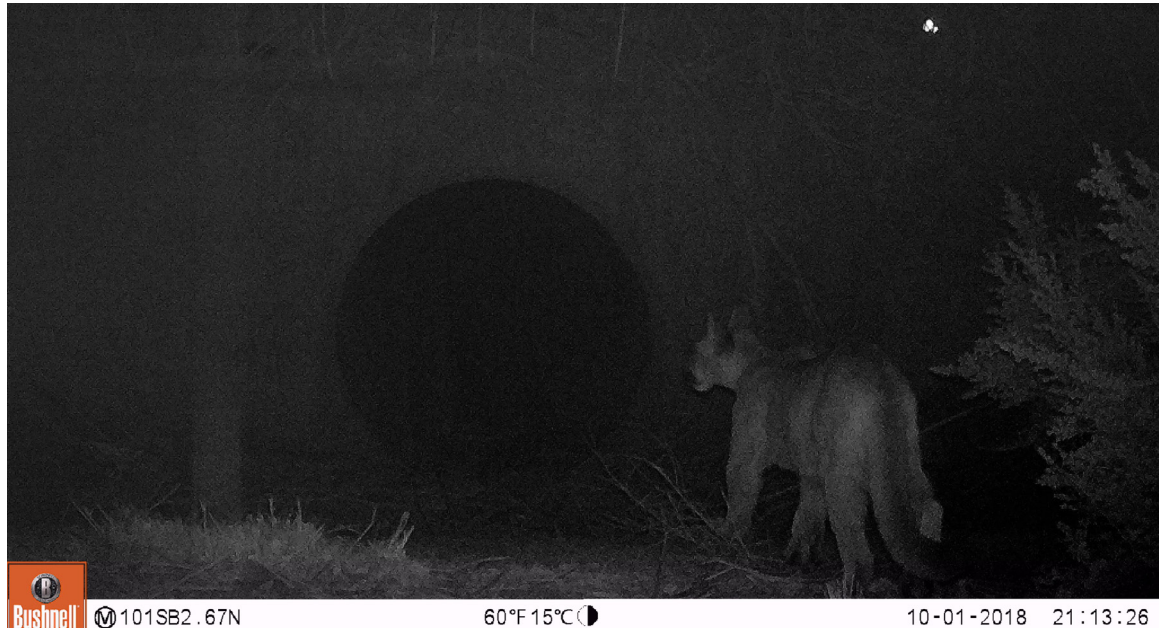
Mountain lion approaching US 101 Site 7 on October 1, 2018.

A mountain lion was recorded on camera at US 101 Site 7 on October 1, 2018. The animal looked into the culvert, but then headed west towards the Eucalyptus Grove. The individual appears to be a young adult, perhaps dispersing from its parental home range (Chris Wilmers, personal communication October 3, 2018). The next day (October 2, 2018), a young mountain lion was recorded looking into but not entering the US 101 Site 11 culvert before heading west through the Eucalyptus Grove. This appears to be the same young adult mountain lion recorded at US 101 Site 7. The mountain lion may have been traveling adjacent to the highway passing by the culverts.

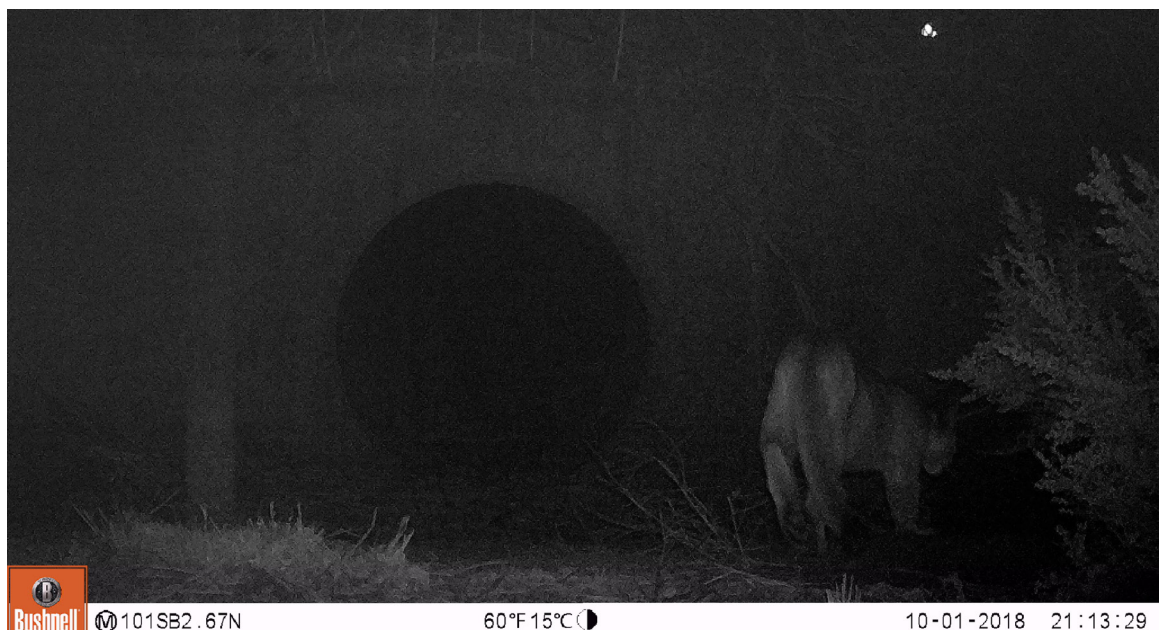
Mountain lion heading west towards the Eucalyptus Grove on October 1, 2018. This recording was immediately following the inspection of US 101 Site 7.

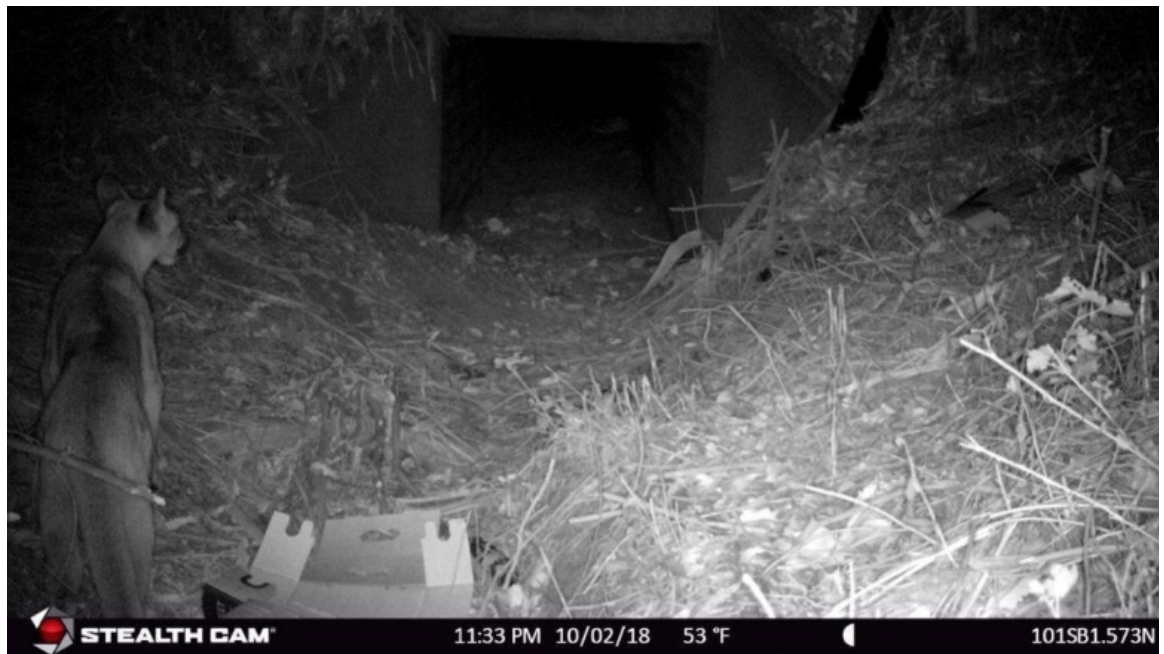
Mountain lion approaching US 101 Site 11 on October 2, 2018.

Of importance, a collared mountain lion, 54M, was hit at the Eucalyptus Grove near US 101 Site 11 in 2016 (Chris Wilmers, personal communication 2016). This mountain lion had been recorded in the area when its collar stopped sending data, and the lion's body was recovered at its last known GPS point. Another mountain lion was recorded as roadkill by CDFW on August 4, 2021, not far from where 54M was hit five years earlier (D. Hacker, personal communication 2021). This reinforces the idea that the Eucalyptus Grove portion of US 101 is a significant barrier for movement and dispersal of mountain lion and other mammals.

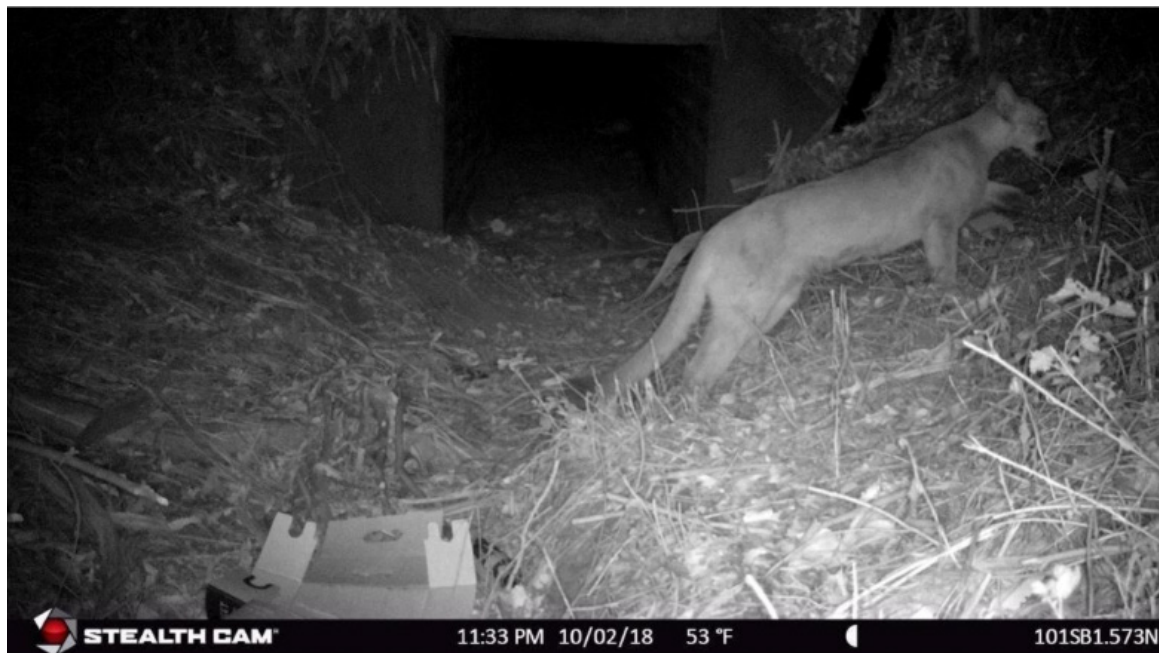
Mountain lion heading west through US 101 Site 11 at the Eucalyptus Grove on October 2, 2018.

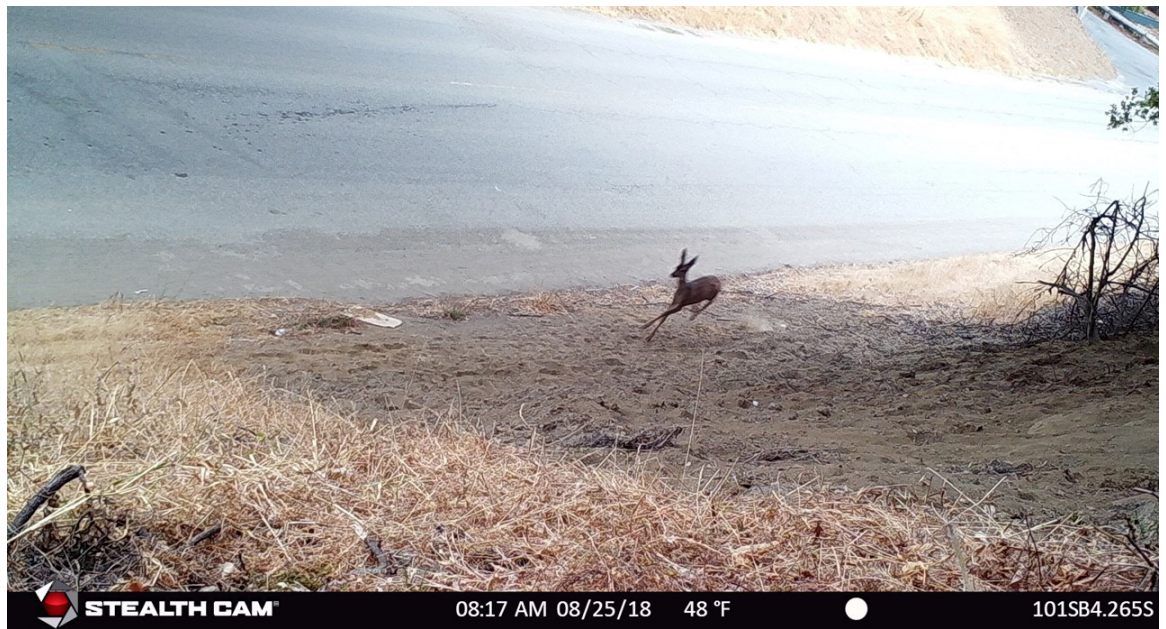
Deer traveling under the US 101 Site 4 Anzar Underpass. This is a busy road with a small habitat strip.

We recorded deer passage at four sites in the US 101 Aromas Hills section. Deer regularly used US 101 Site 4 Anzar Road underpass and US 101 Site 20B. Anzar Road is a busy road with high vehicular traffic, with only a small strip of habitat available for deer to travel safely through the Site 4 Anzar Road underpass. We detected a male and female deer and a fawn traveling through US 101 Site 20B. The other sites in this section where deer were detected had very low passage rates.

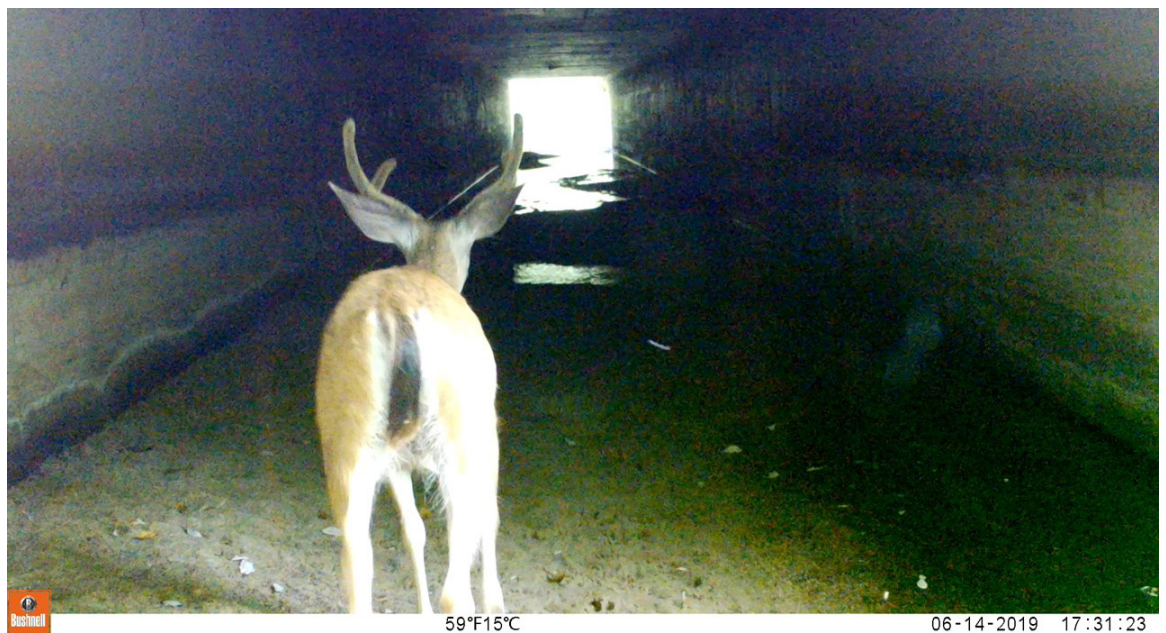
Deer traveling through US 101 Site 20B at the Monterey County line.

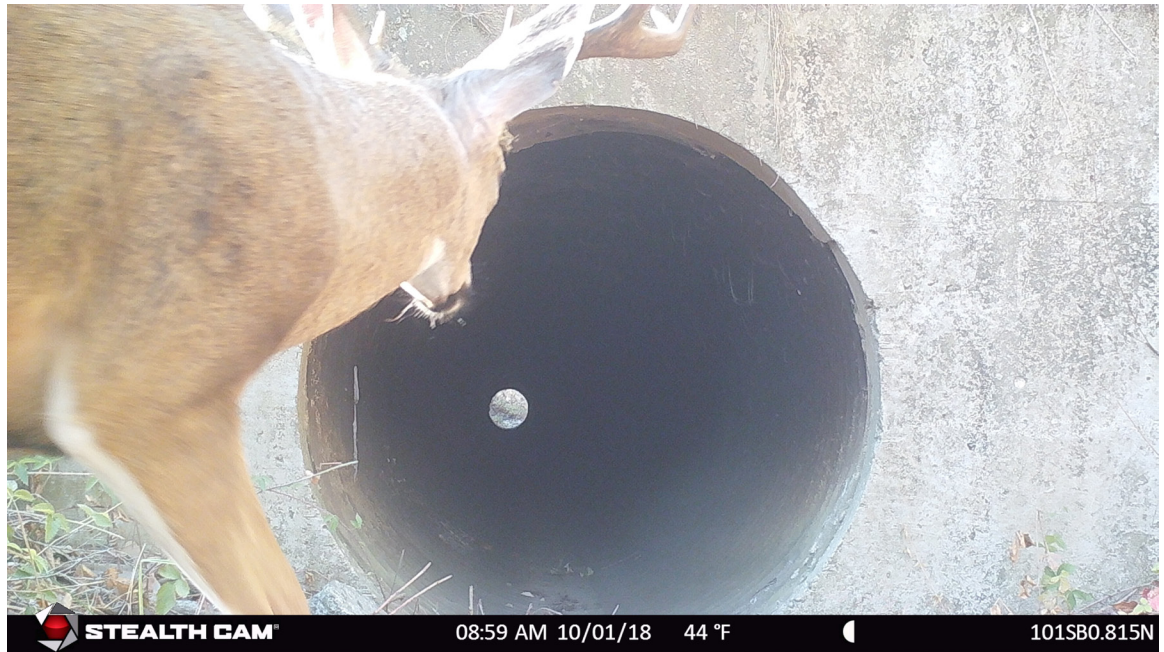
Deer approaching US 101 Site 15, but not traveling through the culvert.

through the culvert, but no deer passages were recorded, suggesting another factor was limiting deer use of this structure, such as fencing, development, and/or habitat quality. Site 15 is likely slightly undersized to facilitate deer passage (3' 10" wide and 4' high) although deer were observed using culverts at San Felipe Lake of similar height (6' wide and 4' high).

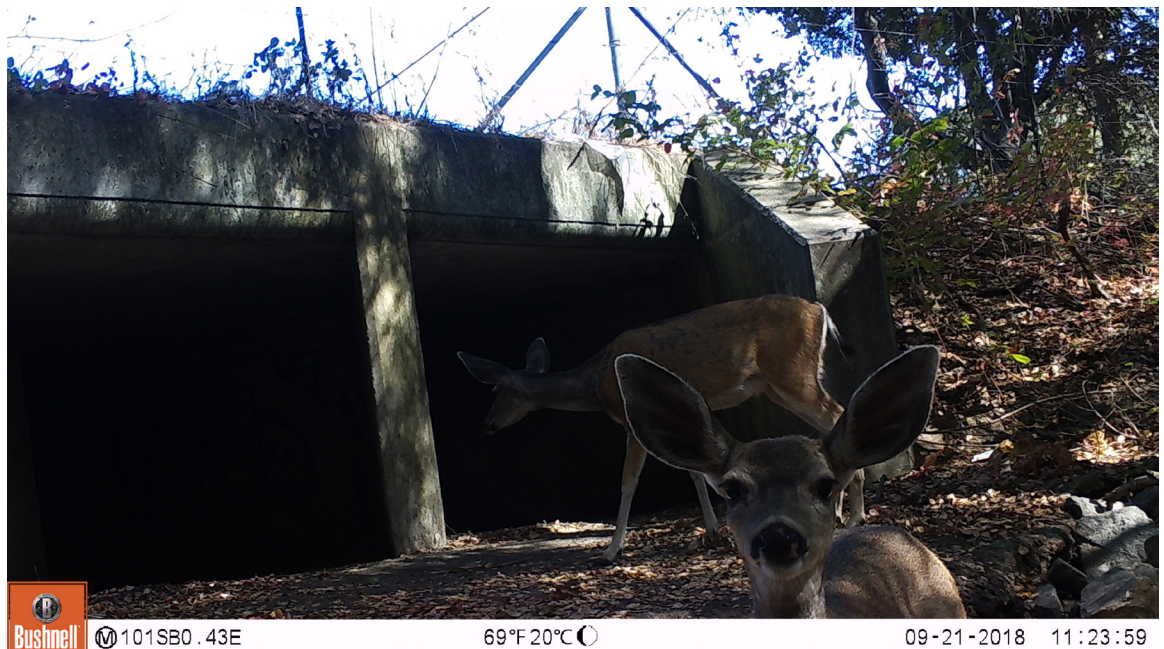
Deer approaching but not traveling through the pair of box culverts at US 101 Site 17.

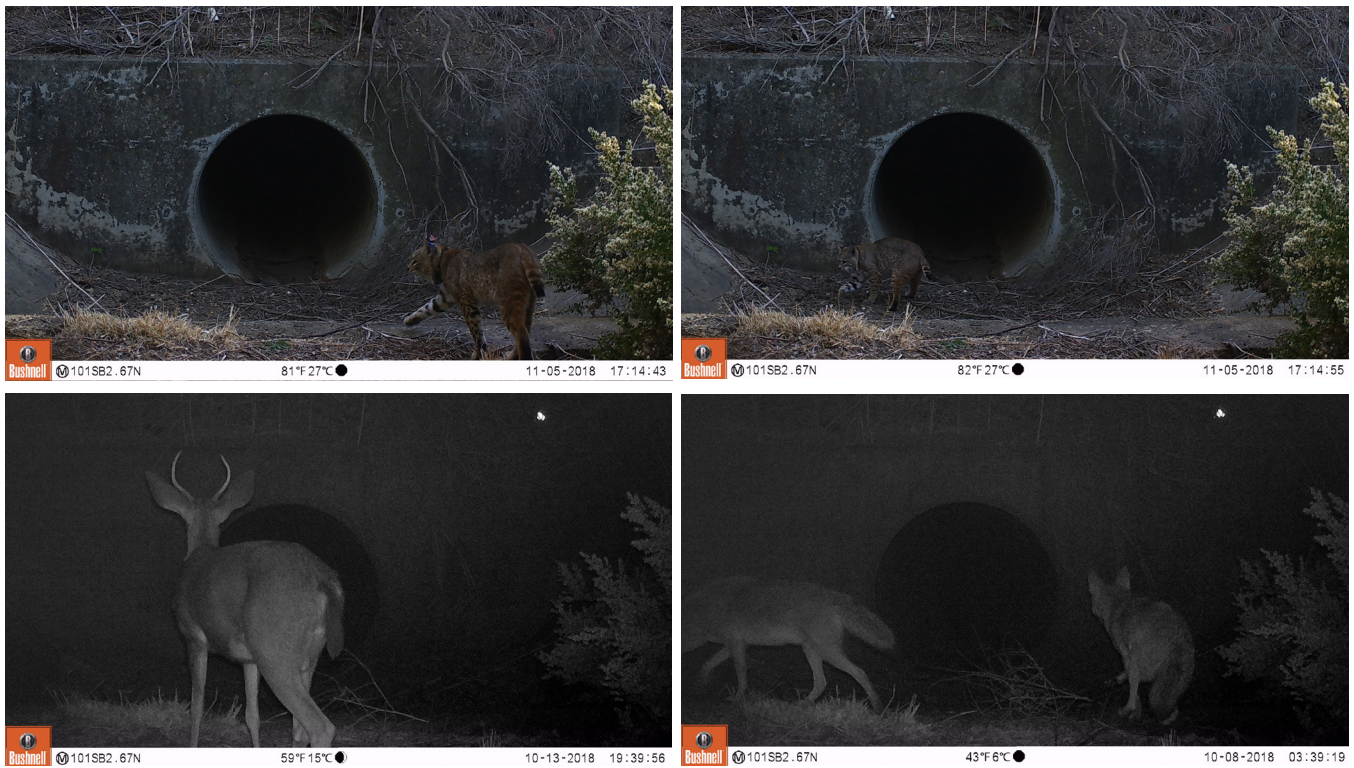
Wildlife approaching but not traveling through the culvert at US 101 Site 7. This culvert is angled and obscured by brush, and visibility is poor.

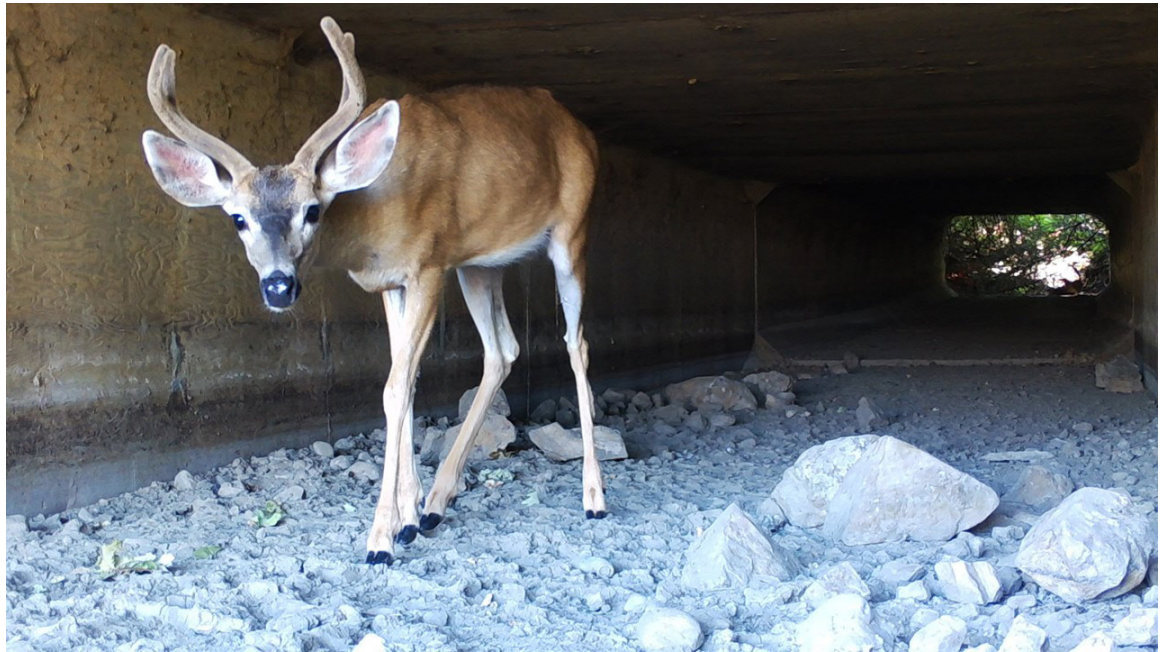
Male deer traveling through the SR 152 Site 2 San Felipe Lake box culvert toward the lake.

in this section (tied with SR 152 Site 6), with six native species detected (Figure 2.23). SR 152 Site 2 was the only site in this section where passage by gray fox and deer were recorded. The deer observations were surprising because the culvert is relatively small (4' height). A coyote pair and juvenile along with a raccoon family were also consistently recorded using this culvert throughout the year. This site was only one of two sites in the study area that recorded passage by wild pig, with 225 total passages detected across all trap nights (Figure 2.24). This culvert is close to San Felipe Lake, which is likely an important year-round source of water for animals. It also connects to expansive open grassland habitat to the north.

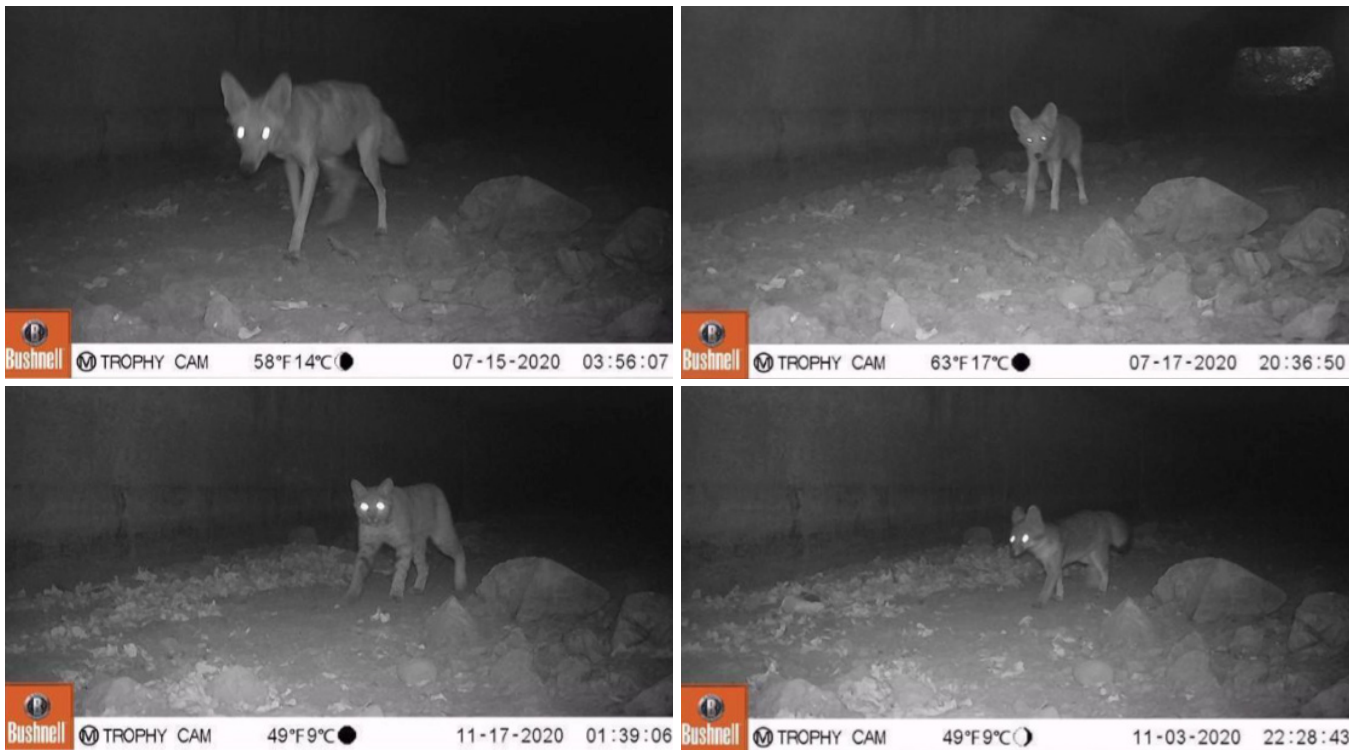
Frequent users of the SR 152 Site 2 San Felipe Lake box culvert included an adult and juvenile coyote (top), bobcat (bottom L), and gray fox (bottom R).

SR 152 Site 2 San Felipe Lake box culvert was by far the most-utilized undercrossing in this section and facilitated the highest number of native species passages in the entire study area, with 594 passages recorded across all trap nights (376 passages in the 100 trap nights analysis) (Figure 2.23). This site had the highest species richness

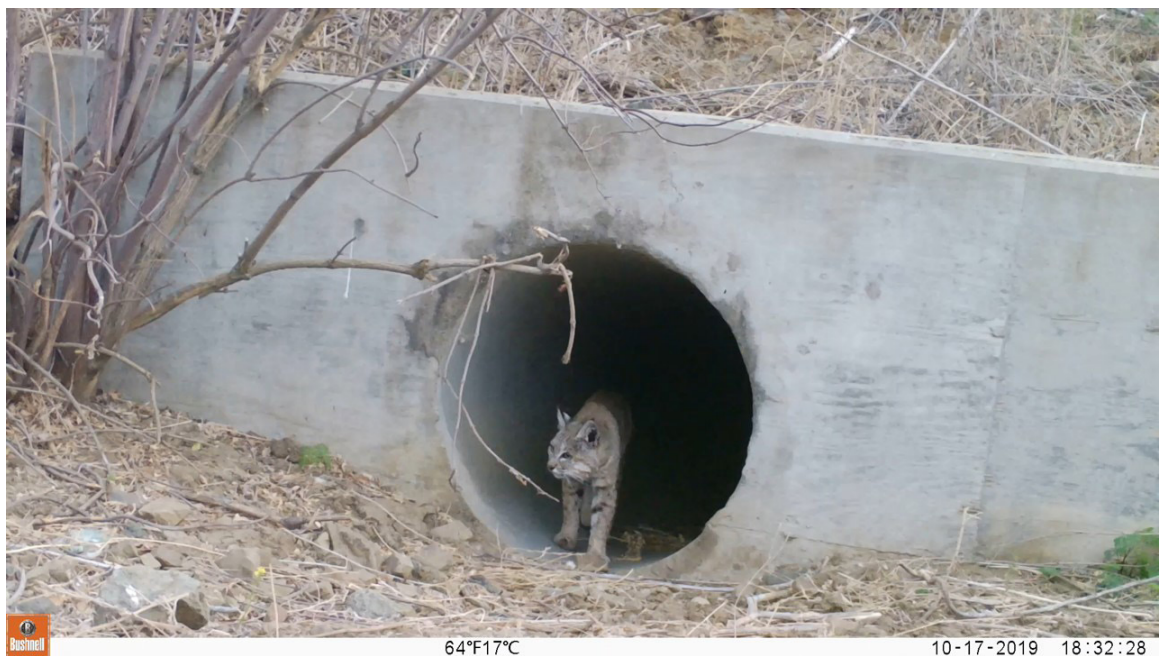
Bobcat traveling through SR 152 Site 6 Tree round culvert

SR 152 Site 6 had the second-highest native species passages in this section, with 471 passages across all trap nights (159 passages in the 100 trap nights analysis) (Figure 2.23). It also tied with SR 152 Site 2 for the highest species richness in this section, with six native species detected (Figure 2.23). A long-tailed weasel was recorded looking into the culvert, but no passages were recorded at this or any other site in the SR 152 Pajaro Valley section. This site recorded three successful passages by badger, with grassland habitat present on both sides of this culvert.

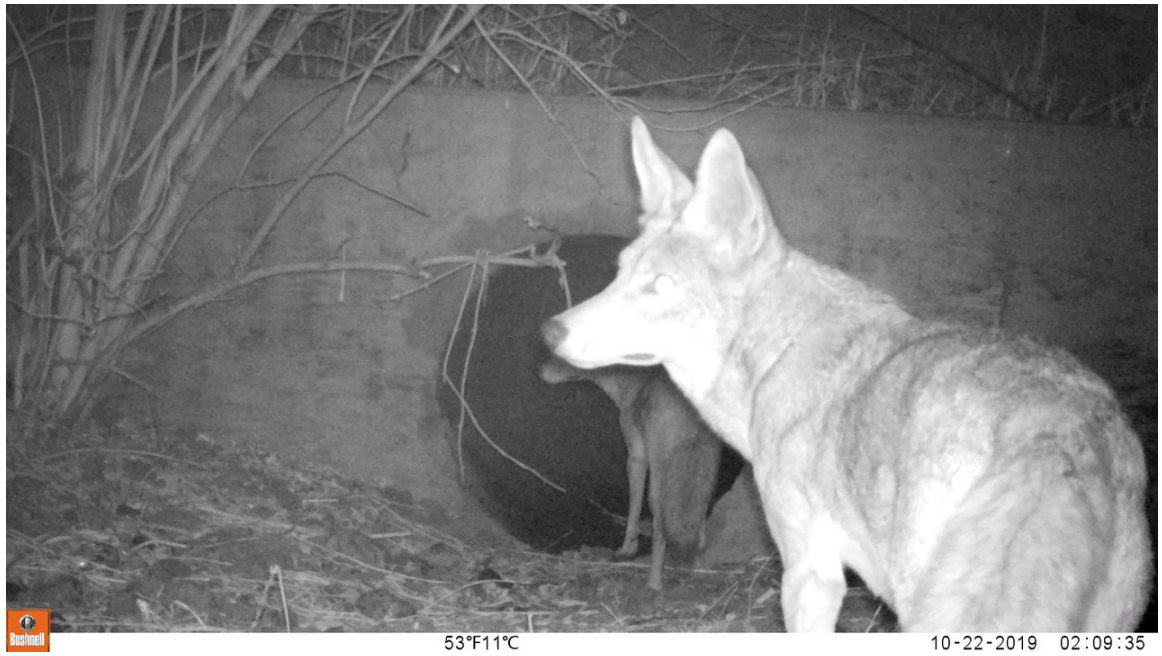
Coyote pair traveling through SR 152 Site 6 Tree round culvert.
