# Enhancing ecological connectivity and safe passage for wildlife on highways between the southern Santa Cruz Mountains, Gabilan Range, and Diablo Range in California

Diamond, TD, A Sandoval, NP Sharma, ME Vernon, PD Cowan, AP Clevenger, and SC Lockwood. 2022. *Enhancing ecological connectivity and safe passage for wildlife on highways between the southern Santa Cruz Mountains, Gabilan Range, and Diablo Range in California*. Pathways for Wildlife and Peninsula Open Space Trust, Palo Alto, CA.

AUGUST 2022

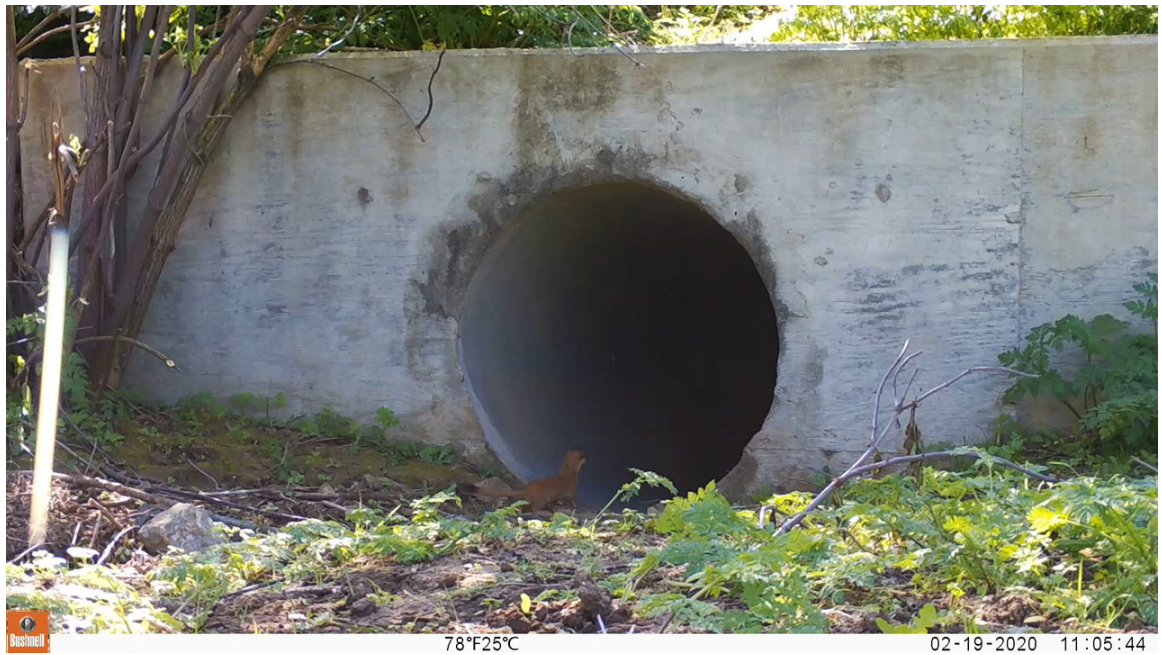
Long-tailed weasel looking into the SR 152 Site 6 Tree round culvert.

SR 152 Site 6 had the second-highest native species passages in this section, with 471 passages across all trap nights (159 passages in the 100 trap nights analysis) (Figure 2.23). It also tied with SR 152 Site 2 for the highest species richness in this section, with six native species detected (Figure 2.23). A long-tailed weasel was recorded looking into the culvert, but no passages were recorded at this or any other site in the SR 152 Pajaro Valley section. This site recorded three successful passages by badger, with grassland habitat present on both sides of this culvert.

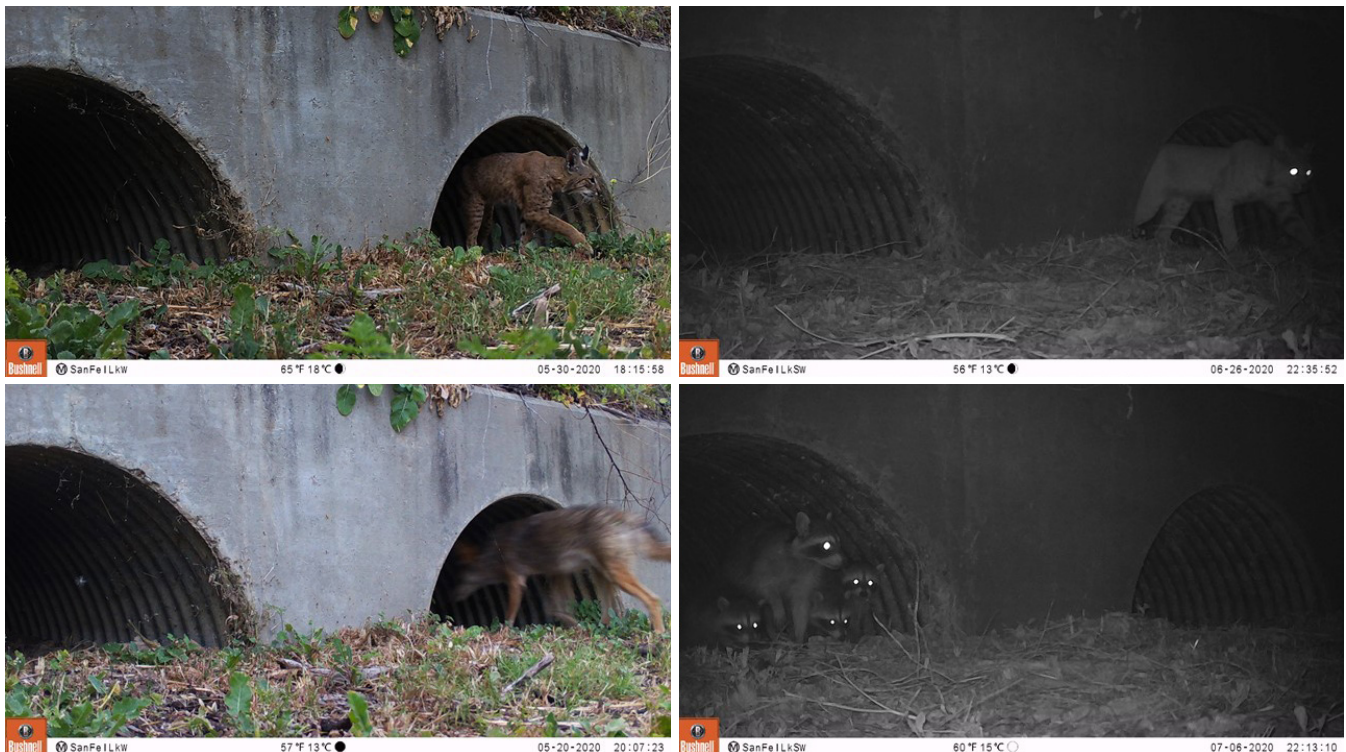
Medium-sized mammals used SR 152 Site 1 San Felipe Lake dual round culverts throughout the year, including bobcat (top L and R), coyote (bottom L) and a raccoon family (bottom R).

SR 152 Site 1 San Felipe Lake dual round culverts recorded 209 native individuals across all trap nights (124 passages in the 100 trap nights analysis). This site saw consistently high rates of passage by coyote, bobcat, raccoon, and skunk throughout the study period (Figure 2.23). With San Felipe Lake holding water even during the height of the drought season, the water source could be attracting wildlife from the hillsides; this could account for the high rate of passages.

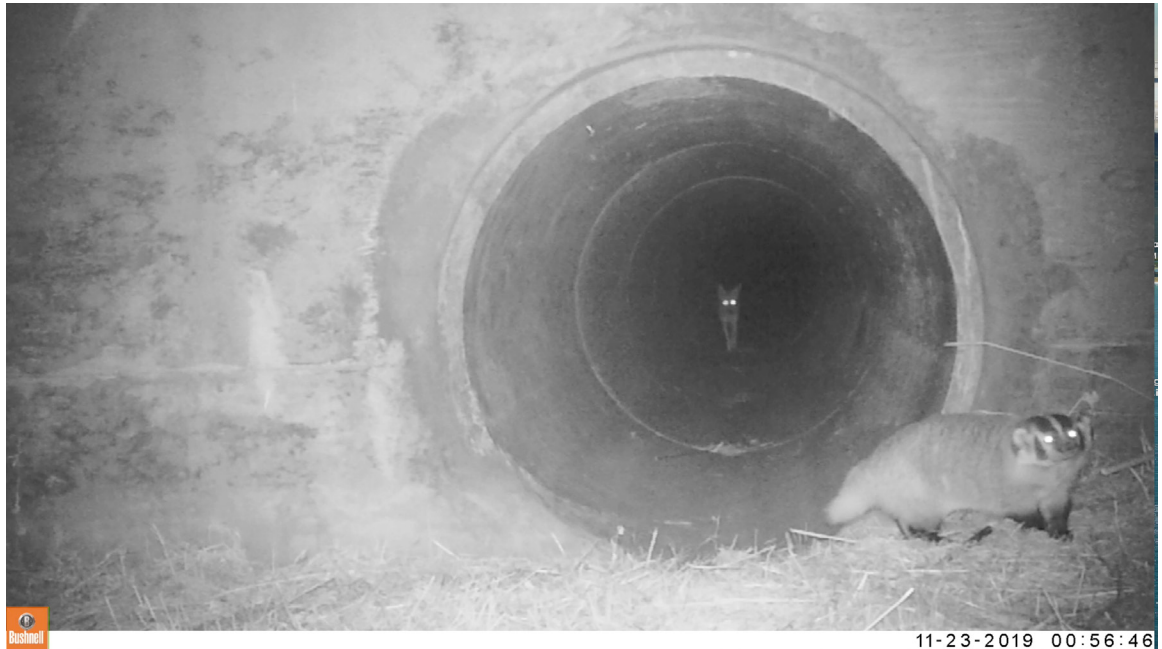
American badger and coyote traveling north through the culvert at SR 152 Site 4 Coyote and badger culvert on November 23, 2019.

At SR 152 Site 4, we recorded an American badger and coyote traveling together through the culvert in both directions. This is the first known documentation of a badger and coyote traveling together through a highway culvert. Nine months later, we documented what appeared to be the same individuals traveling together, with the coyote passing through first, followed by the badger eight minutes later. Cameras at this site also routinely recorded a family of three coyotes traveling through the culvert in both directions throughout the study period. Because we recorded so few coyotes at this site, it's possible that one of these coyotes — in particular the sub-adult — was the coyote traveling with the badger. Other species detected traveling through this culvert regularly throughout the study period included bobcat, raccoon, and skunk.

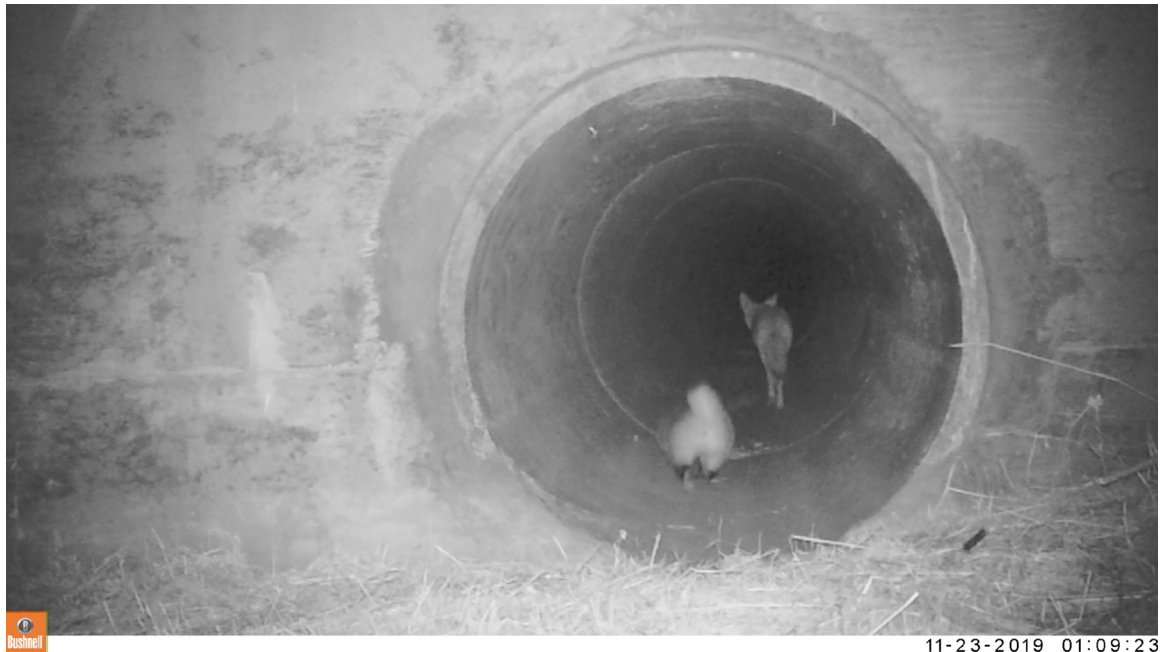
American badger and coyote traveling back south through SR 152 Site 4 Coyote and badger culvert on November 23, 2019.

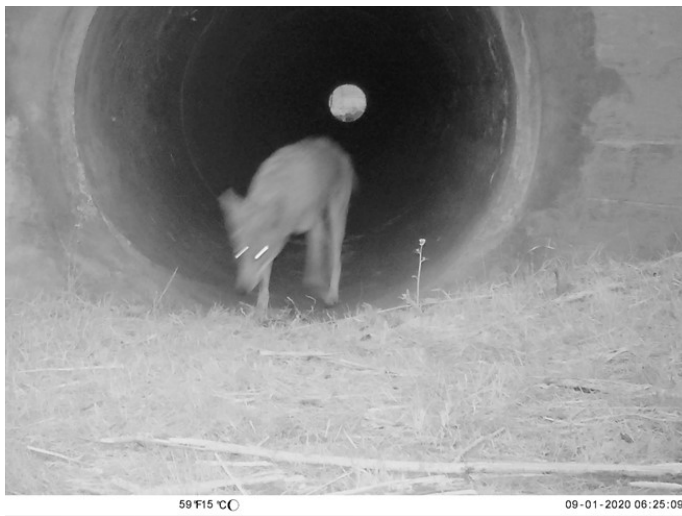
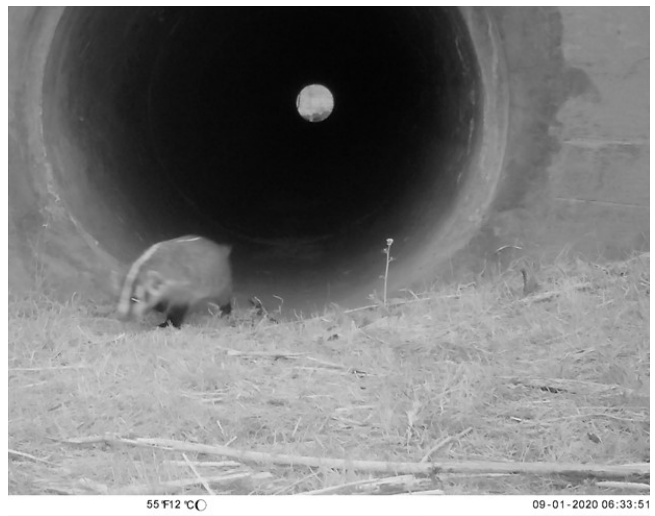
American badger and coyote traveling north through SR 152 Site 4 Coyote and badger culvert eight minutes apart.

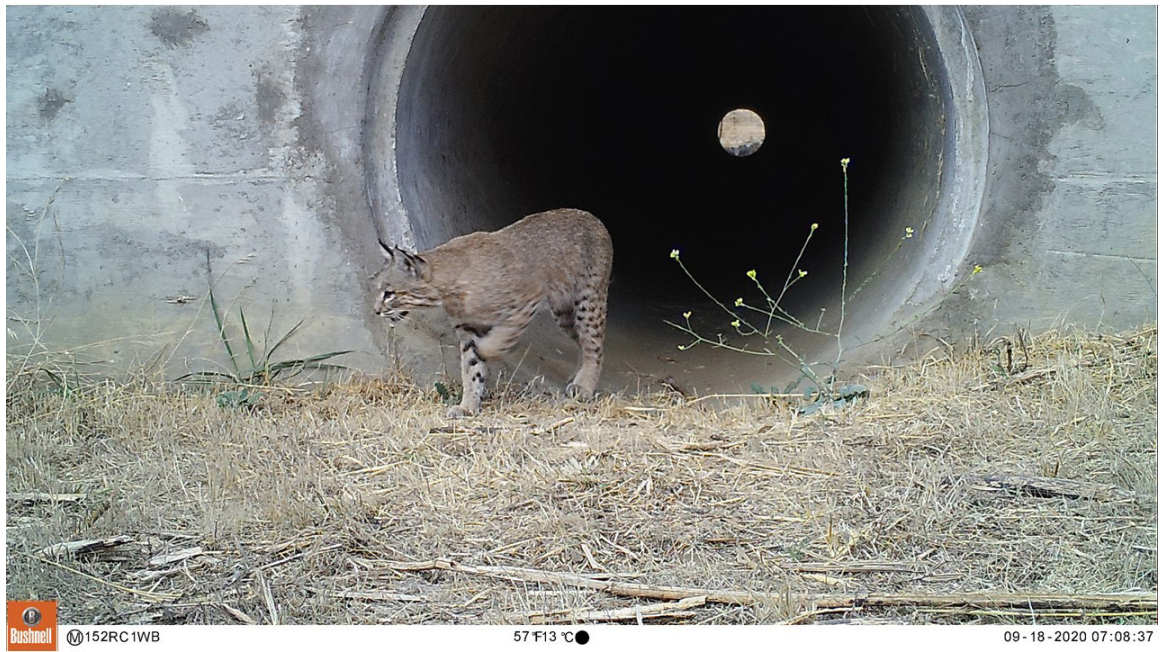
Bobcat traveling through SR 152 Site 4 Coyote and badger culvert.

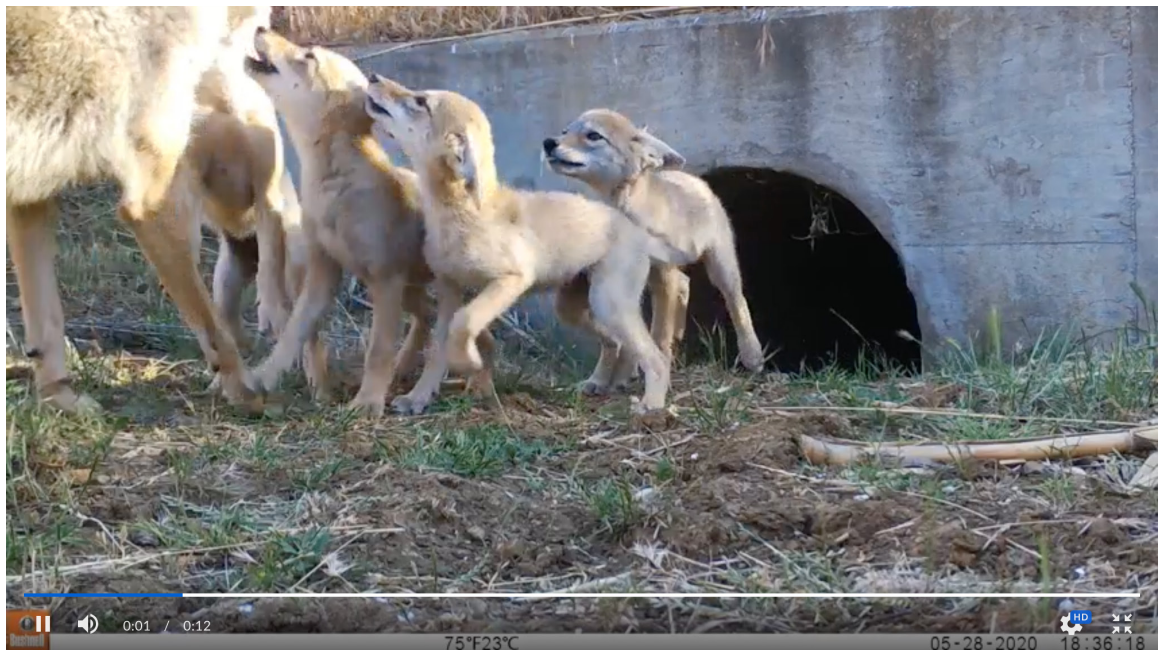
Adult coyote traveling with pups through SR 152 Site 5 Coyote puppy culvert.

At the middle culvert east of the Ortega Creek Bridge, SR 152 Site 5 Coyote Puppy culvert, we recorded a coyote family traveling through the culvert in spring of 2020. Badgers were also recorded passing through this site, as well as through the culvert to the east (SR 152 Site 6 Tree round culvert). Based on a badger's home range size and the face and back markings, these recordings are most likely of the same individual. This site connects grassland habitat on either side of the highway.

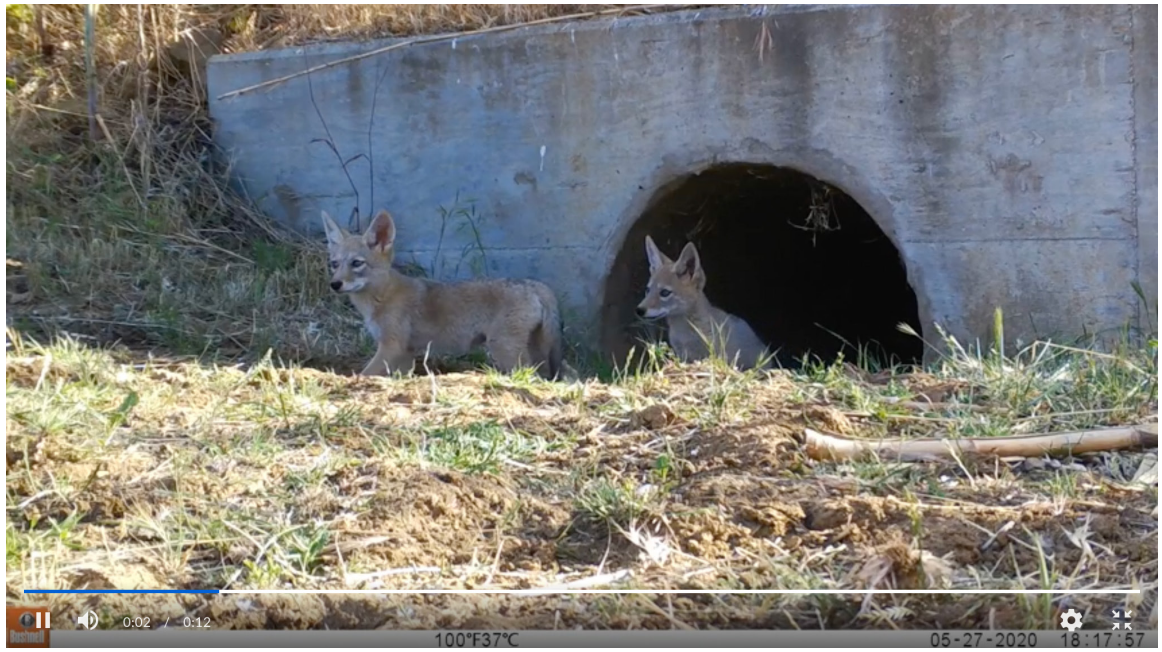
Coyote pups traveling through SR 152 Site 5 Coyote puppy culvert.

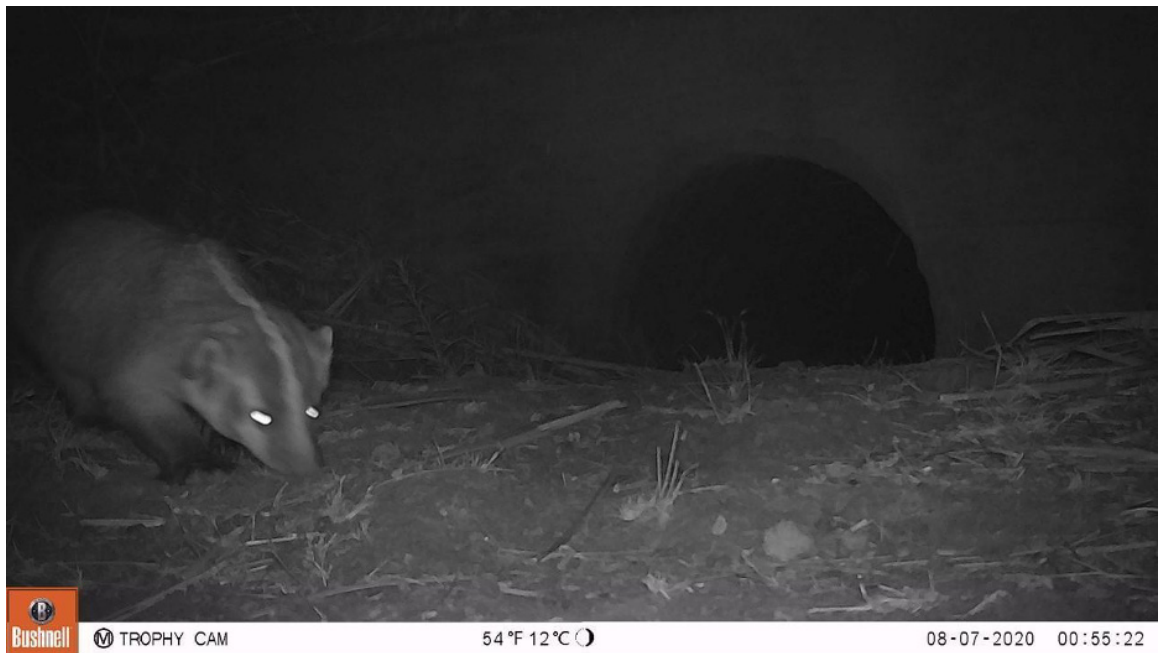
American badger traveling by SR 152 Site 5 Coyote puppy culvert.

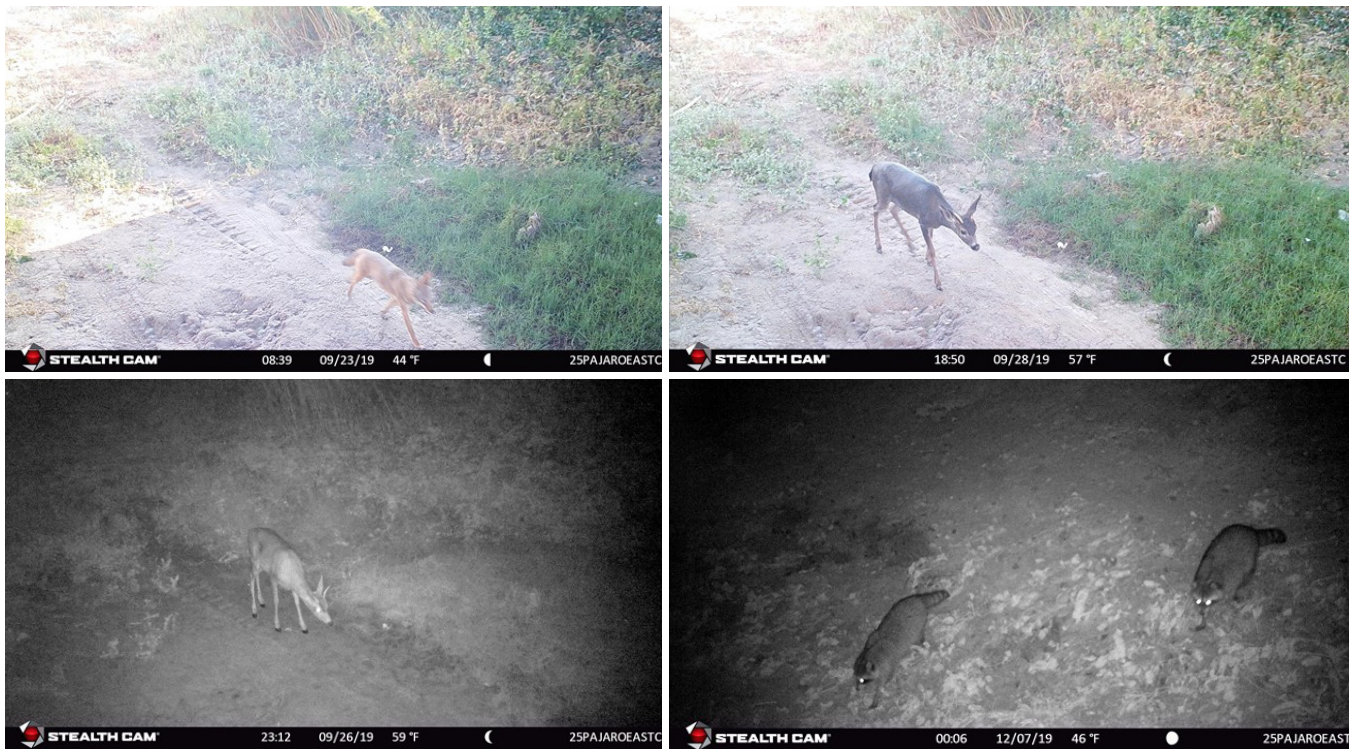
Coyote, deer, and raccoon traveling beneath the bridge at SR 25 Site 2 Pajaro Bridge.

Deer were recorded only under SR 25 Site 2 Pajaro River Bridge, with a total of 14 passages (Figure 2.26). We also recorded more passages by coyotes and bobcats at SR 25 Site 2 Pajaro River Bridge relative to SR 25 Site 1 Carnadero Creek Bridge (Figure 2.26), including a coyote family routinely traveling under this bridge. SR 25 Site 1 Carnadero Creek Bridge was one of only two camera monitoring sites (along with SR 129 Site 8) of the 42 we monitored in this study where we recorded a bobcat traveling with two kittens.

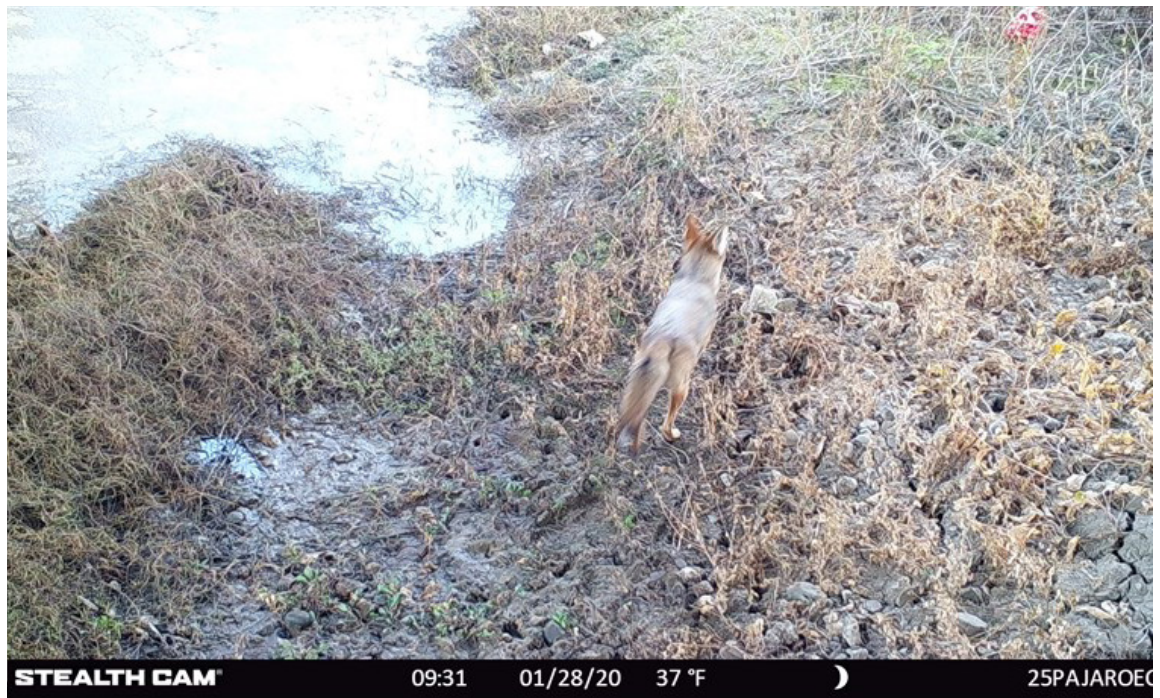
A coyote family of three traveled both north and south through the SR 25 Site 2 Pajaro Bridge undercrossing on January 28, 2020.

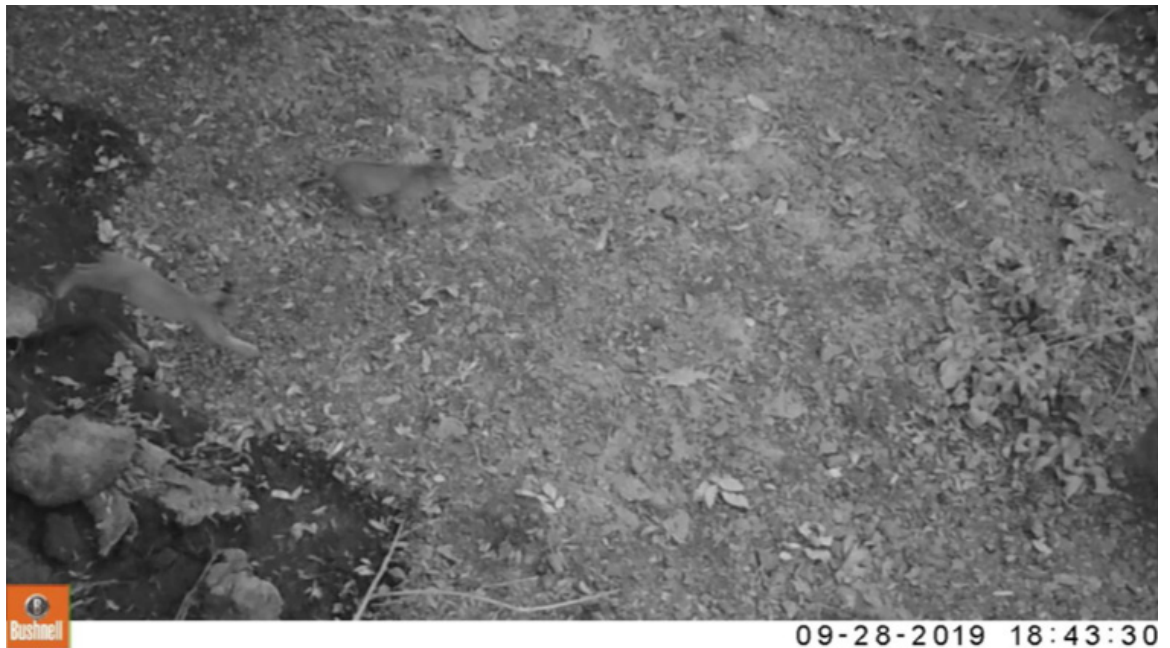
At SR 25 Site 1 Carnadero Creek Bridge, we recorded a female bobcat traveling with two kittens.

SR 25 Site 1 Carnadero Creek Bridge had slightly more native species passages (43 passages in the 100 trap nights analysis) than SR 25 Site 2 Pajaro River Bridge when standardized on a trap night basis (Figure 2.26). While we initially recorded coyotes and bobcats traveling along the bank on a consistent basis, there was a substantial decrease in the number of passages at this site in the months of December through April. During this period, increased water levels in the creek decreased the amount of dry bank available for wildlife to use in the middle section of the bridge. When water was high and there was very little bank left, we only recorded raccoons swimming across the creek to access the other side of the bridge through the middle section. The westernmost section of the bridge was along an agricultural field, and tractors were driven back and forth under the bridge through this western section, which might have deterred wildlife use. This site also had one recorded passage by non-native red fox (Figure 2.27).

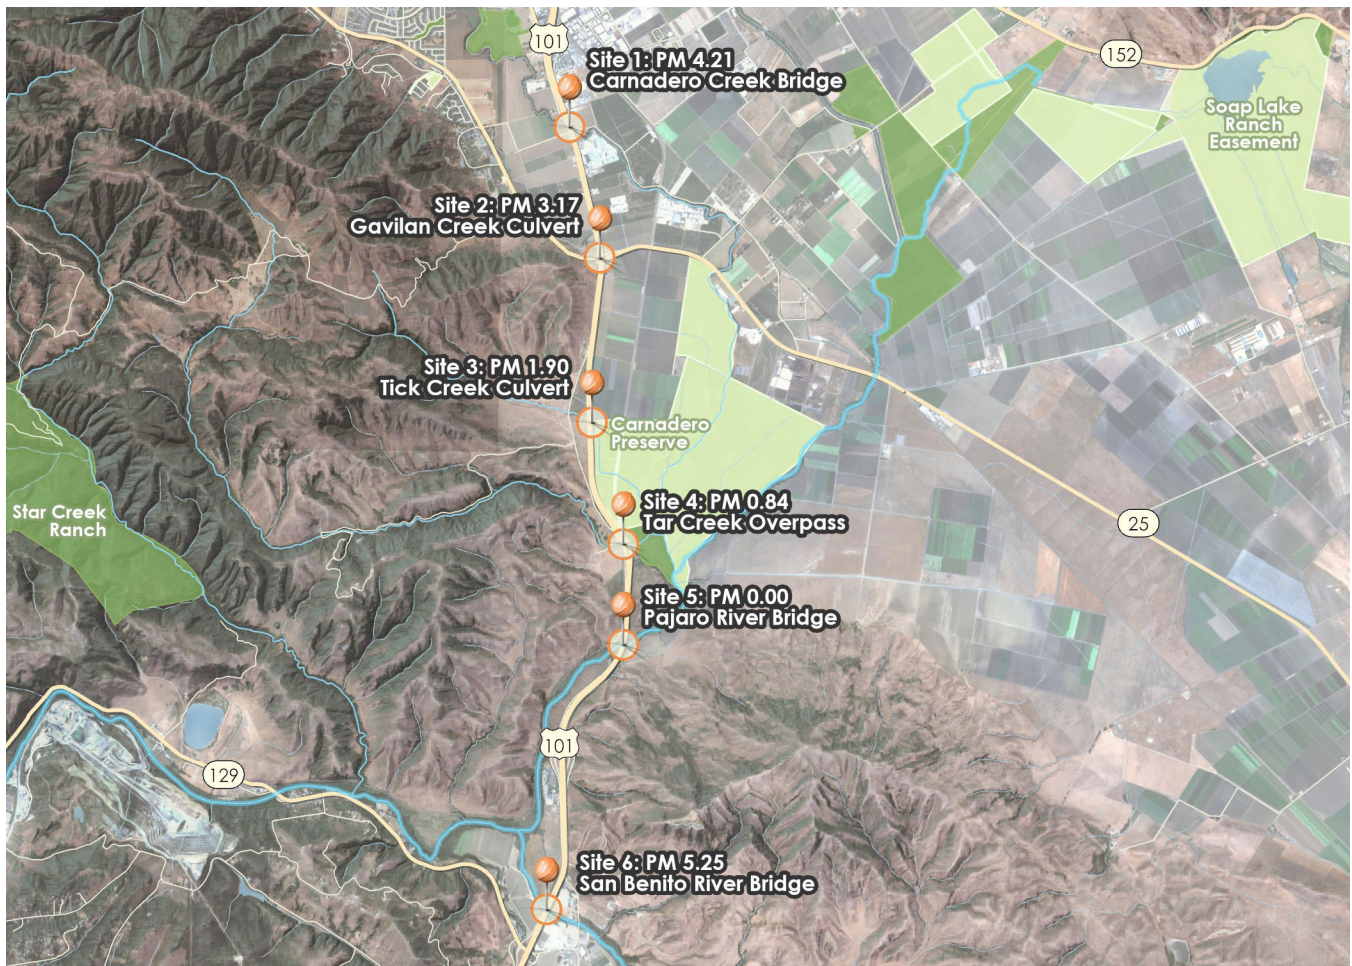
**Figure 2.28.** Map of camera monitoring sites in the US 101 Pajaro Valley section.

The US 101 Pajaro Valley section consists of six camera monitoring sites: four crossings beneath bridges or overpasses, and two culverts (Figure 2.28). We recorded a total of 1,564 passages by native species in this section. When standardized, this section recorded a total of 561 native species passages with an average of 93 passages, the second highest in the study area. We detected eight native species in this section, the highest of any section. The native species with the highest passage rates when standardized were deer (323), raccoon (110), and coyote (73) (Figure 2.29). Notably, 91 total bobcat passages were recorded in this section. The presence of several bridges and one highway overpass suitable for passage by a variety of mammals as well as this highway's interface core habitat in the southern Santa Cruz Mountains may have contributed to the high native species richness. This section had the highest number of passages by non-native red fox within the entire study area (168), all recorded at US 101 Site 1 Carnadero Creek Bridge (Figure 2.30).

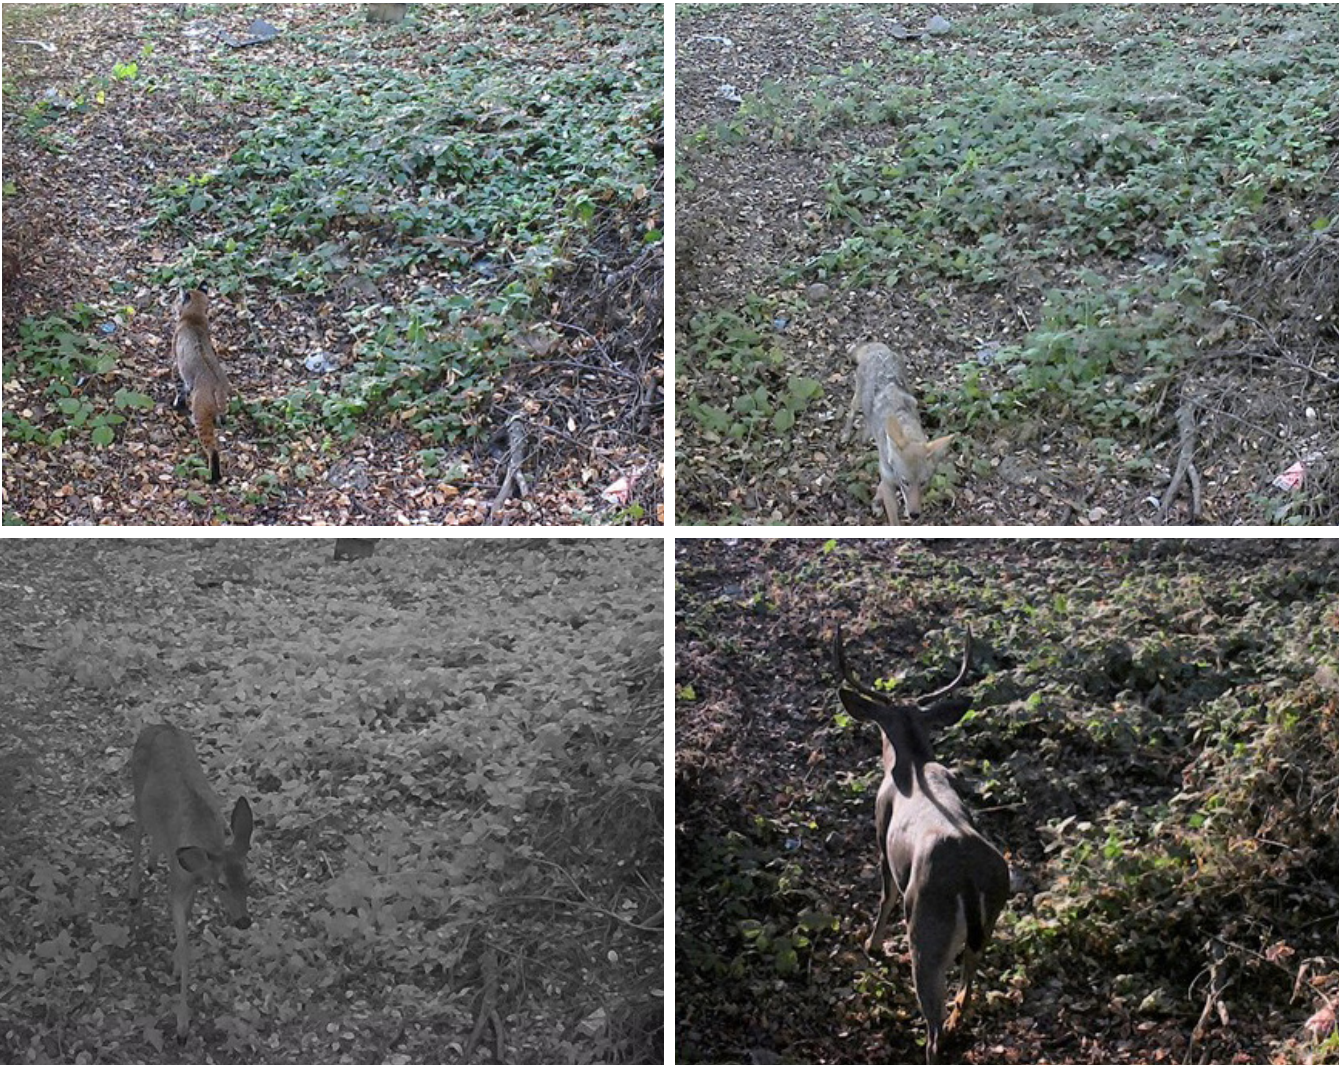
Various wildlife crossing at US 101 Site 5 Pajaro Bridge.

US 101 Site 5 Pajaro River Bridge facilitated the highest number of native species passages in this section, with a total of 502 passages across all trap nights (226 passages in the 100 trap nights analysis) (Figure 2.29). Bobcat, deer, skunk, and raccoon were routinely recorded traveling under the bridge. This site had five native species recorded (Figure 2.29) and was also only one of two in the entire study area where wild pig passages were recorded (six total passages) (Figure 2.30). US 101 Site 6 San Benito River Bridge had the second-highest number of documented passages by native wildlife in this section, with a total of 421 passages across all trap nights (118 passages in the 100 trap nights analysis) (Figure 2.29). Both of these bridges feature a wide riparian corridor with high-quality habitat, which likely contributed to high passages by native wildlife and high species richness.

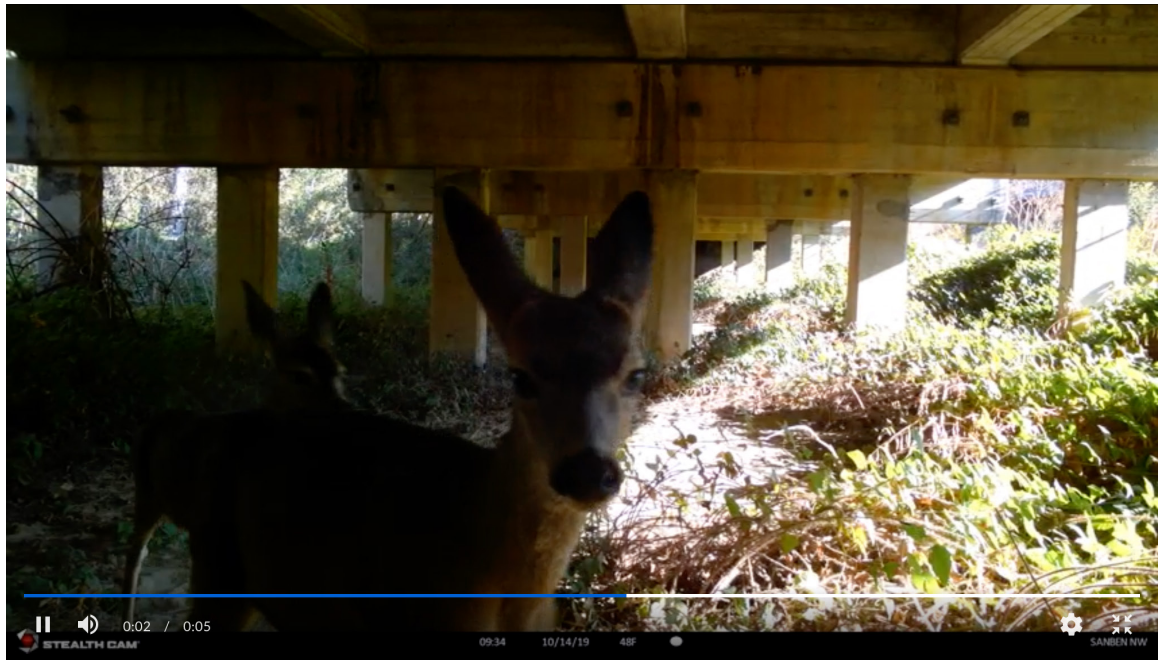
Female deer with two fawns traveling under the US 101 Site 6 San Benito Bridge.

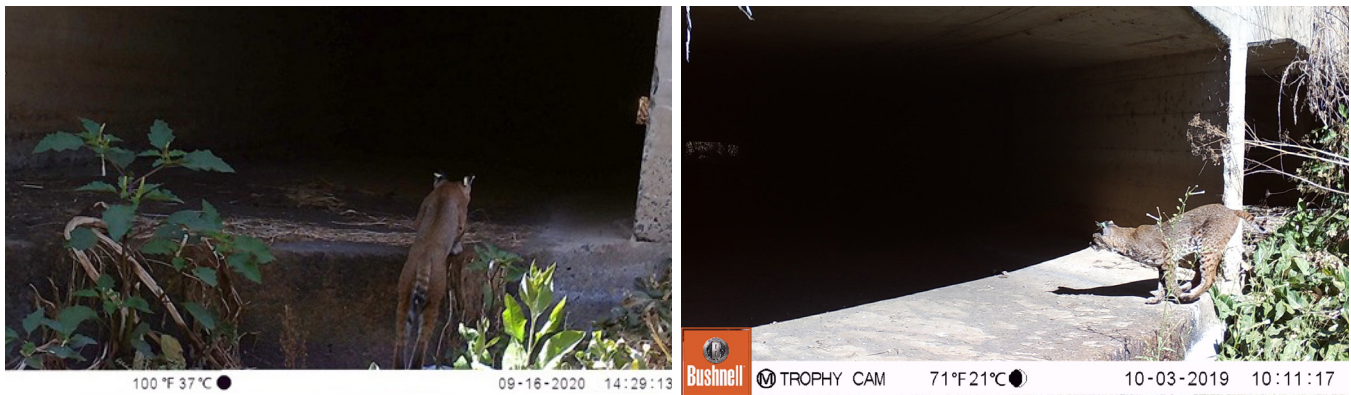
Bobcat in US 101 Site 3 Tick Creek culvert. The animal in the left photo has two yellow ear tags.

US 101 Site 3 Tick Creek culvert recorded the most bobcat passages within the section (Figure 2.29). Two bobcats with ear tags (from another study) were recorded heading both into Carnadero Preserve and from the preserve into the Sargent Hills. A family of four coyotes was also consistently recorded using this culvert. These data suggest this is an important culvert for facilitating movement of medium-sized mammals.

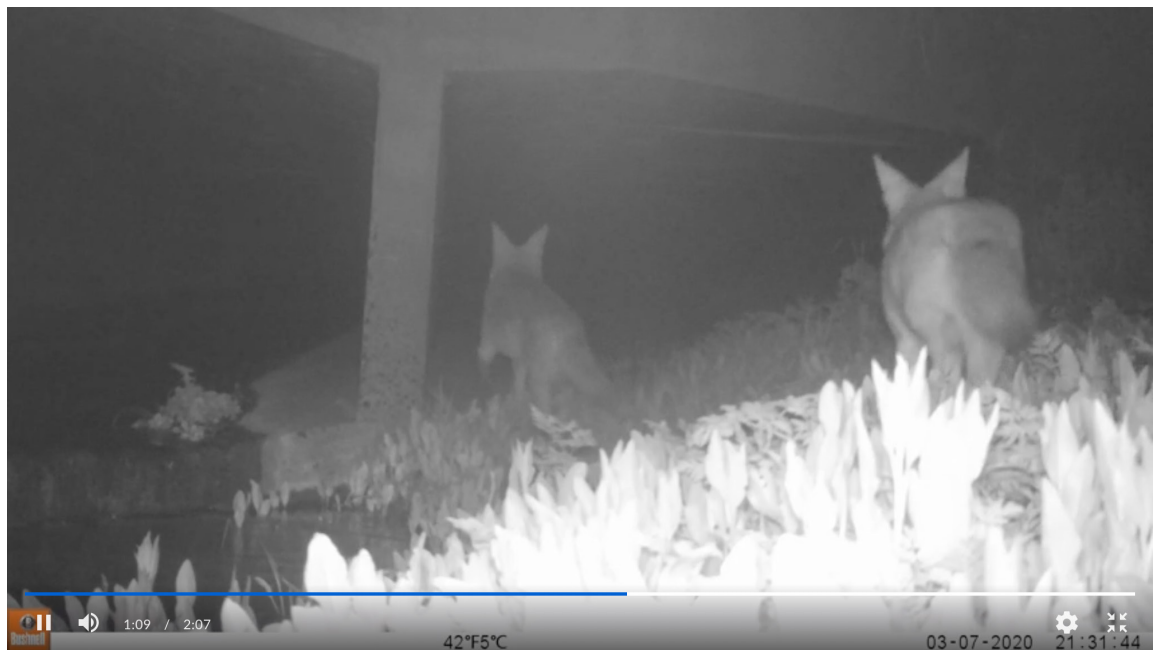
Coyote family traveling west into the Sargent Hills through the US 101 Site 3 Tick Creek Culvert.

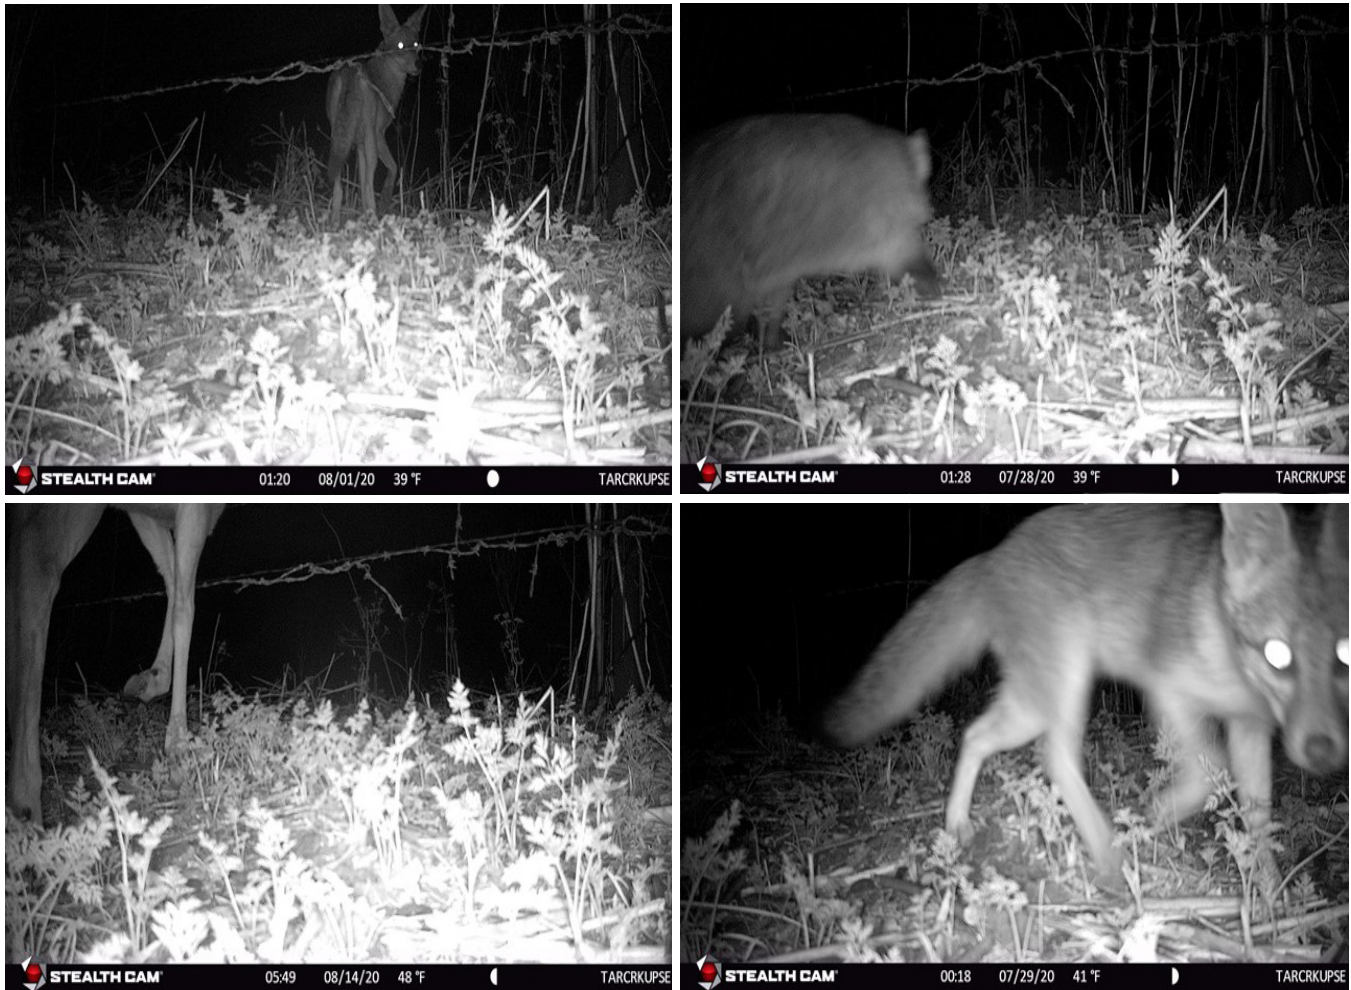
Wildlife recorded in the US 101 Site 4 Tar Creek overpass included coyote (top L), badger (top R), deer (bottom L) and gray fox (bottom R).

The US 101 Site 4 Tar Creek overpass had the highest species richness in the entire study area, with eight species detected (Figure 2.29). Native species detected with successful passage included badger, bobcat, coyote, deer, gray fox, long-tailed weasel, raccoon, and skunk. We also detected a coyote family and opossum at this site, along with ground squirrels, rabbits, San Francisco dusky-footed woodrats, and other unidentified rodents, though we did not calculate the number of passages by these small mammals.

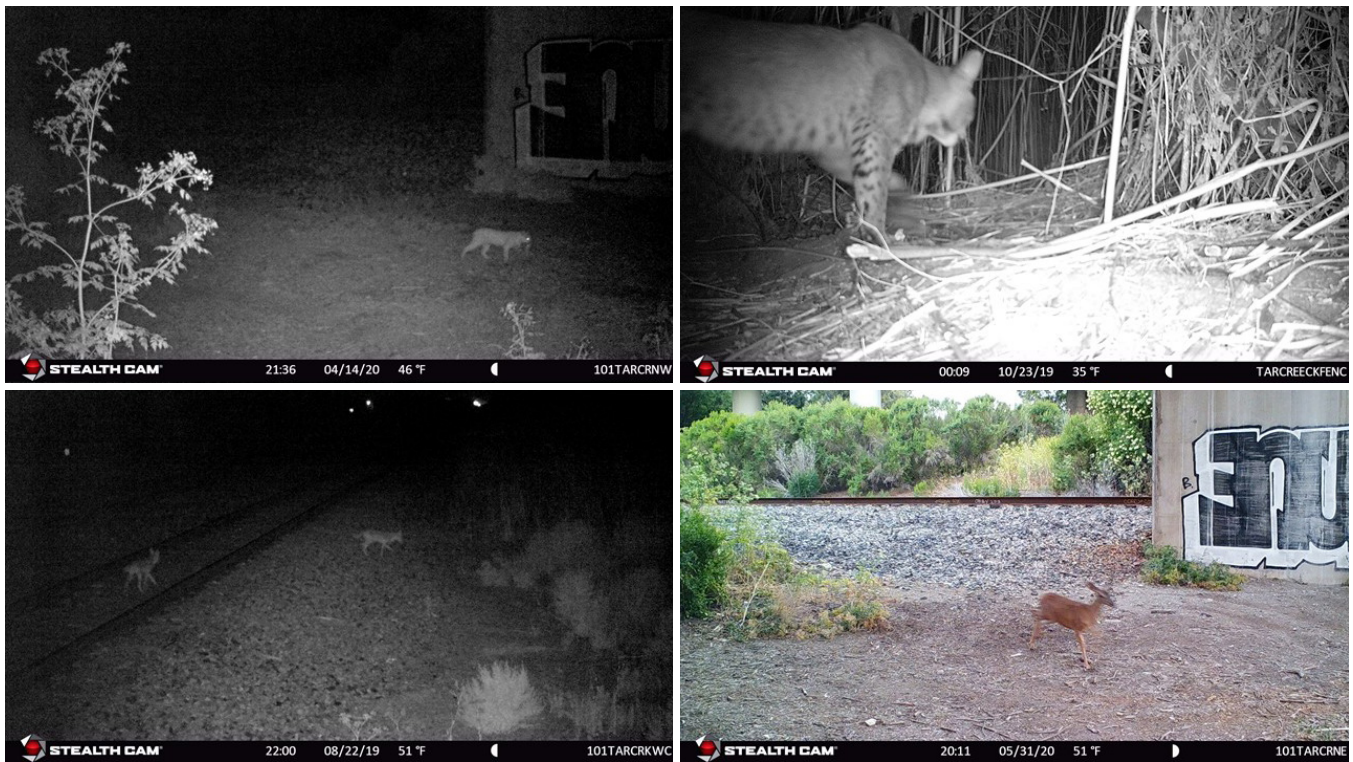
We also recorded bobcat (top), coyote (bottom L), and deer (bottom R) in the US 101 Site 4 Tar Creek overpass.

As evaluated in the aforementioned studies, the Tar Creek overpass is of particular value in supporting existing connectivity. This site facilitates movement by adults and juveniles (deer, coyote, and bobcat) between core habitat in the Santa Cruz Mountains through the Upper Pajaro Valley and supports a diverse assemblage of native wildlife, the highest recorded in the study area. Though the Upper Pajaro is largely agricultural, past studies have documented species such as deer, coyote, and bobcat using this landscape for movement, including in the Carnadero Preserve, which is adjacent to the Tar Creek overpass (Diamond and Snyder 2013).

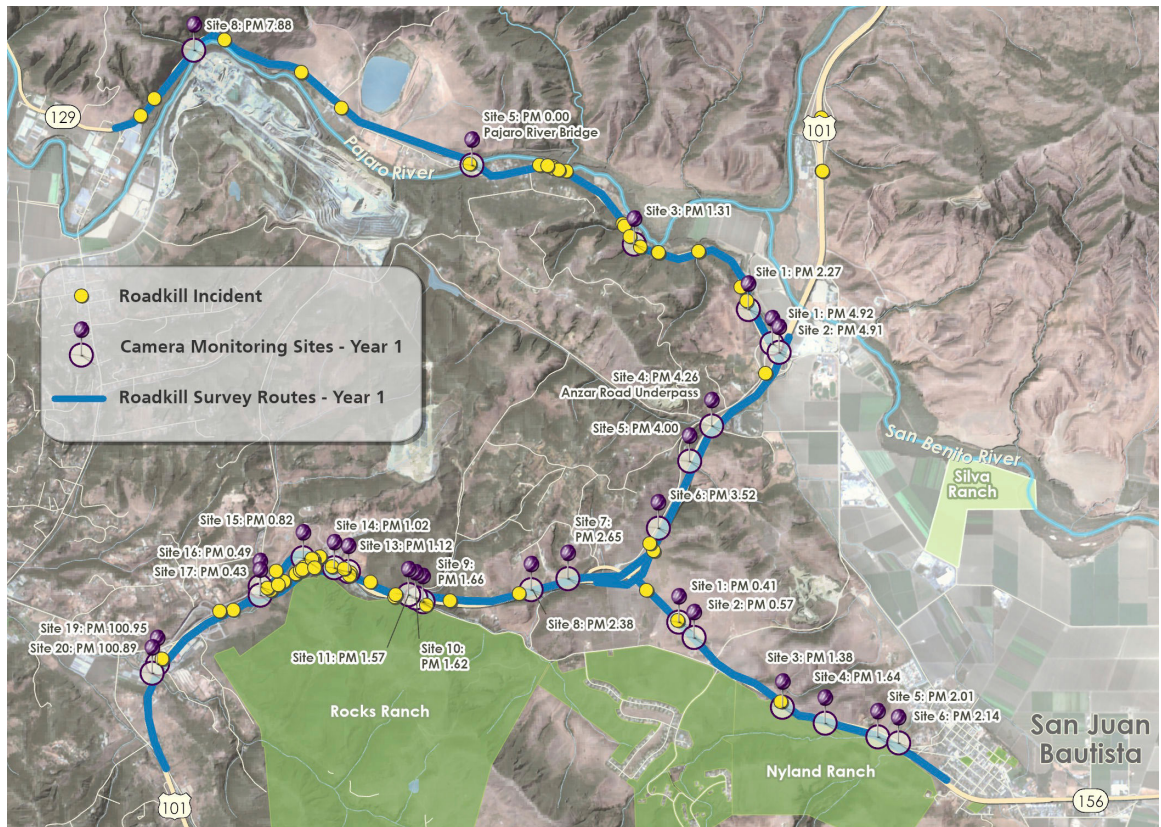
**Figure 3.5.** Locations of all roadkill records (from this study, additional records from previous studies, personal communications by other researchers, and CNDDDB records - available for badger only) in the Pajaro Valley subarea (top) and the Aromas subarea (bottom).

We found several segments of highway with relatively high concentrations of WVC. The main area of concentrated roadkill was the US 101 Aromas Hills section west of the junction of US 101 with SR 156, specifically between the Eucalyptus Grove culverts and the Habitat Island culverts. The lack of large culverts spanning the entire highway in the Eucalyptus Grove region and low rates of native species passages through the existing culverts may have contributed to wildlife attempting to cross US 101 at-grade near this location. Additionally, the Habitat Island culverts were investigated but not used by deer, which again may have contributed to deer attempting to cross US 101 at-grade. Because the Habitat Island median separates the northbound and southbound lanes of US 101, deer may be more likely to attempt to cross at-grade at this location because they have only two lanes to cross.

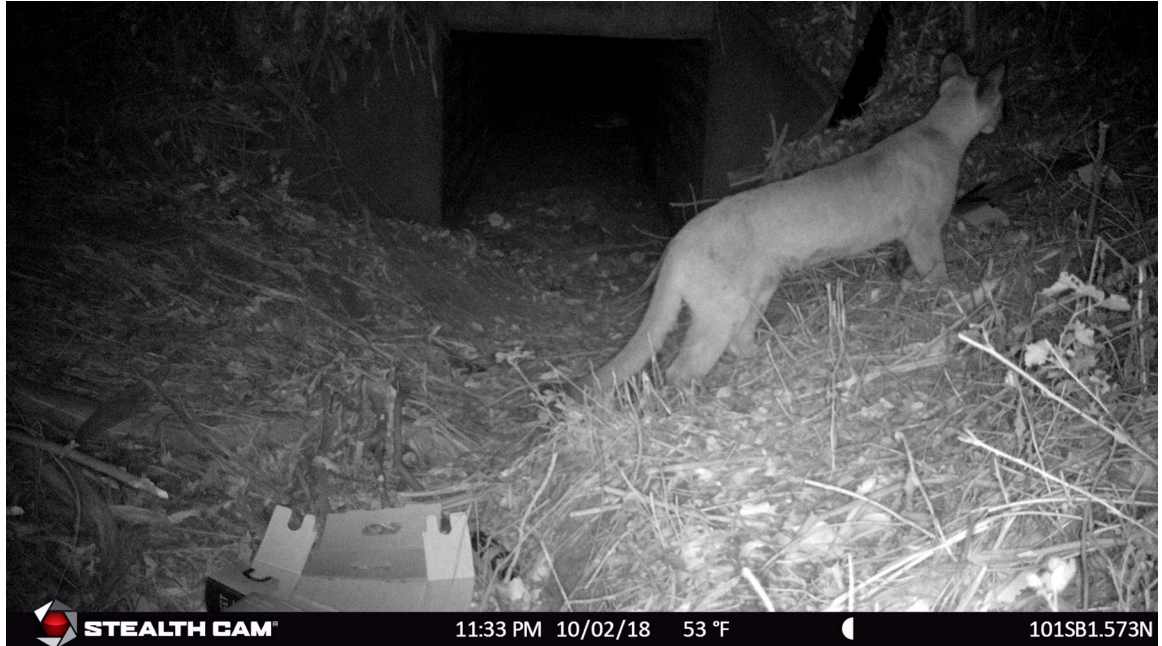
Mountain lion near culvert under US 101 in the Aromas Hills section on October 2, 2018.

As noted in Chapter 2 of this report, in early October 2018, a young mountain lion was recorded on camera approaching two culverts in the Aromas Hills section, near where 54M’s body was recovered: US 101 Site 7 (October 1, 2018) and US 101 Site 11 (October 2, 2018). The individual did not use these culverts to travel beneath US 101. No large mammals were recorded using the Habitat Island or Eucalyptus Grove culverts to travel beneath US 101, suggesting factors such as culvert dimensions and/or land use may be deterring use of these culverts by deer and mountain lion.

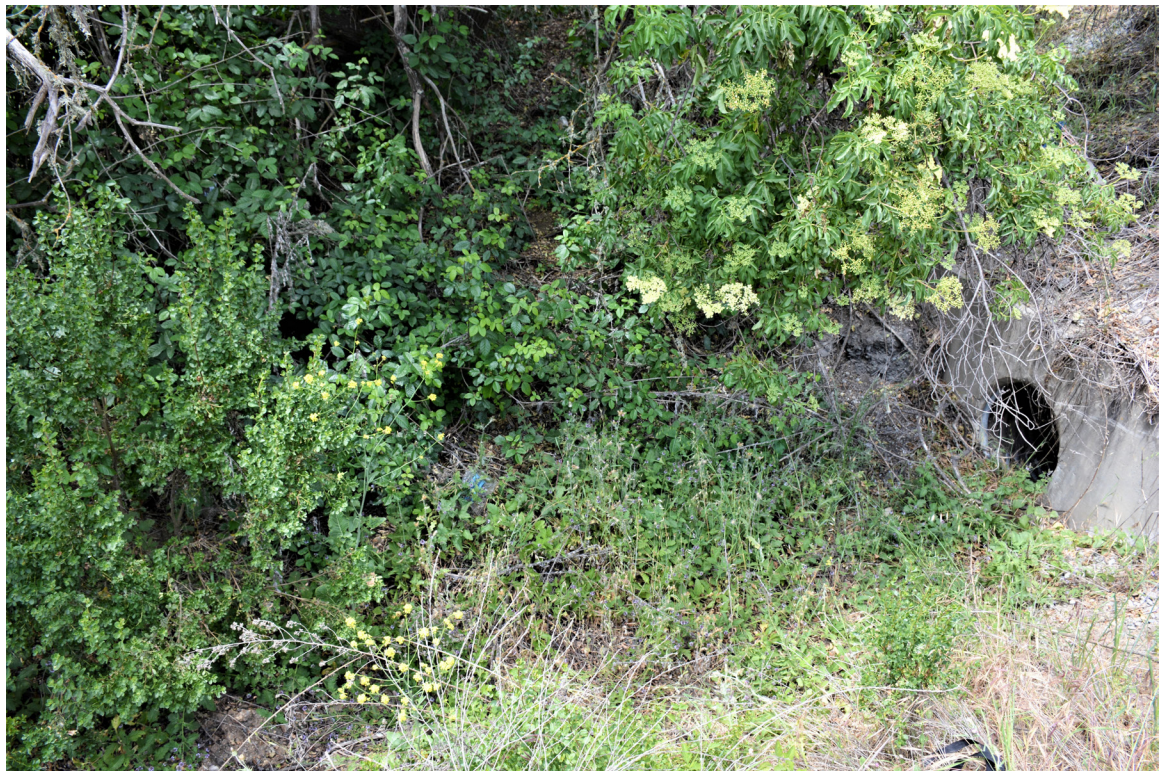
SR 129 Site 1. Southwest opening. Photo faces northwest.

SR 129 SITE 1	
<b>Postmile</b>	SBT, SR 129, PM 2.27
<b>GPS location</b>	Latitude: 36.88695 Longitude: -121.56503
<b>Dimensions</b>	Round corrugated culvert 2' in diameter
<b>Direction</b>	Southwest - northeast. Direction is toward the decline.
<b>Visibility</b>	Yes
<b>Substrate</b>	Corrugated steel (bare bottom). No buildup at southwestern opening.
<b>Habitat/land use</b>	Southwestern area leads to riparian habitat, and open grassland. Northeastern opening leads to Pajaro River.
<b>Wildlife track and sign</b>	Medium-sized mammal bones were found approximately 25' north of the southwestern opening. Raccoon ( <i>Procyon lotor</i> ) tracks identified on westbound shoulder, above northeastern opening of culvert.
<b>Track and sign transects</b>	Both the westbound and eastbound shoulders have suitable substrate for tracking transects. The substrate consists of fine dirt mixed with gravel.
