# Enhancing ecological connectivity and safe passage for wildlife on highways between the southern Santa Cruz Mountains, Gabilan Range, and Diablo Range in California

Diamond, TD, A Sandoval, NP Sharma, ME Vernon, PD Cowan, AP Clevenger, and SC Lockwood. 2022. *Enhancing ecological connectivity and safe passage for wildlife on highways between the southern Santa Cruz Mountains, Gabilan Range, and Diablo Range in California*. Pathways for Wildlife and Peninsula Open Space Trust, Palo Alto, CA.

AUGUST 2022

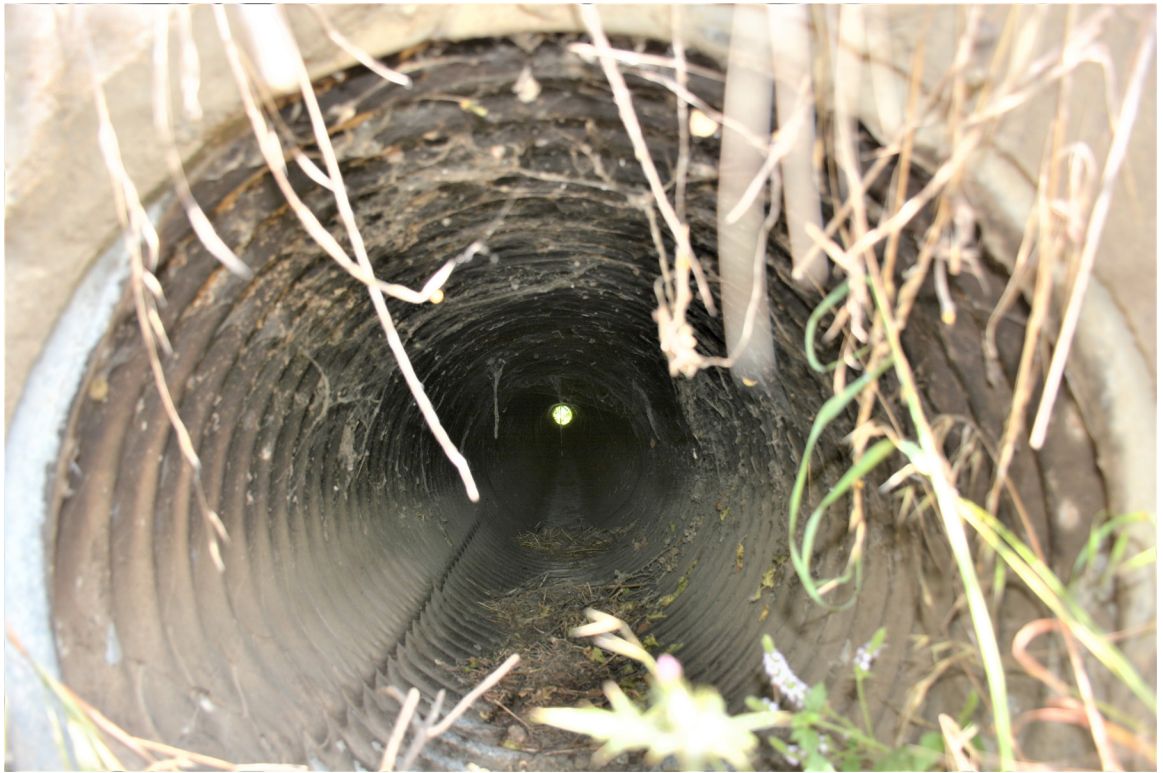
SR 129 Site 1. Close-up of southwest opening. Photo faces northeast.

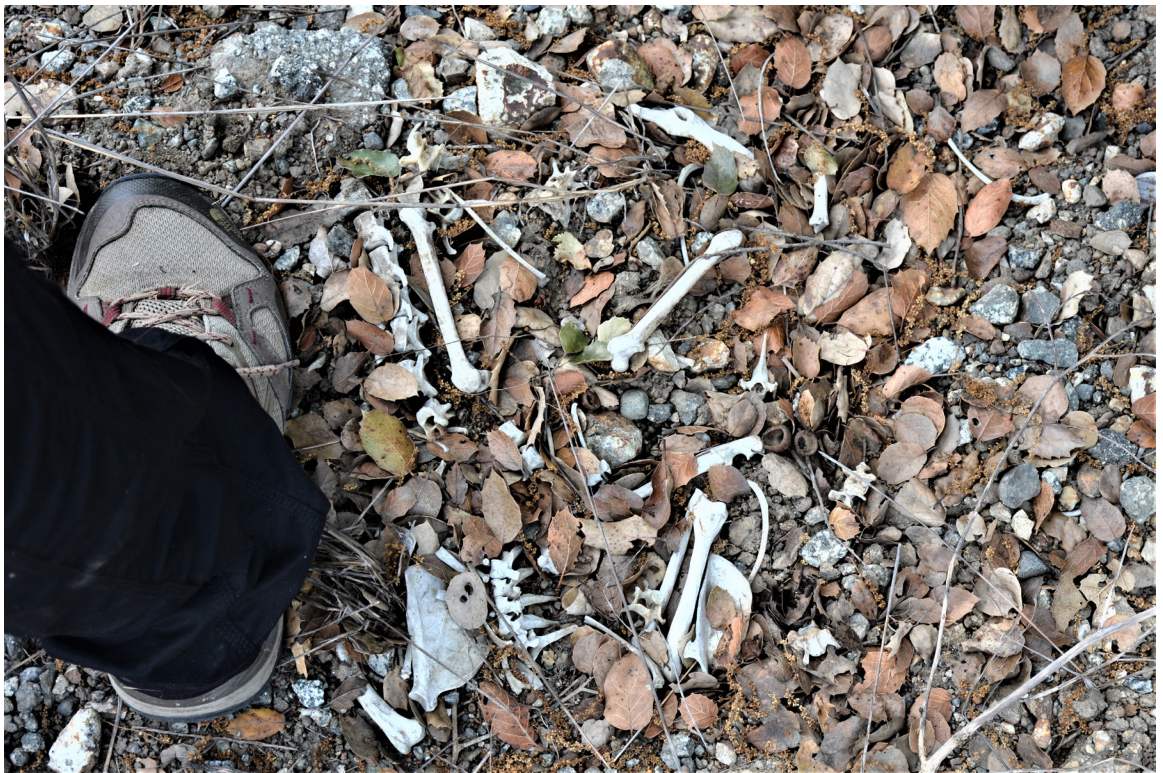
SR 129 Site 1. Medium-sized mammal bones located approximately 25' from southwestern opening of culvert.

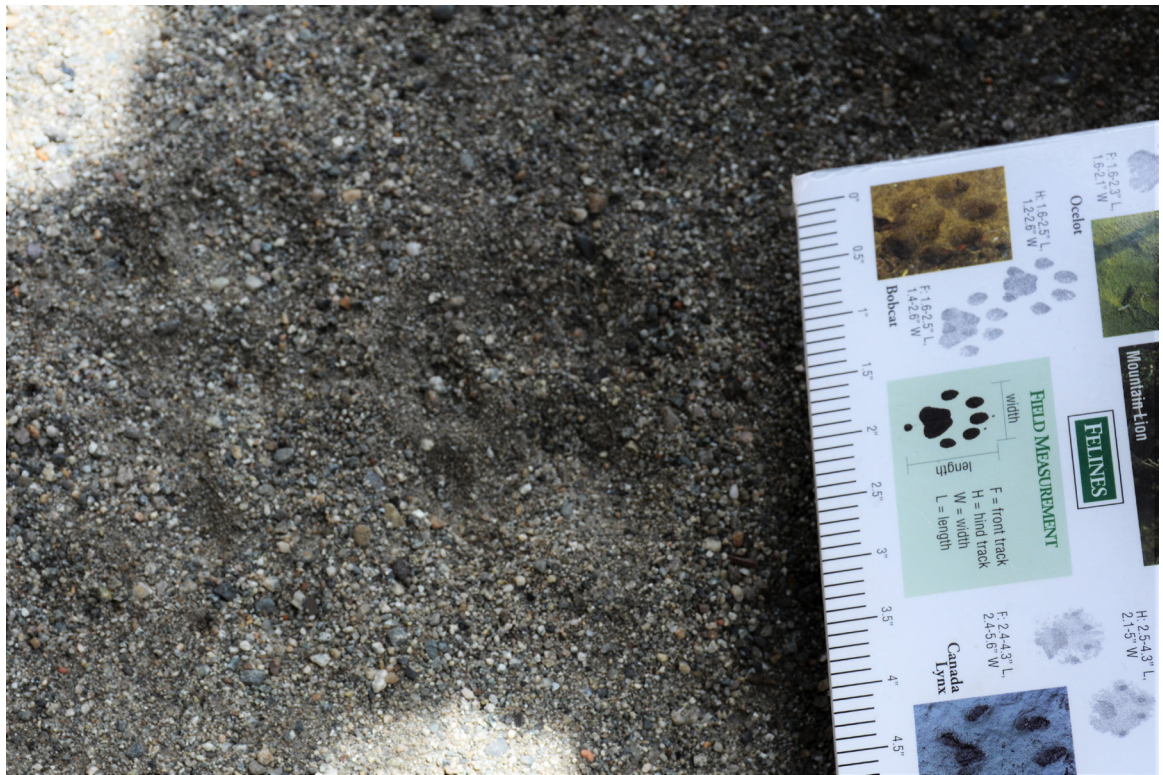
SR 129 Site 1. Right hind track of raccoon (*Procyon lotor*) heading east on the westbound shoulder of SR 129. Track was recorded above the northeastern opening of culvert.

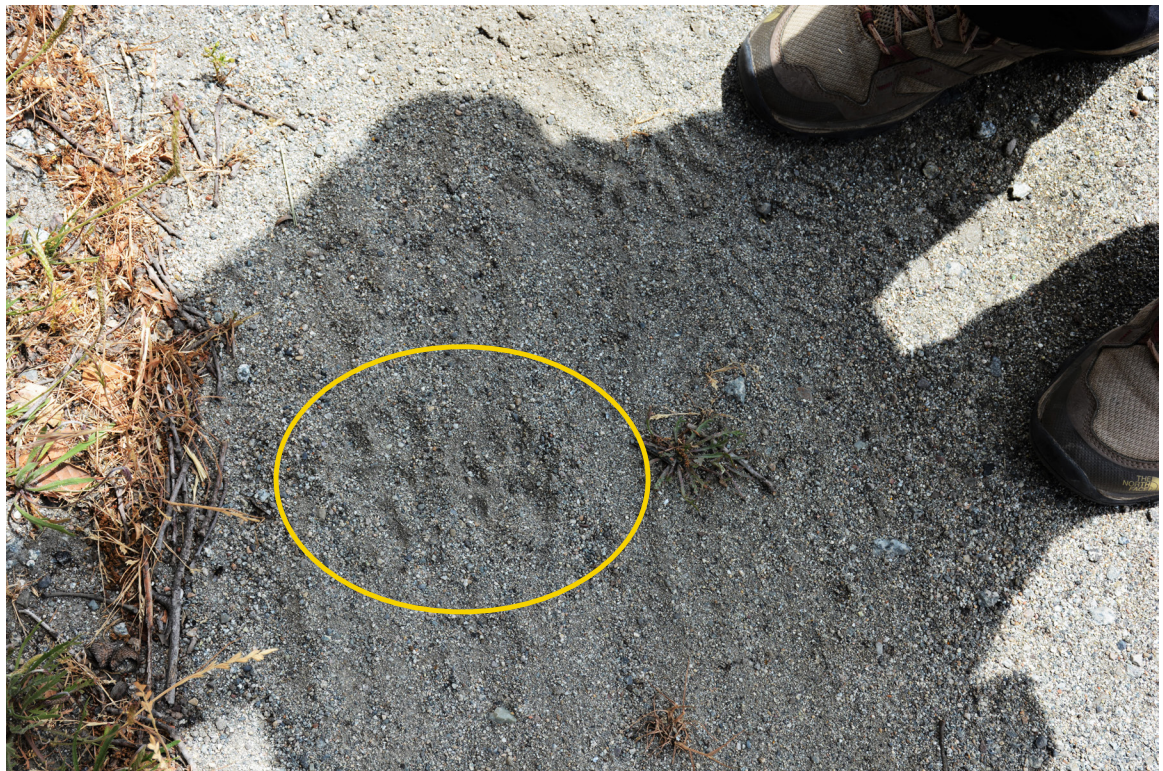
SR 129 Site 1. Detailed look at right hind track showing five toes of raccoon.

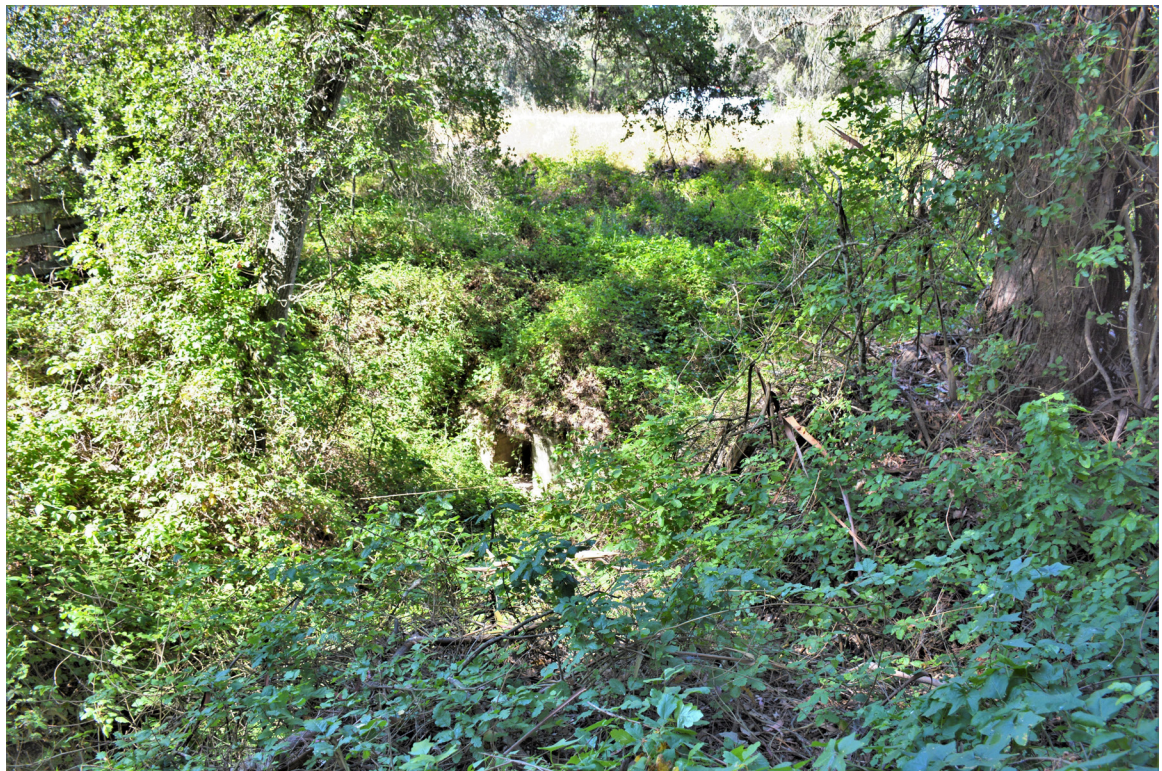
SR 129 Site 3. Southwest opening. Photo faces north.

<b>Postmile</b>	SBT, SR 129, PM 1.31
<b>GPS location</b>	Latitude: 36.89307 Longitude: -121.57847
<b>Dimensions</b>	Square/box concrete culvert 3' wide and 3' 1" high
<b>Direction</b>	Southwest - northeast
<b>Visibility</b>	No visibility. Unable to see through the culvert.
<b>Substrate</b>	Concrete (bare bottom). No buildup at southwestern opening.
<b>Habitat/land use</b>	Southwestern opening leads to open habitat via a ravine. Eucalyptus and oak providing cover. Northeastern opening is oak woodland and open habitat, although there is a house nearby to the north.
<b>Wildlife track and sign</b>	Bobcat scat found within the southwestern opening of the culvert. Two wildlife trails lead to/from the ravine at the southwestern opening of the culvert.
<b>Track and sign transects</b>	The two wildlife trails and ravine leading to the southwestern opening of the culvert are suitable areas for track and sign identification.

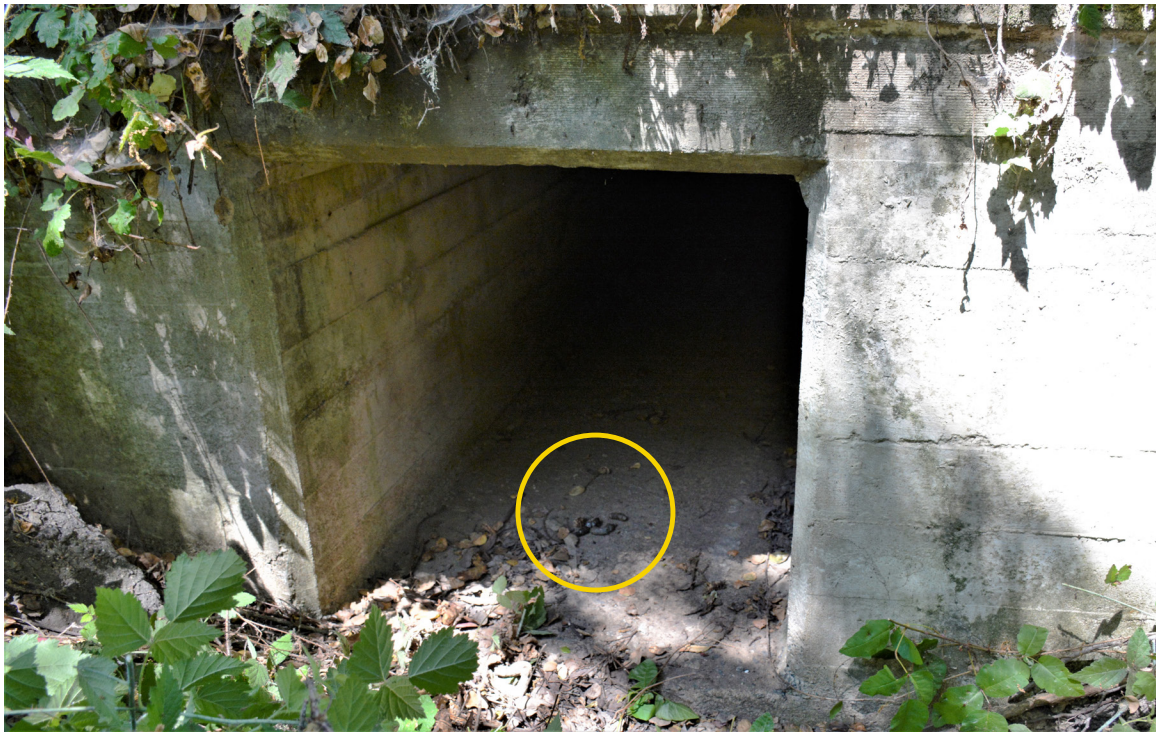
SR 129 Site 3. Close-up of southwest opening. Bobcat scat (*Lynx rufus*) visible in entrance of culvert (circled in yellow).

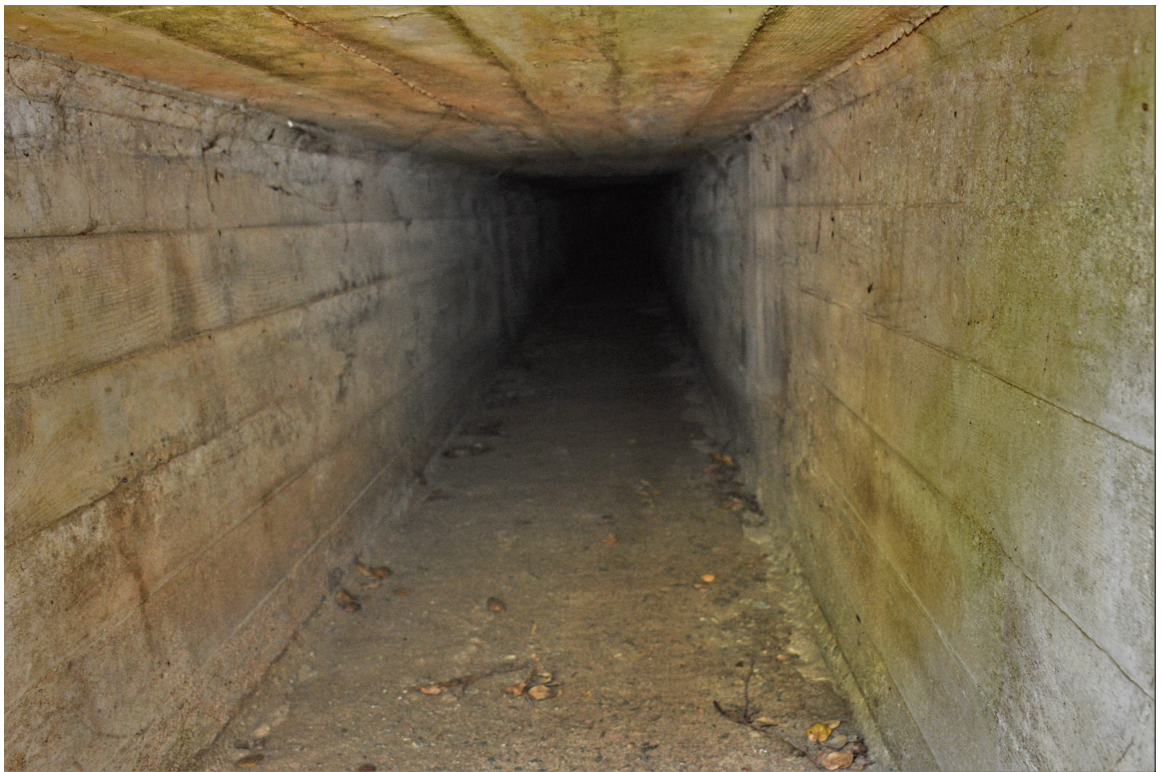
SR 129 Site 3. Within southwest opening of culvert. Photo faces northeast. The northeast end of the culvert is not visible.

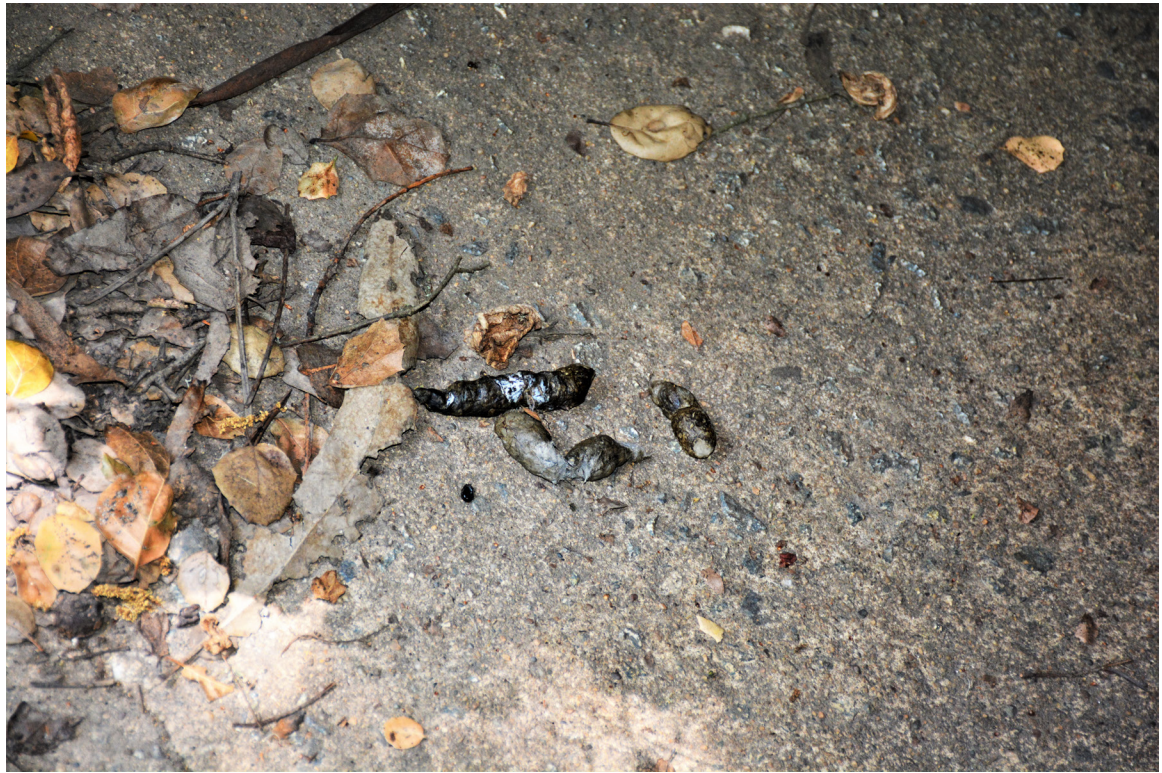
SR 129 Site 3. Bobcat scat within southwest opening of culvert.

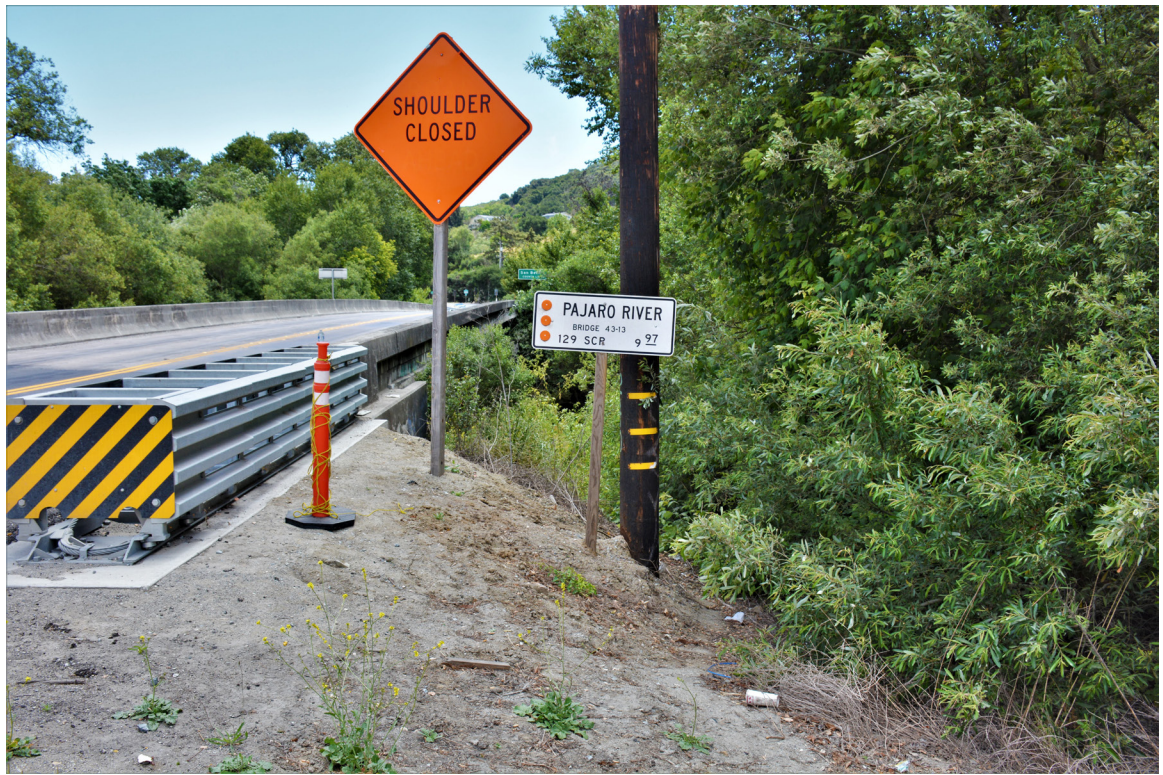
SR 129 Site 5 Pajaro River Bridge. Postmile marker of Pajaro River Bridge and SR 129. Photo faces east.

SR 129 SITE 5 PAJARO RIVER BRIDGE	
<b>Postmile</b>	SBT, SR 129, PM 0.00
<b>GPS location</b>	Latitude: 36.90051 Longitude: -121.5976
<b>Dimensions</b>	Pajaro River Bridge with the western section 82' 6" wide and approximately 20'+ high. The Pajaro River flows through another section to the east, which is separated by a structural wall. This section is wider and higher than the western section. The current water level is low enough so that a 2'-wide area of bank is exposed for wildlife to travel along at that section.
<b>Direction</b>	Northeast - southwest. Direction is based on the flow of the Pajaro River.
<b>Visibility</b>	Yes, this bridge is well lit and has high visibility throughout.
<b>Substrate</b>	The western section is made up of fine dirt mixed with sand. The middle section (to the east) has mud banks. Both are typical substrates of riparian habitat.
<b>Habitat/land use</b>	This is the largest underpass structure and only bridge on SR 129 in the study area. The Pajaro River is a major natural thoroughfare providing water and cover for wildlife connectivity.

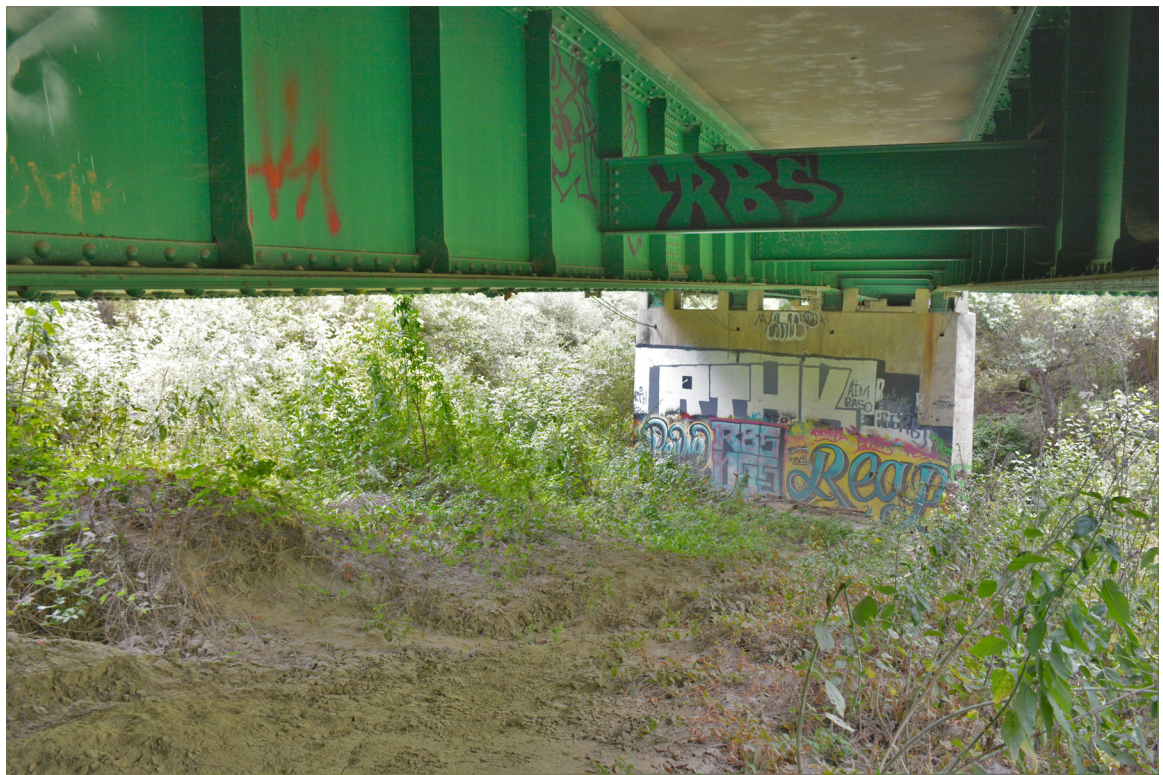
SR Site 5 Pajaro River Bridge. Western section. Photo faces east.

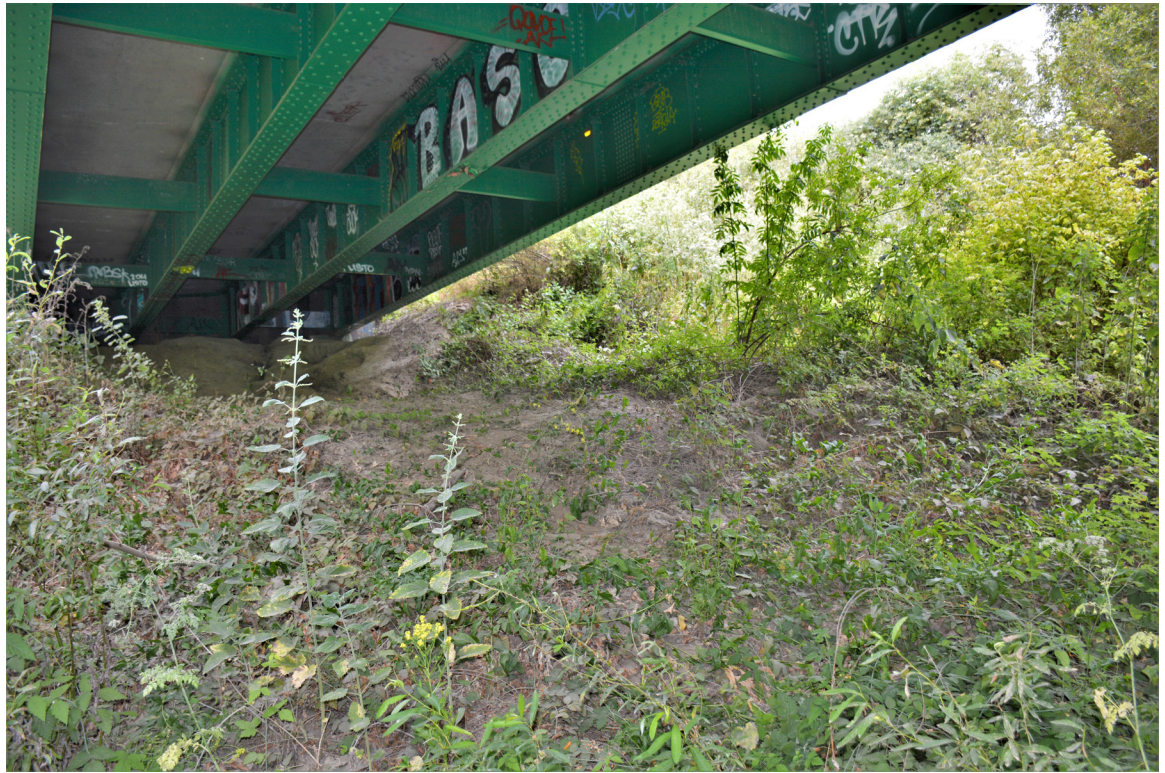
SR 129 Site 5 Pajaro River Bridge. Western section. Photo faces west.

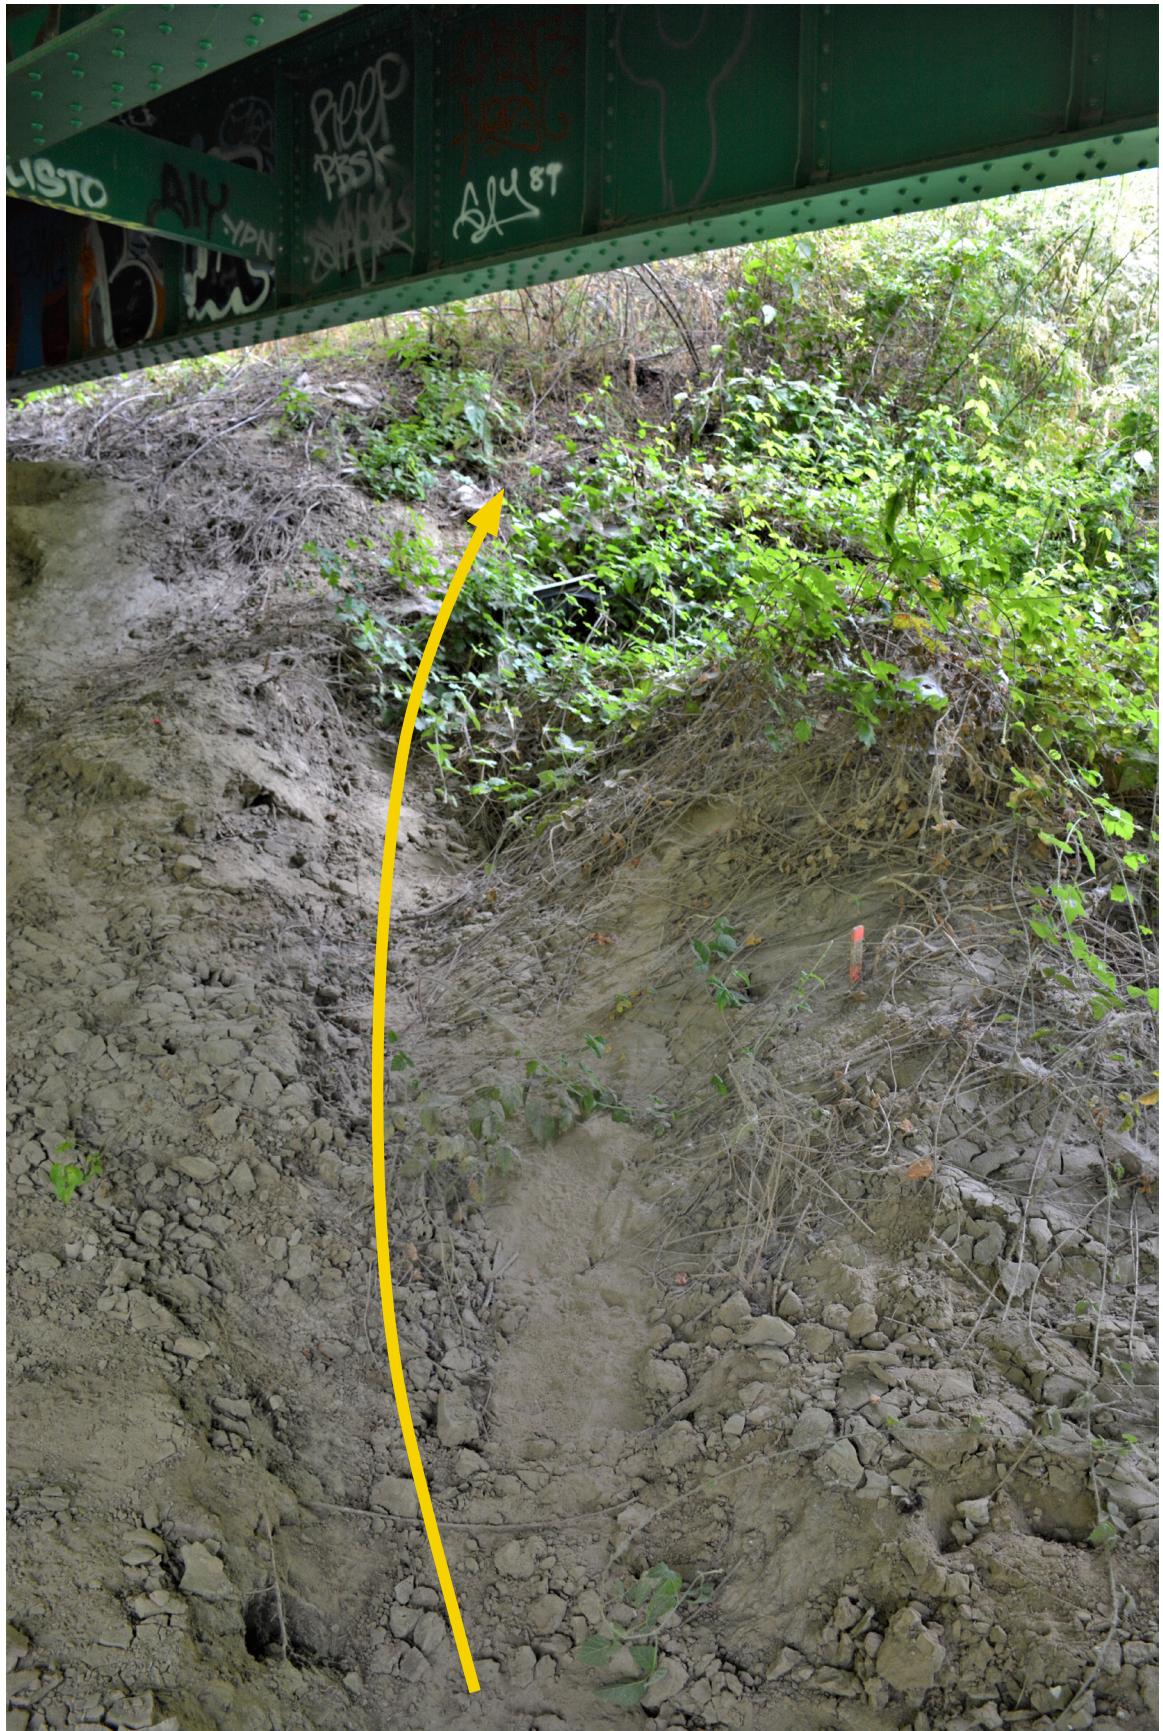
SR 129 Site 5 Pajaro River Bridge. Photo of wildlife trail at western section, facing north. Trail with tracks indicated by yellow arrow.

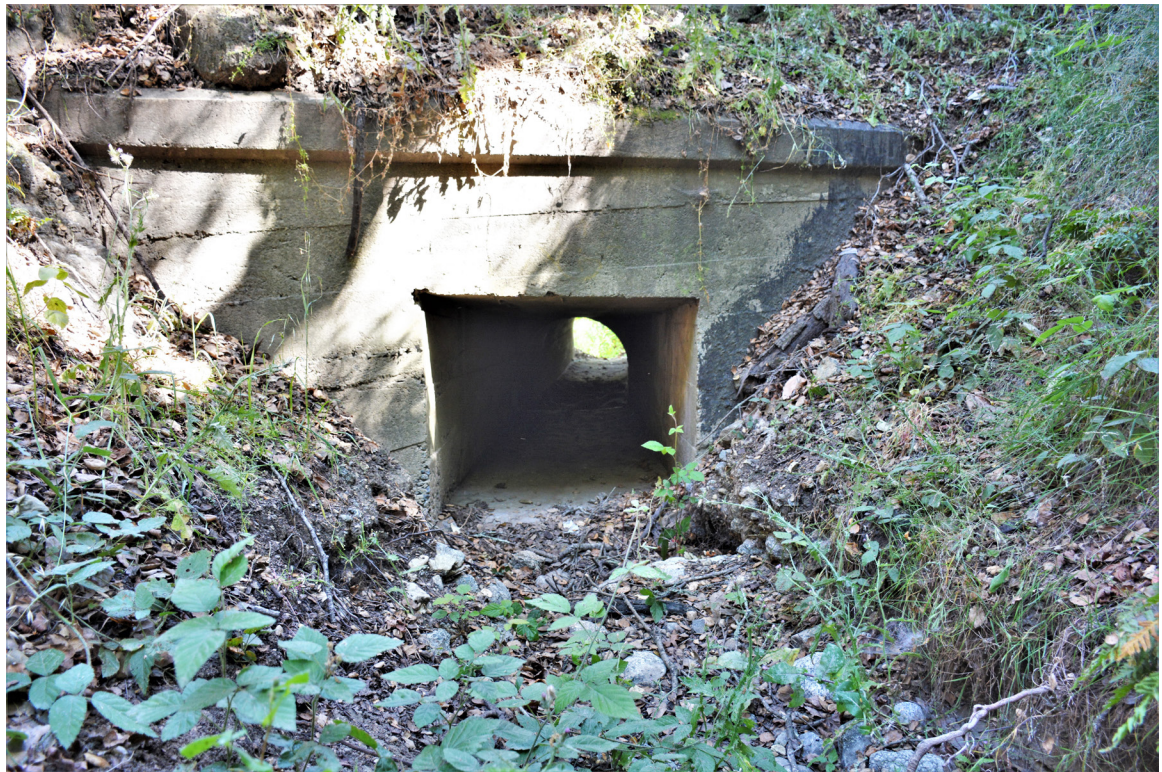
<b>Postmile</b>	SCR, SR 129, PM 7.88
<b>GPS location</b>	Latitude: 36.91135 Longitude: -121.63035
<b>Dimensions</b>	Cement box/arch culvert. Northwest opening is a box 4' 4" wide and 3' 7" high. Southeast opening is an arch 4' wide at the center (midway vertically), and 4' high at top middle of arch (down the center).
<b>Direction</b>	Northwest - southeast (toward decline).
<b>Visibility</b>	Yes. Opposite opening can be seen through the culvert, and the culvert is well lit throughout.
<b>Substrate</b>	Concrete (bare bottom) at both openings. No build-up at either opening. There is a dip in the middle of the culvert.
<b>Habitat/land use</b>	The northeastern opening leads to one of the only ravines that break up the sheer steep cliffs along SR 129 at this section. The southeastern opening has cover along the ravine leading to the Pajaro River.
<b>Wildlife track and sign</b>	None
<b>Track and sign transects</b>	Due to the concrete and rocky ravine this site would not benefit from a wildlife track and sign transect.

SR 129 Site 8. Northwest square/box opening. Photo faces southeast.

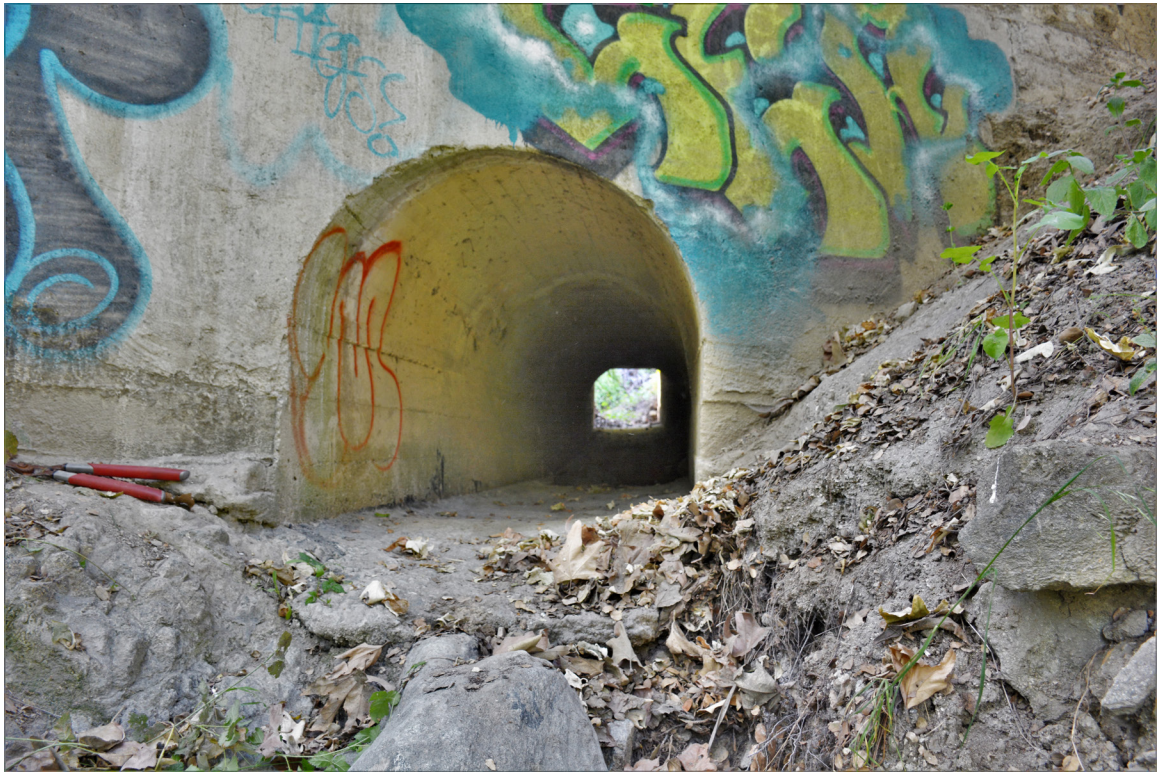
SR 129 Site 8. Southeast arch opening. Photo faces northwest.

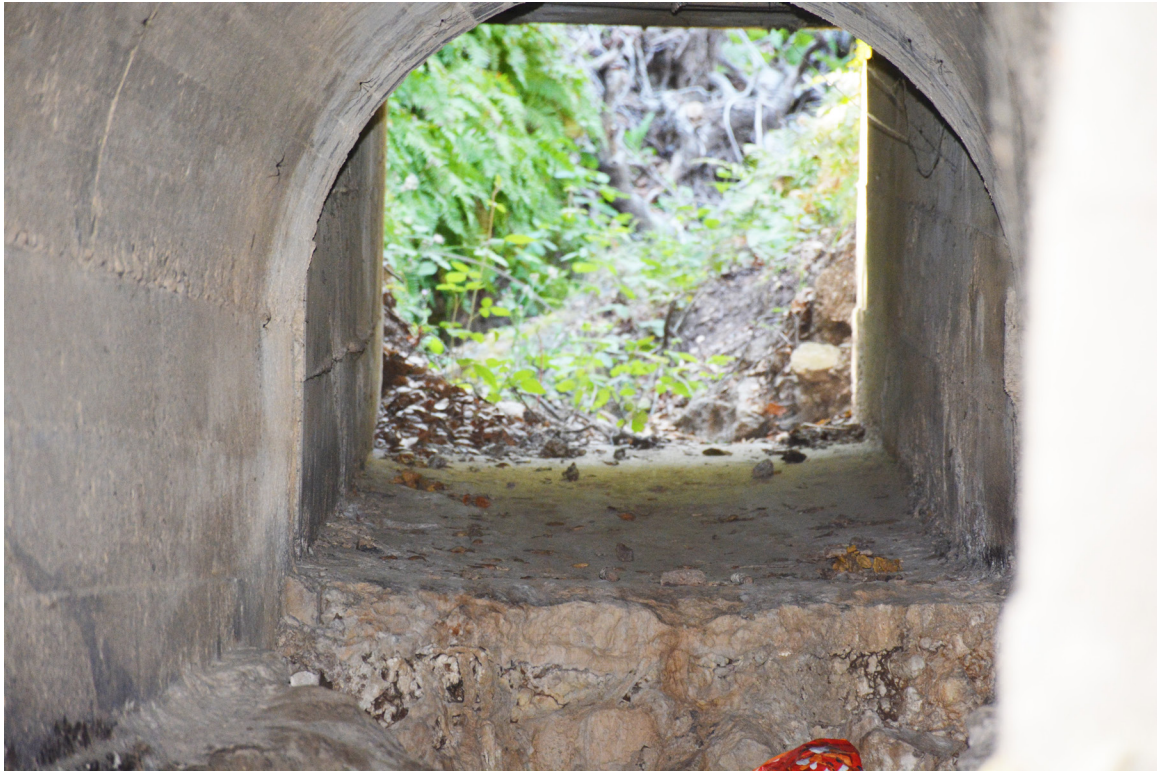
SR 129 Site 8. Photo shows drop in midway through the culvert. Photo faces northwest.

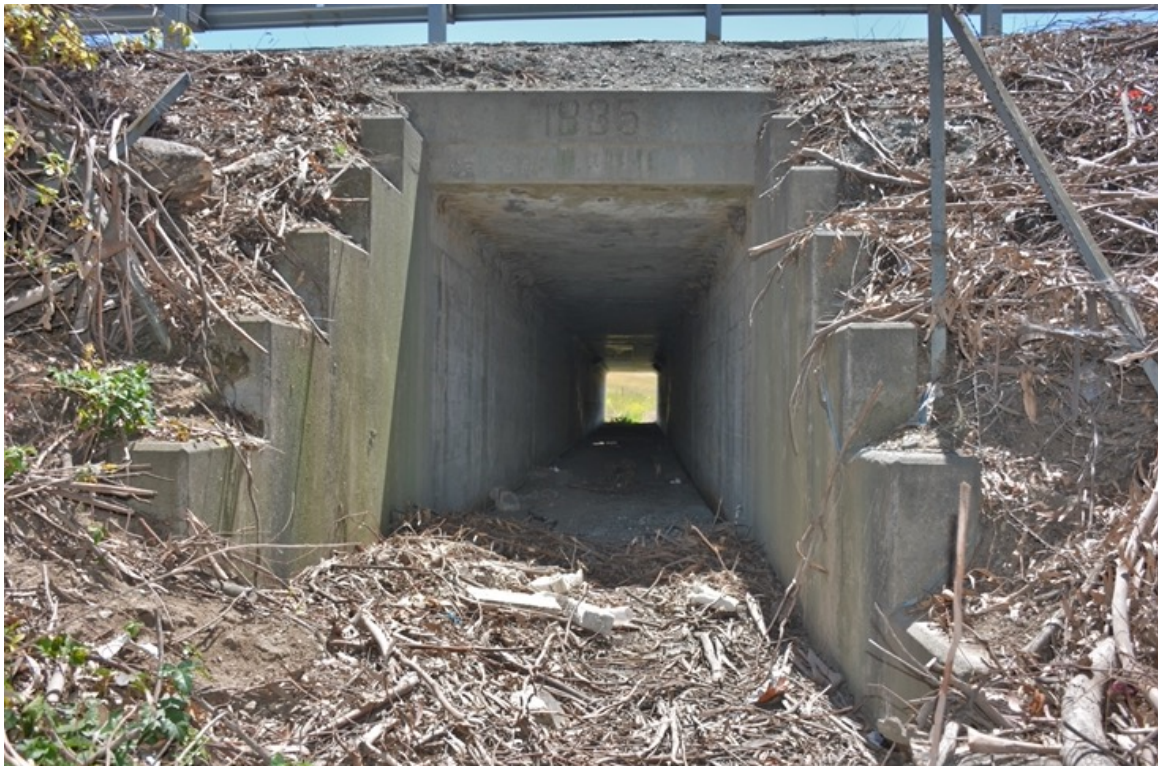
SR 156 SITE 1	
<b>Postmile</b>	SBT, SR 156, PM 0.41
<b>GPS location</b>	Latitude: 36.85751 Longitude: -121.57321
<b>Dimensions</b>	Large cement box culvert 6' wide and 7' high. Measurements were taken from the northeastern opening only as there were swallows actively flying from and returning to their nests at the southwestern opening. From our vantage point (without disturbing the swallows) we were able to estimate that the southwestern opening was similar to the northeastern opening.
<b>Direction</b>	Northeast - southwest. Unable to determine direction of decline.
<b>Visibility</b>	Yes. The openings of this culvert are large enough to see through and keep this culvert well lit throughout. In addition to the large openings, a circular cutout in the ceiling of the culvert allows more light to pass through. This opening leads up to the highway and is covered by a grate, concrete median, and then another grate from left to right.

SR 156 Site 1. Northeastern opening. Photo faces southwest.

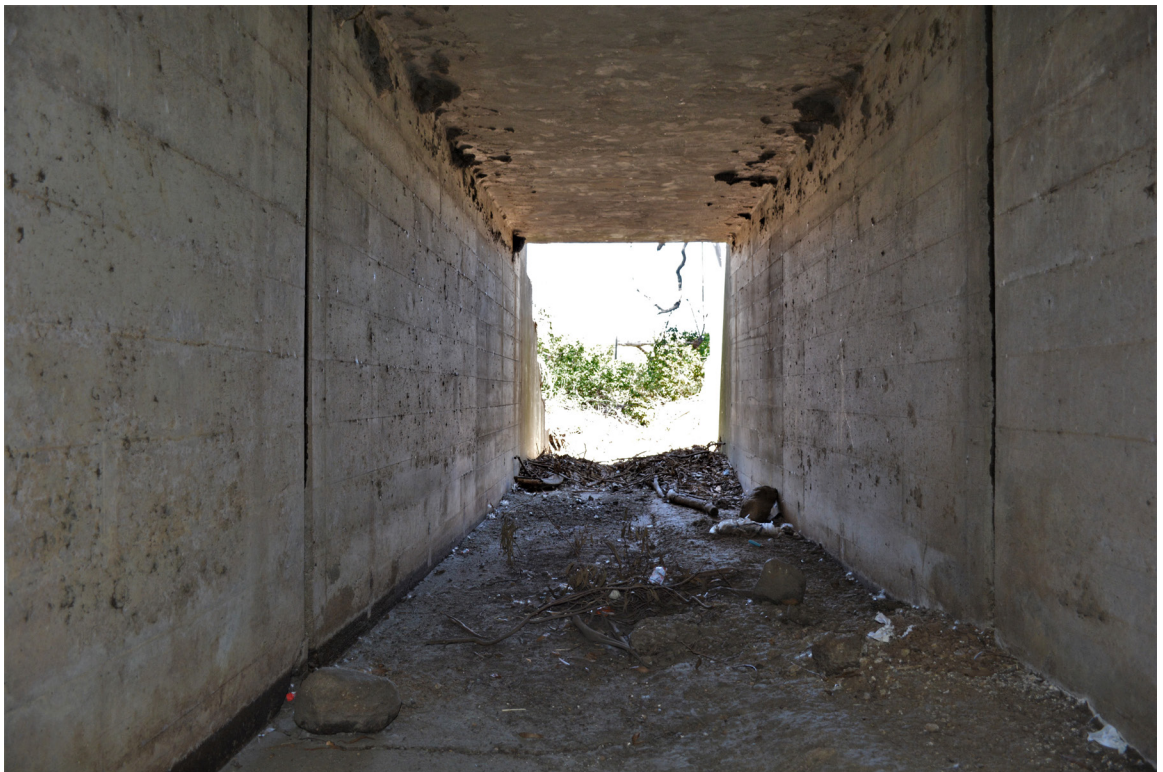
SR 156 Site 1. Photo from within the culvert faces outward from the northeast opening.

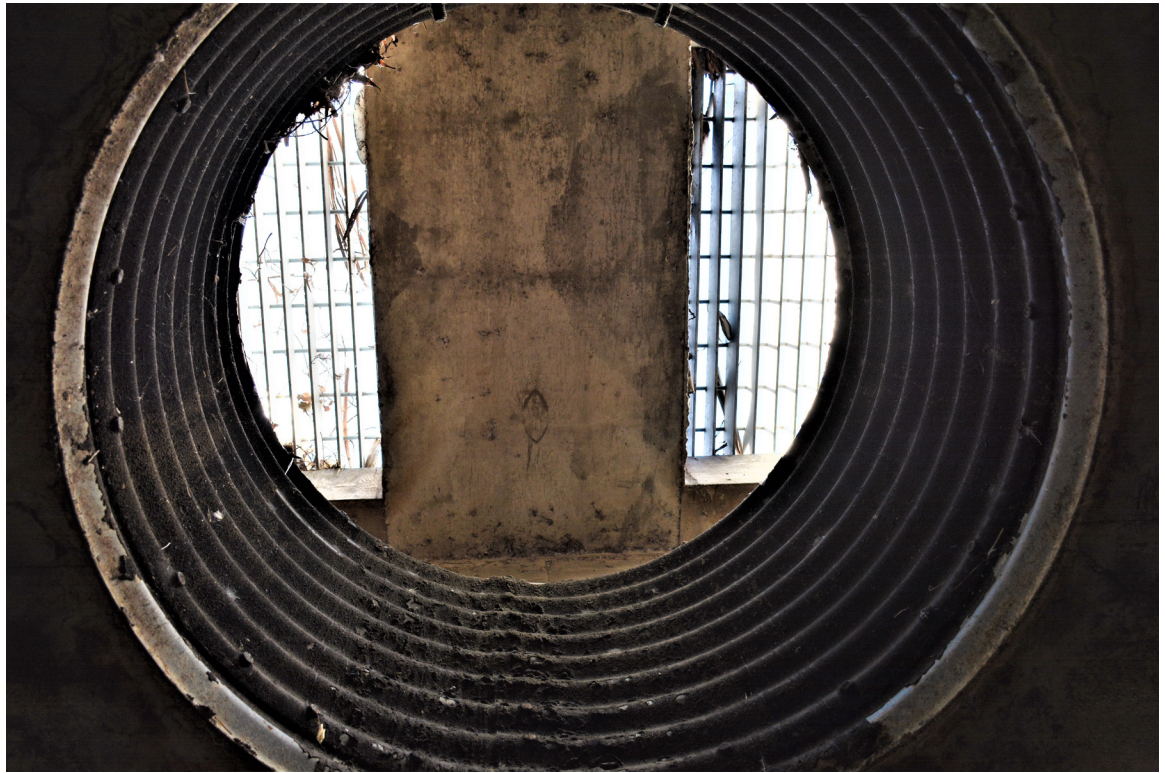
SR 156 Site 1. Circular opening in ceiling within middle of culvert with grate, median, then grate visible.

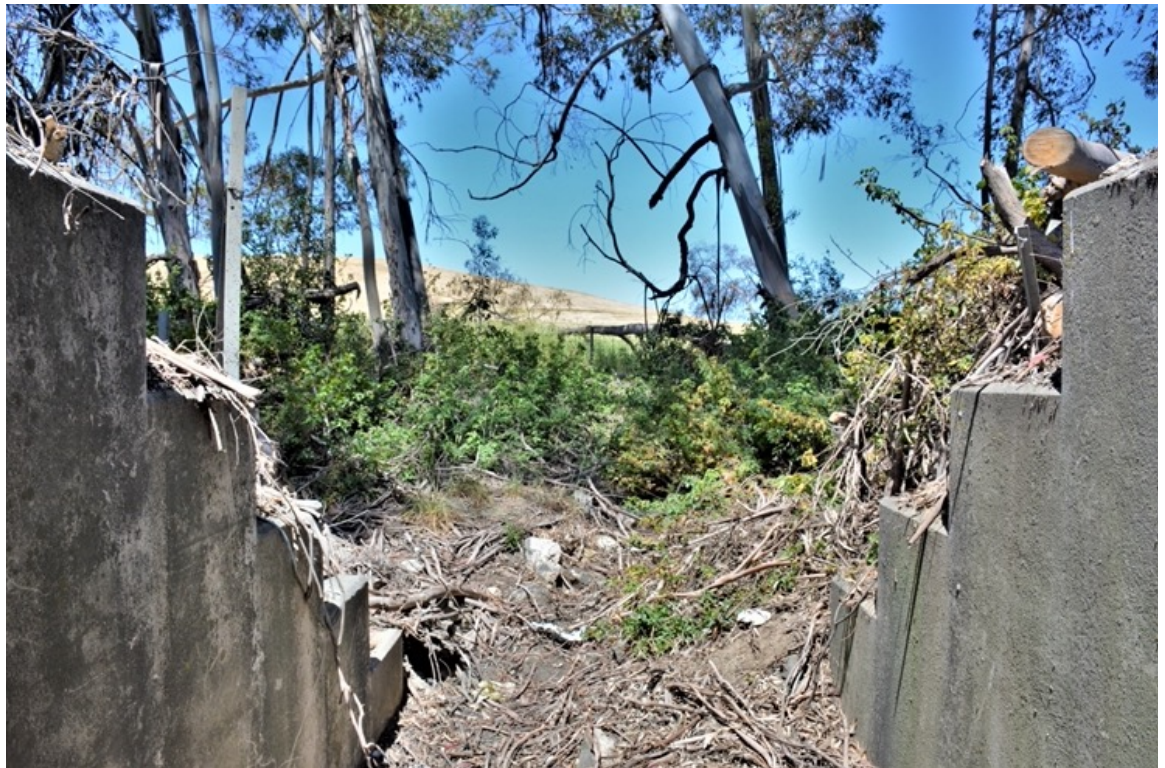
SR 156 Site 1. View of the habitat outside of northeastern opening.

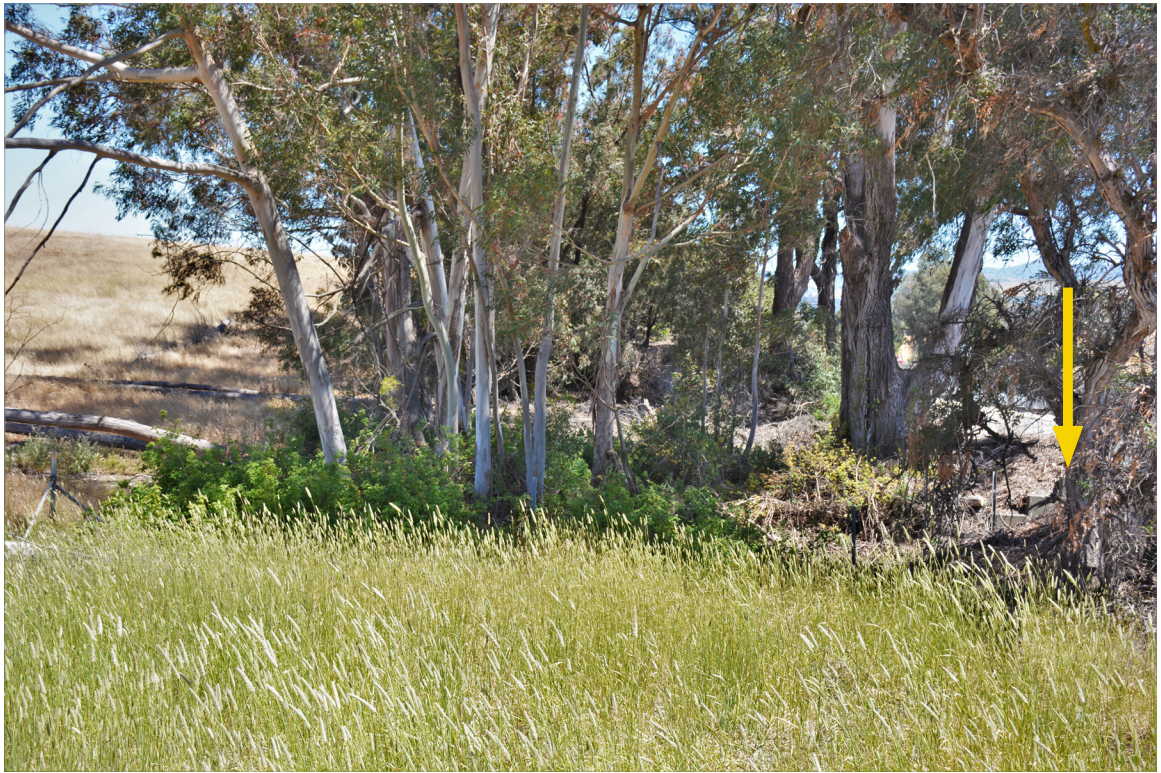
SR 156 Site 1. Another view of the adjacent habitat outside northeastern opening Photo faces east; the culvert opening is indicated by yellow arrow.

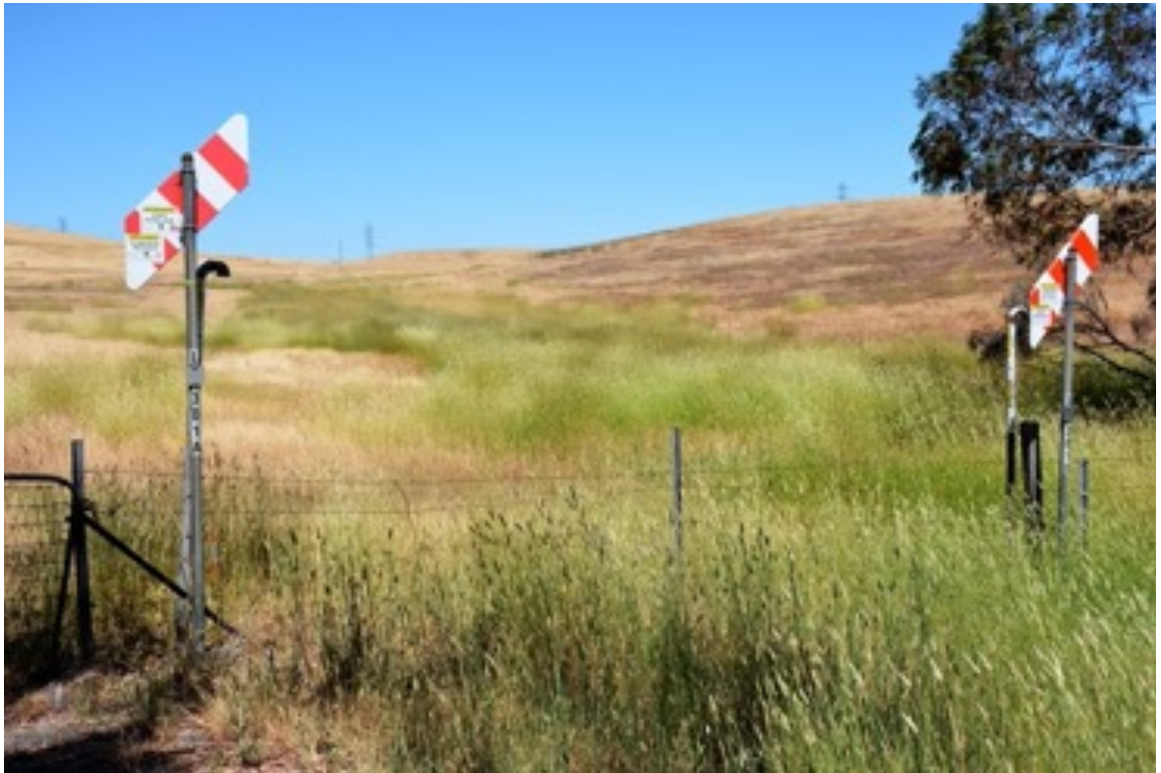
SR 156 Site 1. Example of barbed wire fence and open habitat beyond northeastern opening. Photo faces north.

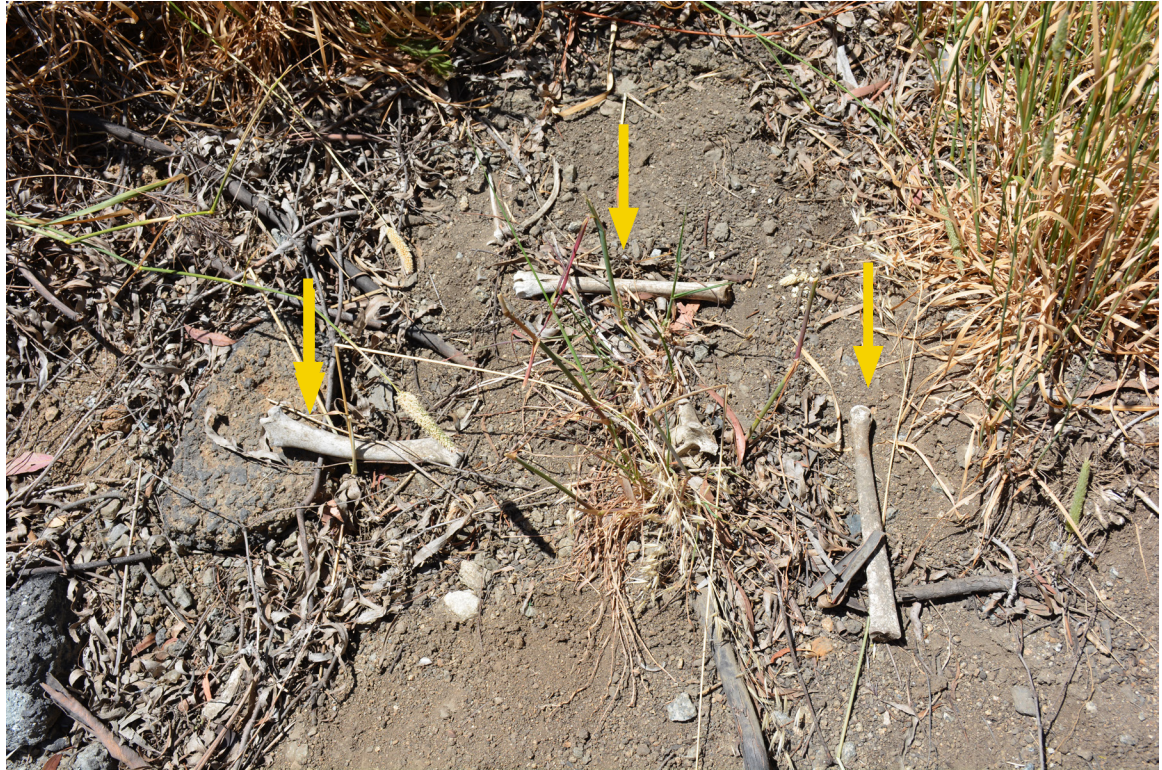
SR 156 Site 1. Unidentified large mammal bones near wildlife trail west of the northeastern opening. Bones are indicated by yellow arrows.
