# Enhancing ecological connectivity and safe passage for wildlife on highways between the southern Santa Cruz Mountains, Gabilan Range, and Diablo Range in California

Diamond, TD, A Sandoval, NP Sharma, ME Vernon, PD Cowan, AP Clevenger, and SC Lockwood. 2022. *Enhancing ecological connectivity and safe passage for wildlife on highways between the southern Santa Cruz Mountains, Gabilan Range, and Diablo Range in California*. Pathways for Wildlife and Peninsula Open Space Trust, Palo Alto, CA.

AUGUST 2022

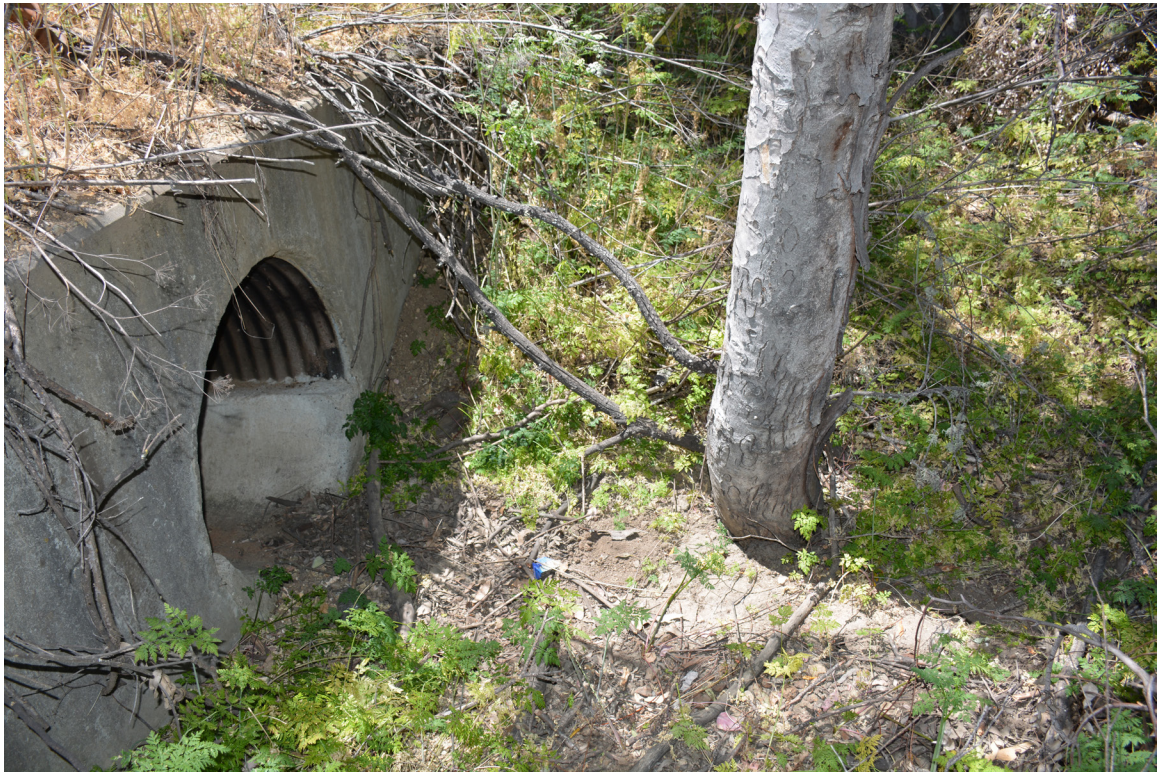
SR 156 SITE 2	
<b>Postmile</b>	SBT, SR 156, PM 0.57
<b>GPS location</b>	Latitude: 36.85603 Longitude: -121.57142
<b>Dimensions</b>	Round corrugated and half cement lined culvert 3' 5" wide and 3' 2" high. The upper portion of this culvert is corrugated steel and the bottom half is cement.
<b>Direction</b>	Northeast - southwest. Unable to determine direction of decline.
<b>Visibility</b>	Yes
<b>Substrate</b>	Cement (bare bottom) without any buildup.
<b>Habitat/land use</b>	Culvert is large enough for medium-sized mammals. There is visibility through the culvert, and open habitat on both sides. The northeastern opening has a small eucalyptus grove and culvert is not obstructed.
<b>Wildlife track and sign</b>	A wildlife trail leads north from the northeastern opening.
<b>Track and sign transects</b>	The wildlife trail leading north is suitable for a tracking transect as it would show if it is actively being used.

SR 156 Site 2. Northern opening.

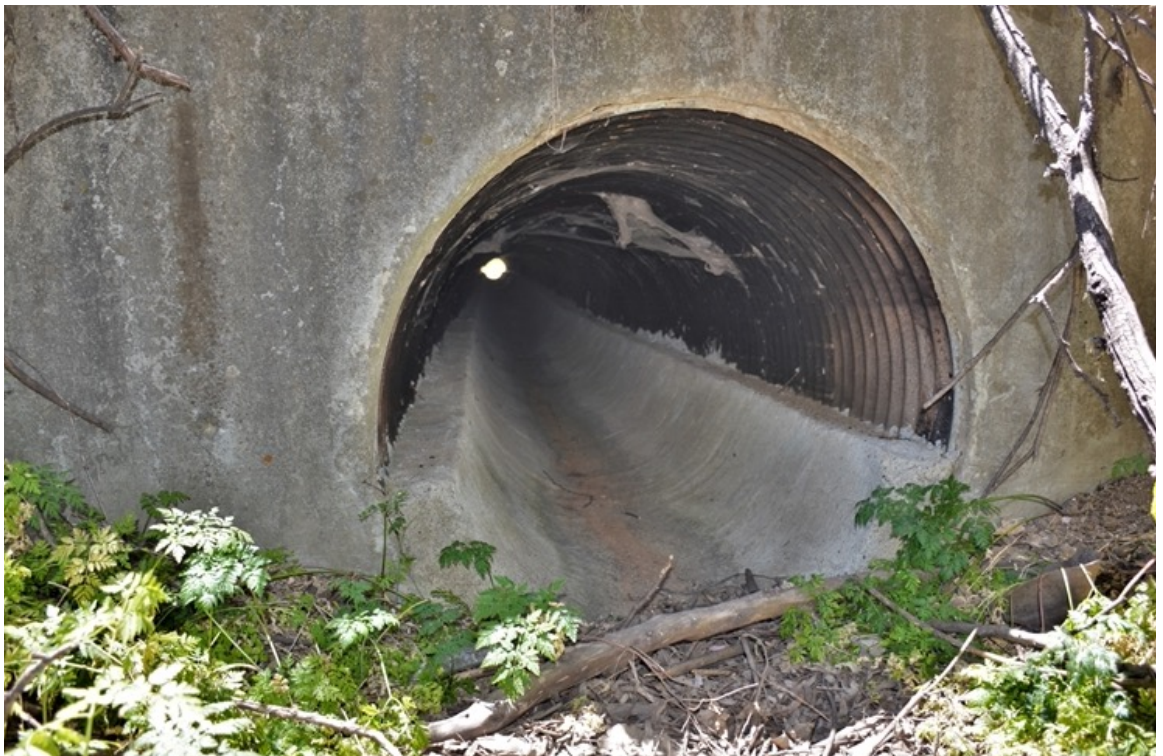
SR 156 Site 2. Close-up of northern opening showing cement bottom.

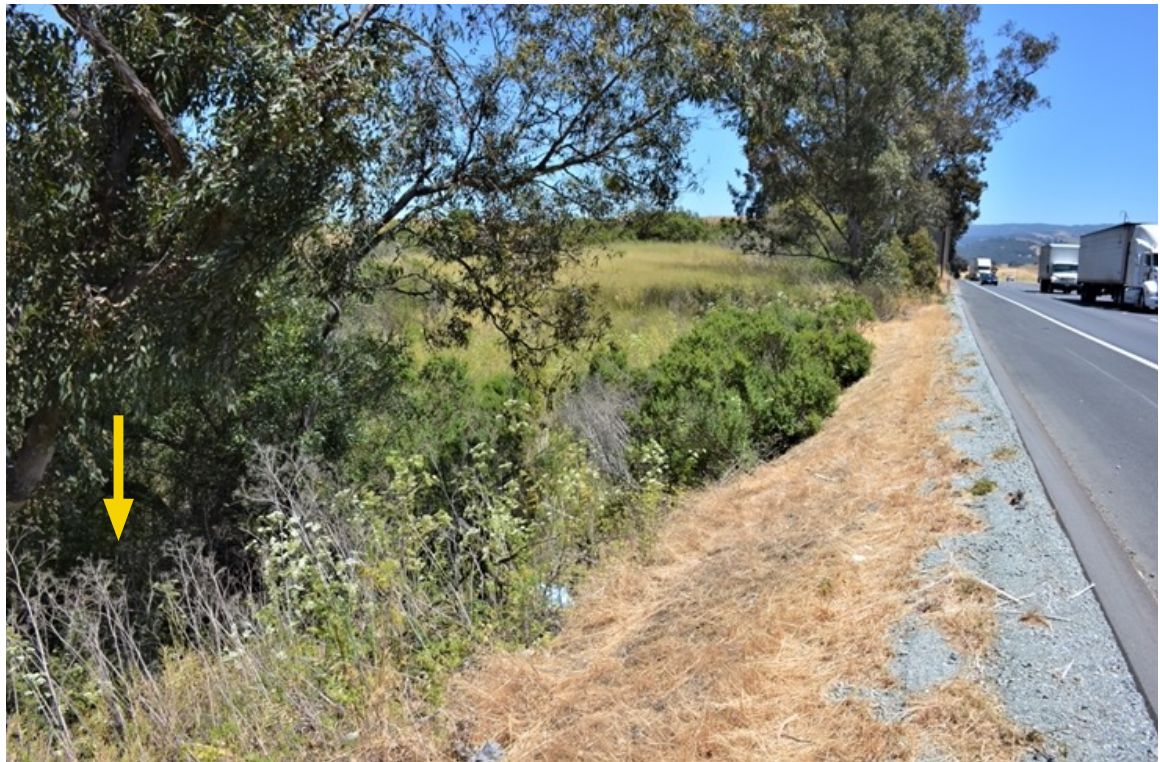
SR 156 Site 2. Example of vegetation/cover alongside the highway and in front of the northeastern opening (shown by yellow arrow).

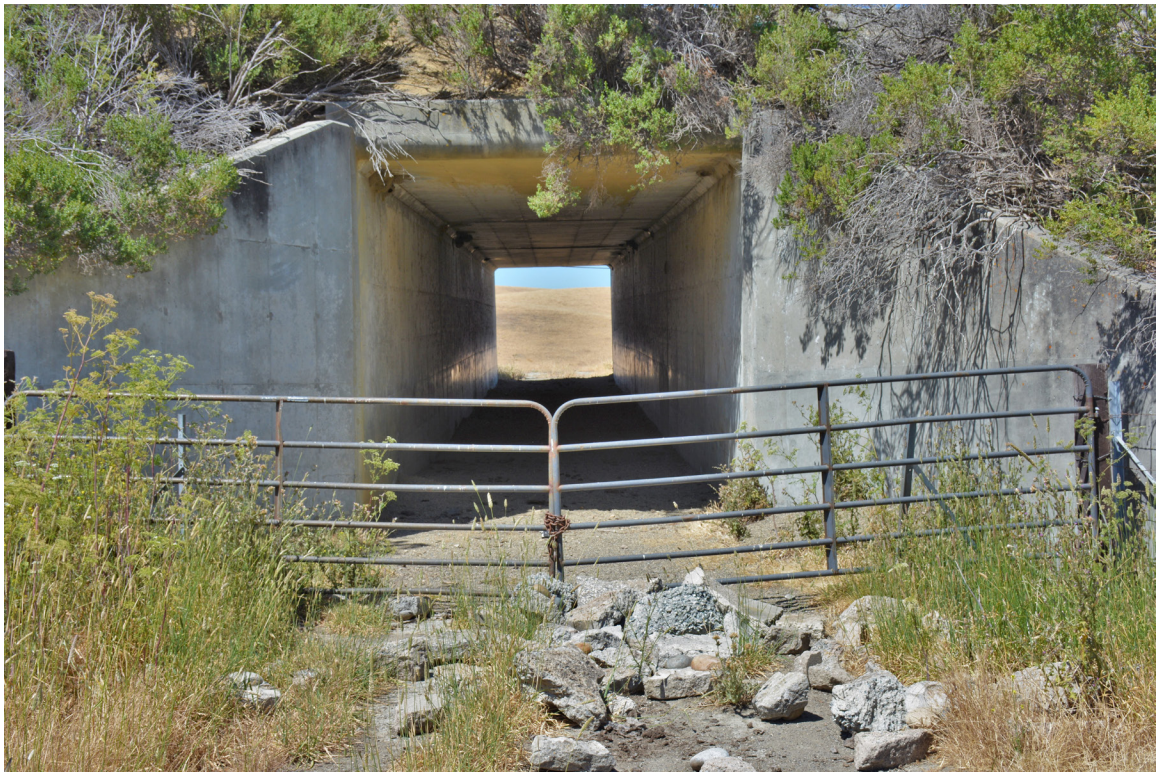
SR 156 SITE 3	
<b>Postmile</b>	SBT, SR 156, PM 1.38
<b>GPS location</b>	Latitude: 36.84949 Longitude: -121.56099
<b>Dimensions</b>	Large box culvert 12' wide and 12' 5" high. This is the largest box culvert under SR 156. It is large enough to drive a vehicle through and appears that it was once a former access road.
<b>Direction</b>	Northeast - southwest. Unable to determine direction of decline as the foundation appears to be level.
<b>Visibility</b>	Yes. This culvert is very well lit with high visibility throughout.
<b>Substrate</b>	Dirt mixed with gravel creating a soft substrate.
<b>Habitat/land use</b>	This culvert is large enough to facilitate large mammal movement. The culvert is well lit, and both openings lead to open habitat without any nearby development. There is a gate in front of the southern opening, however it does seem to be permeable for some species of wildlife.
<b>Wildlife track and sign</b>	Numerous tracks show throughout the culvert.

SR 156 Site 3. Southwestern opening with gate in front of entrance.

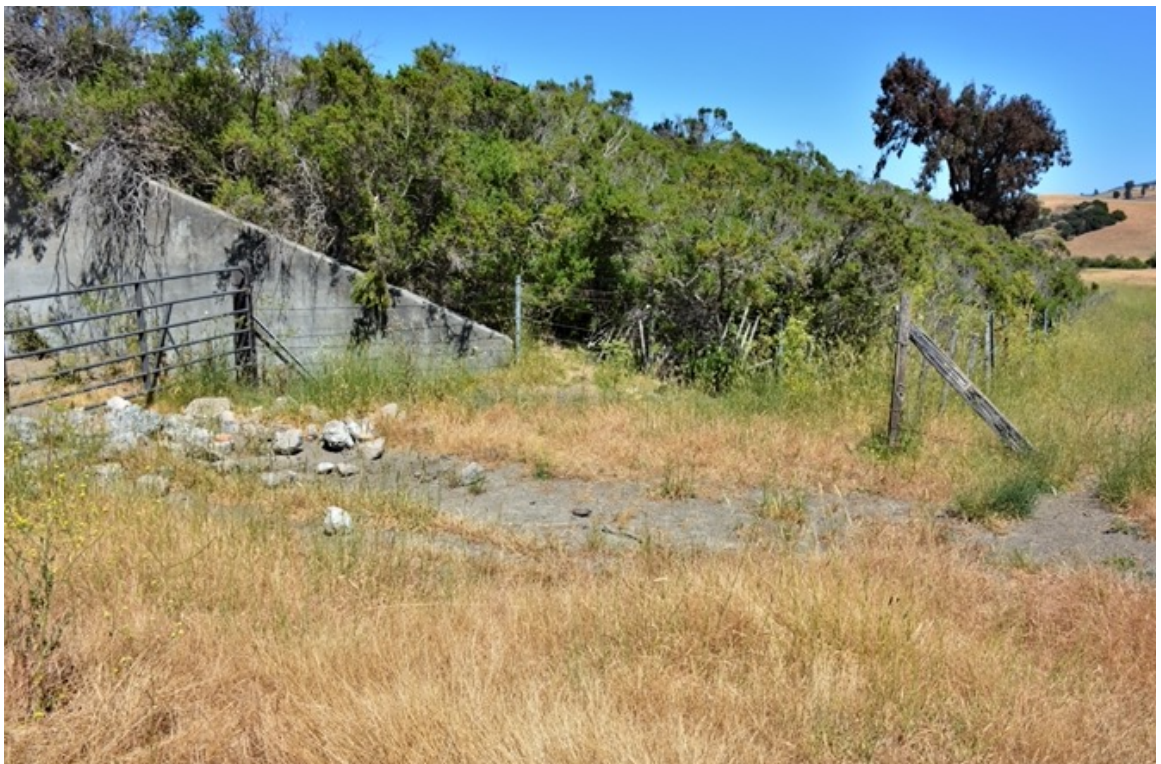
SR 156 Site 3. Photo of southwestern opening (facing east) showing fence and adjacent habitat.

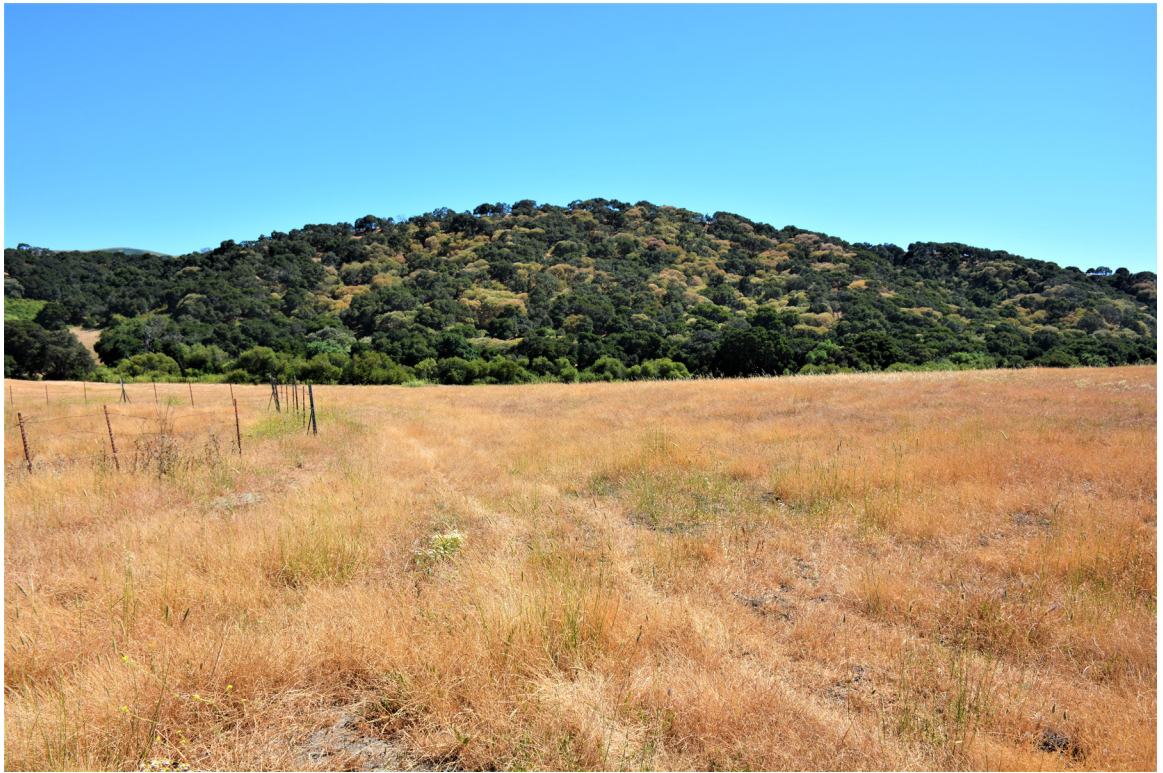
SR 156 Site 3. View of habitat beyond southwestern opening.

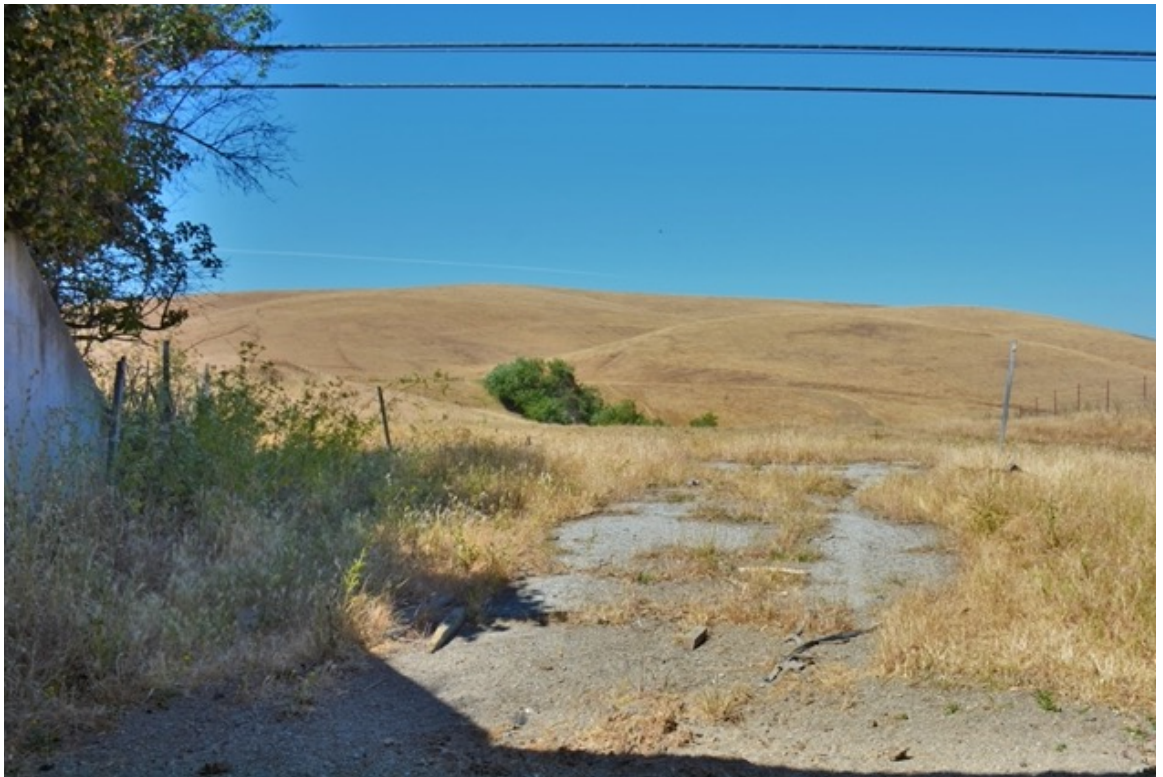
SR 156 Site 3. View from within northeastern opening showing open habitat.

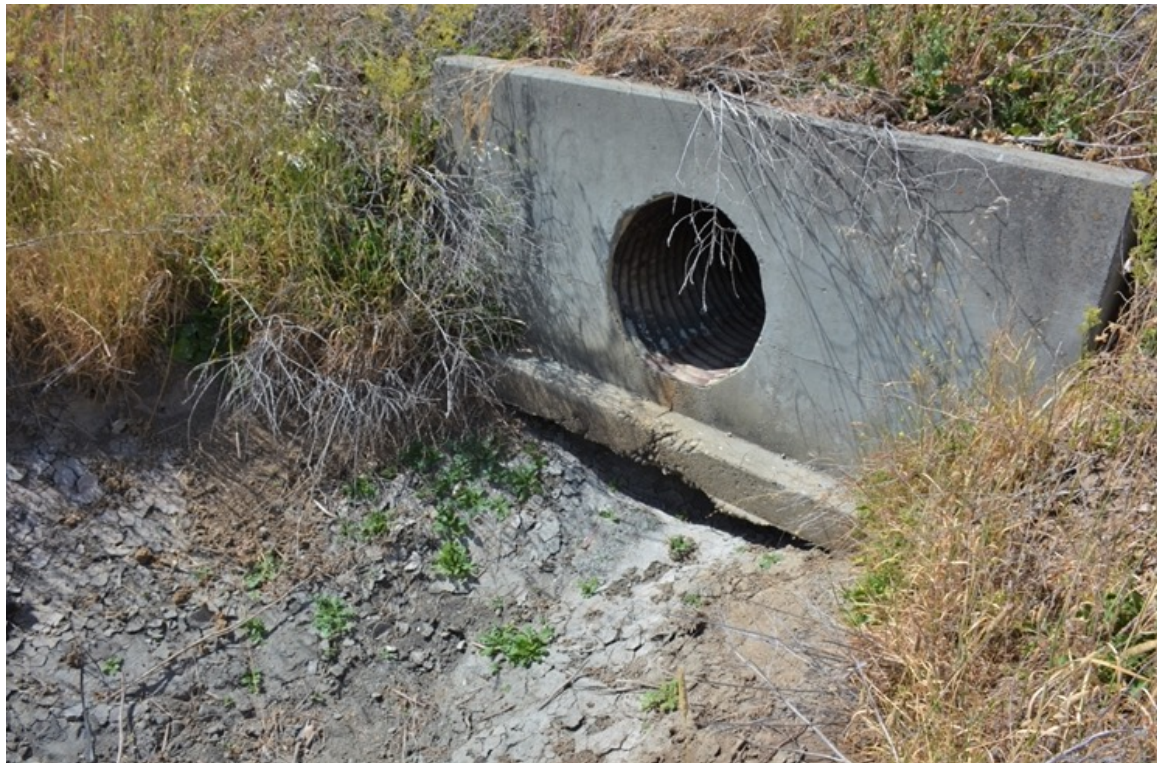
<b>Postmile</b>	SBT, SR 156, PM 1.64
<b>GPS location</b>	Latitude: 36.84798 Longitude: -121.55598
<b>Dimensions</b>	Round corrugated culvert 2' 5" in diameter
<b>Direction</b>	North - south. This culvert is 2' 6" above ground level and it appears that water pools in front of the southern opening. However, looking through the culvert to the other side reveals that the northern entrance of the culvert curves down. The direction cannot be accurately stated.
<b>Visibility</b>	Yes
<b>Substrate</b>	Corrugated steel (bare bottom).
<b>Habitat/land use</b>	This culvert is large enough to facilitate movement of medium-sized mammals. There is visibility through the culvert and the raised southern opening has a concrete ledge making access more feasible for small to medium-sized mammals.  10' south of the southern opening, a fence has a small section with loose barbed wire strands that may allow medium-sized mammals to pass through.

SR 156 Site 4. Southern opening showing raised entrance and concrete ledge. Photo faces northwest.

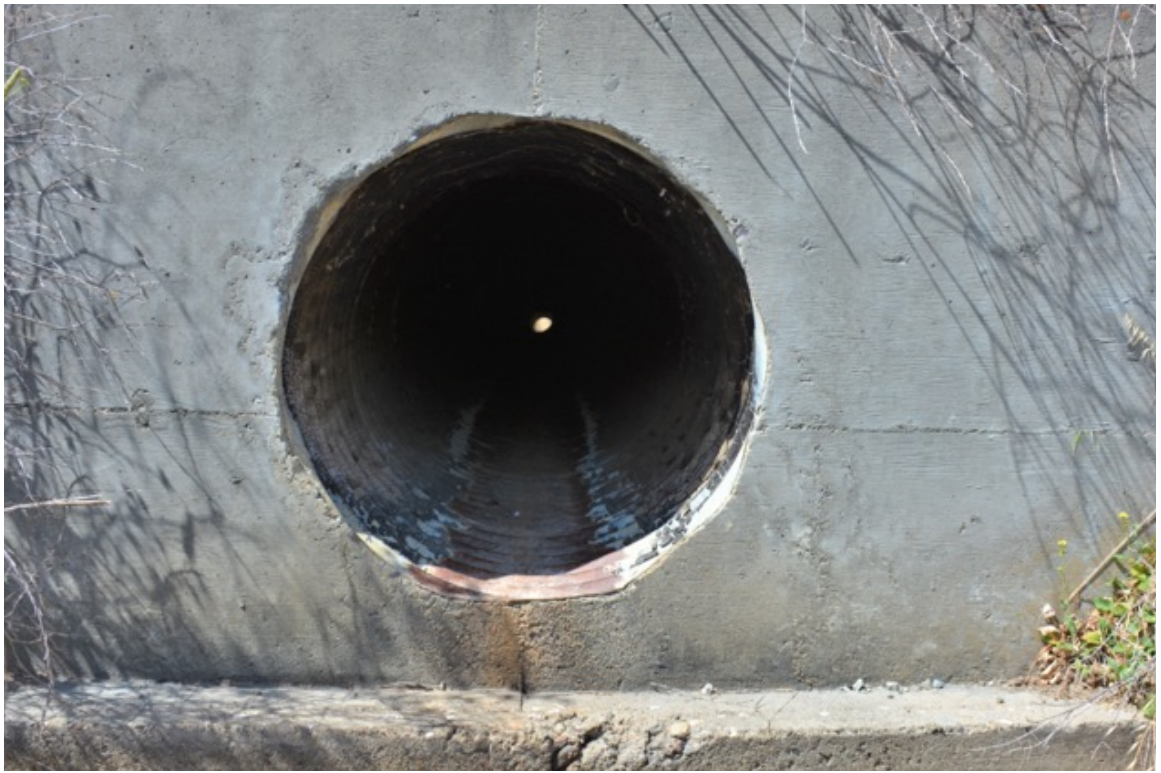
SR 156 Site 4. Close-up of southern opening.

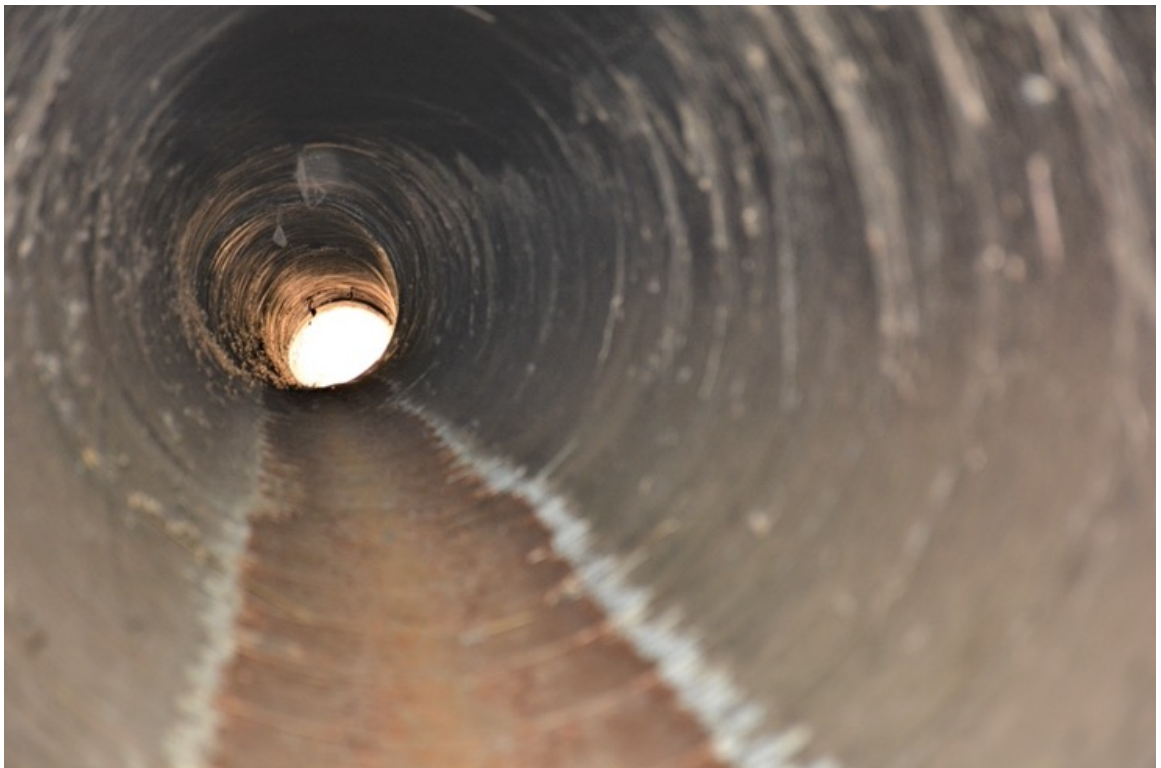
SR 156 Site 4. Photo from within southern opening showing curve. Photo faces north.

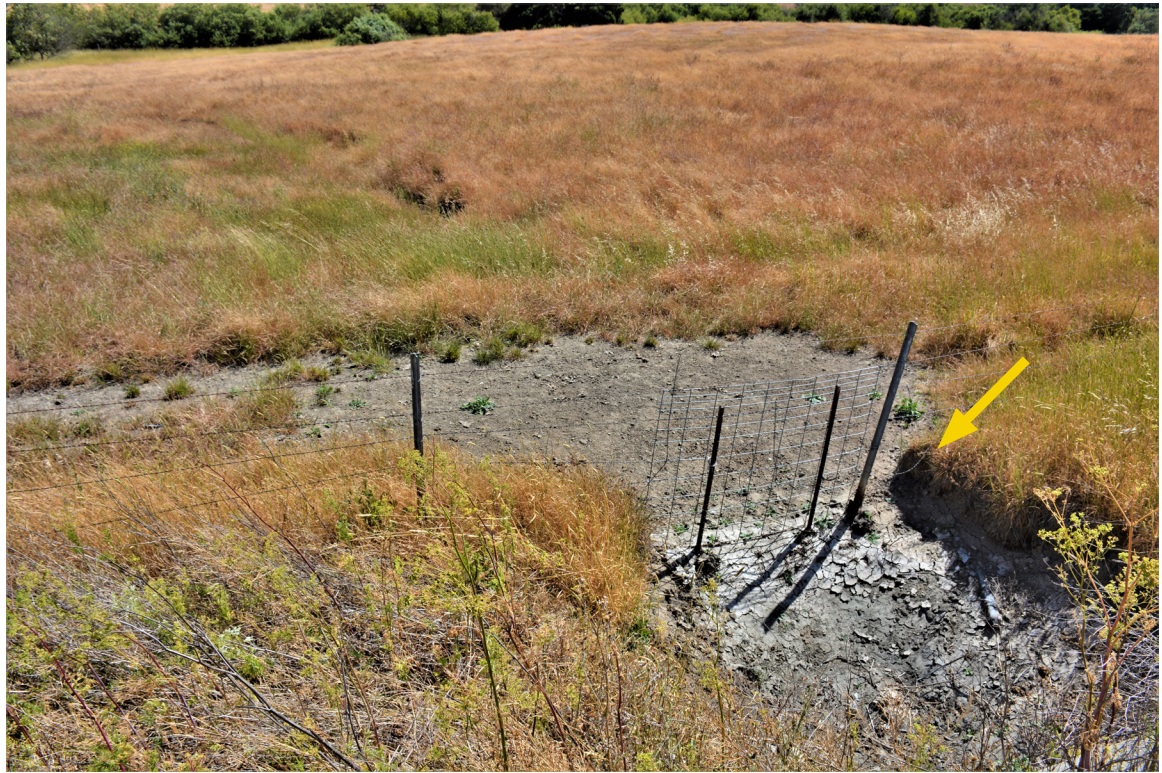
SR 156 Site 4. View of fence and section of loose barbed wire strands. Loose barbed wire strands are indicated by yellow arrow. Photo faces southwest.

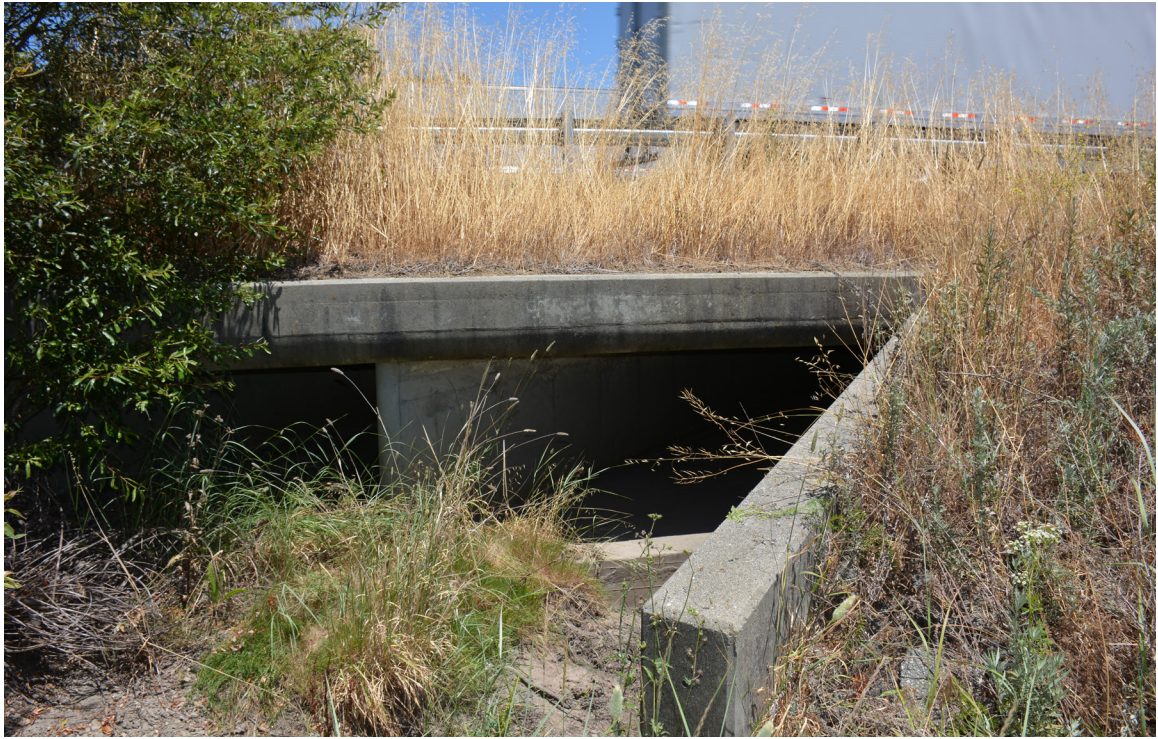
SR 156 SITE 5	
<b>Postmile</b>	SBT, SR 156, PM 2.01
<b>GPS location</b>	Latitude: 36.84675 Longitude: -121.54977
<b>Dimensions</b>	Dual box culverts. Western culvert is 11' wide and 3' 11" high. An open section of the ceiling in the western culvert allows light. The eastern culvert is 12' 7" wide and 4' high.
<b>Direction</b>	Northeast - southwest. Unable to determine direction of decline.
<b>Visibility</b>	Yes. There is visibility through both culverts. However, vegetation growing at the western portion of the southwestern opening of the western culvert may affect visibility.
<b>Substrate</b>	The western culvert has dirt substrate from the southern opening to the opposite opening. The eastern culvert has dirt substrate at the southern opening to approximately 12' within the culvert where the cement (bare bottom) is revealed.
<b>Habitat/land use</b>	This culvert connects open grassland with rolling hills on both sides. A riparian strip offers cover leading to the southwestern opening. There is a barbed wire fence approximately 17' from the southwestern opening, and an old barn to the south. An access road is visible to the south leading to the barn.

SR 156 Site 5. Southwestern opening. Photo faces north.

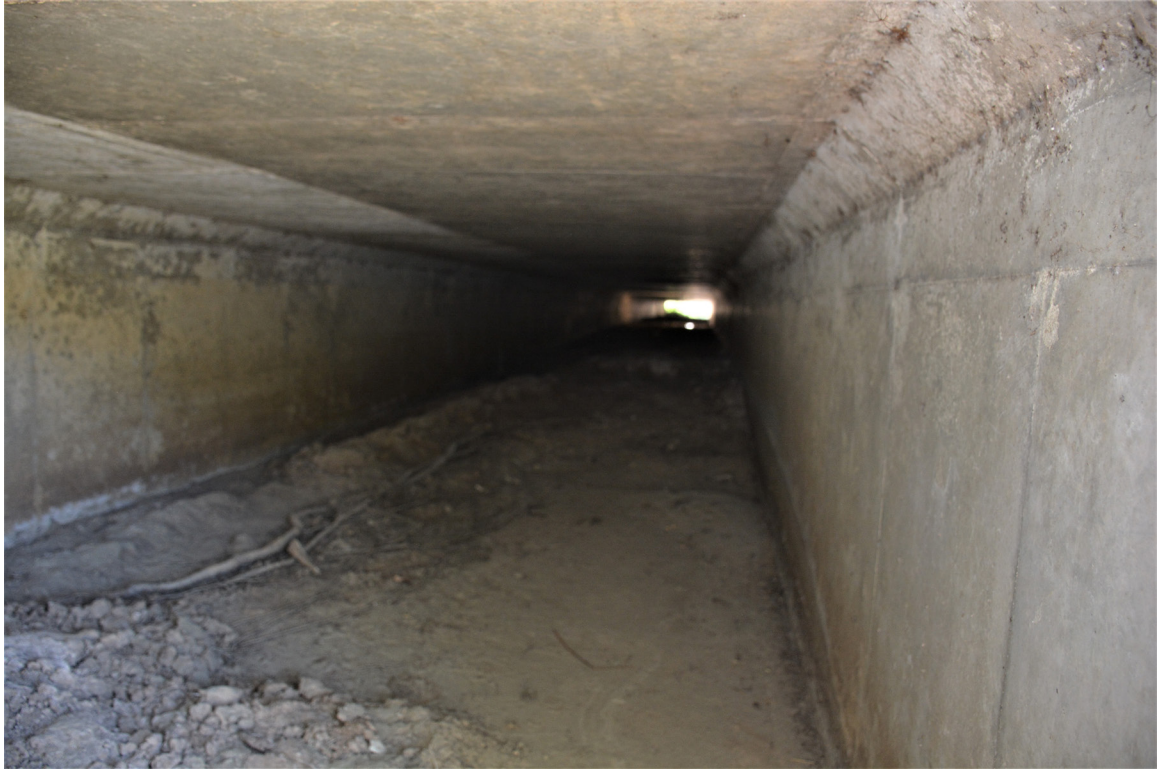
SR 156 Site 5. Inside western culvert, facing northeast to the southwestern opening.

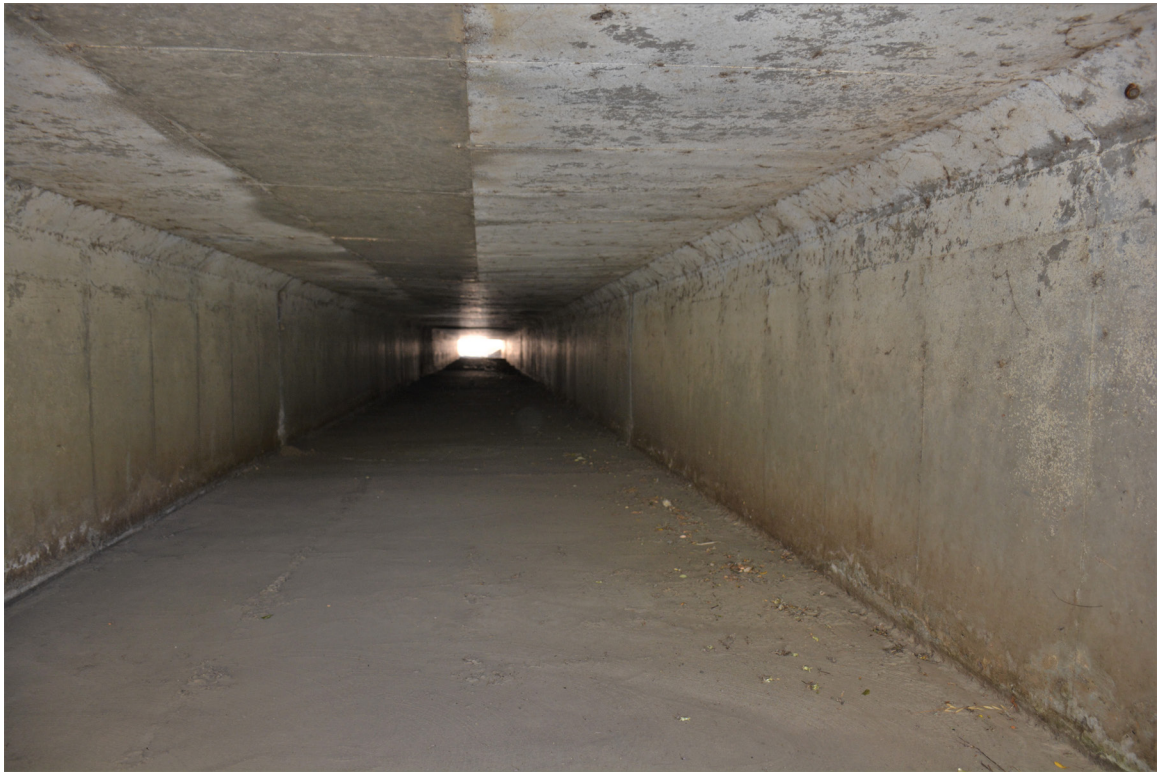
SR 156 Site 5. Inside eastern culvert, facing northeast to the southwestern opening.

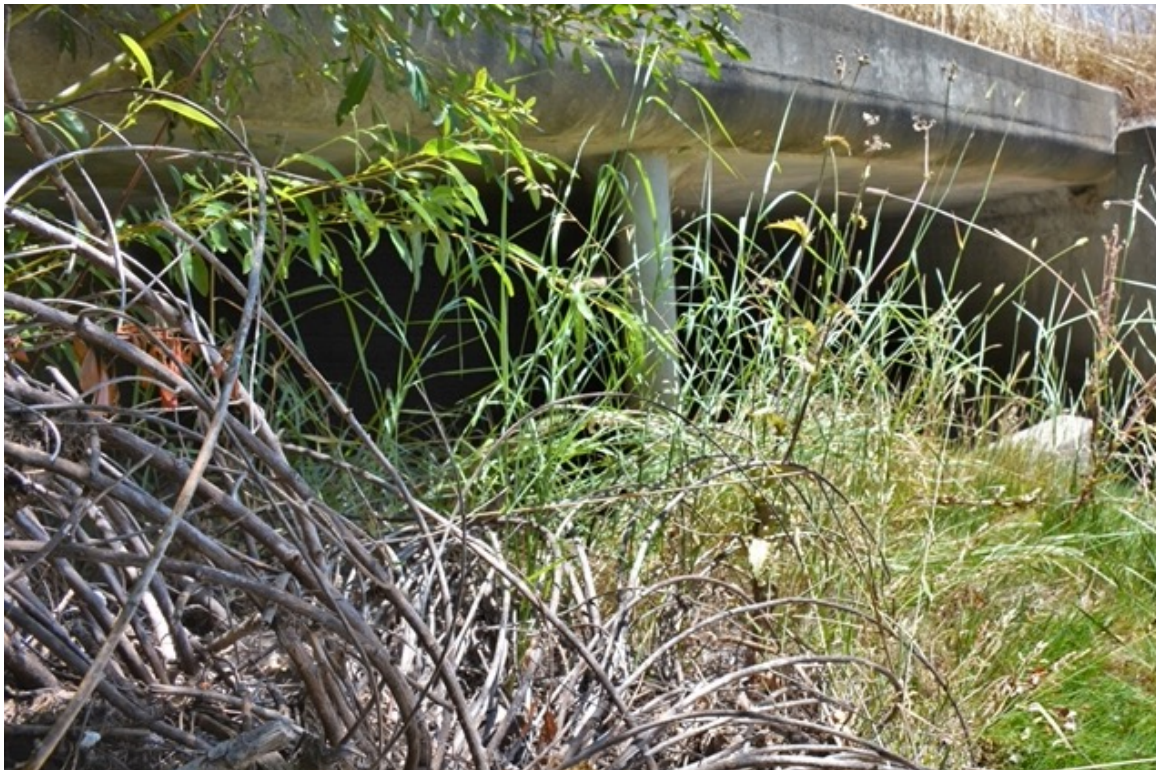
SR 156 Site 5. Vegetation in front of southwestern opening. Photo faces east.

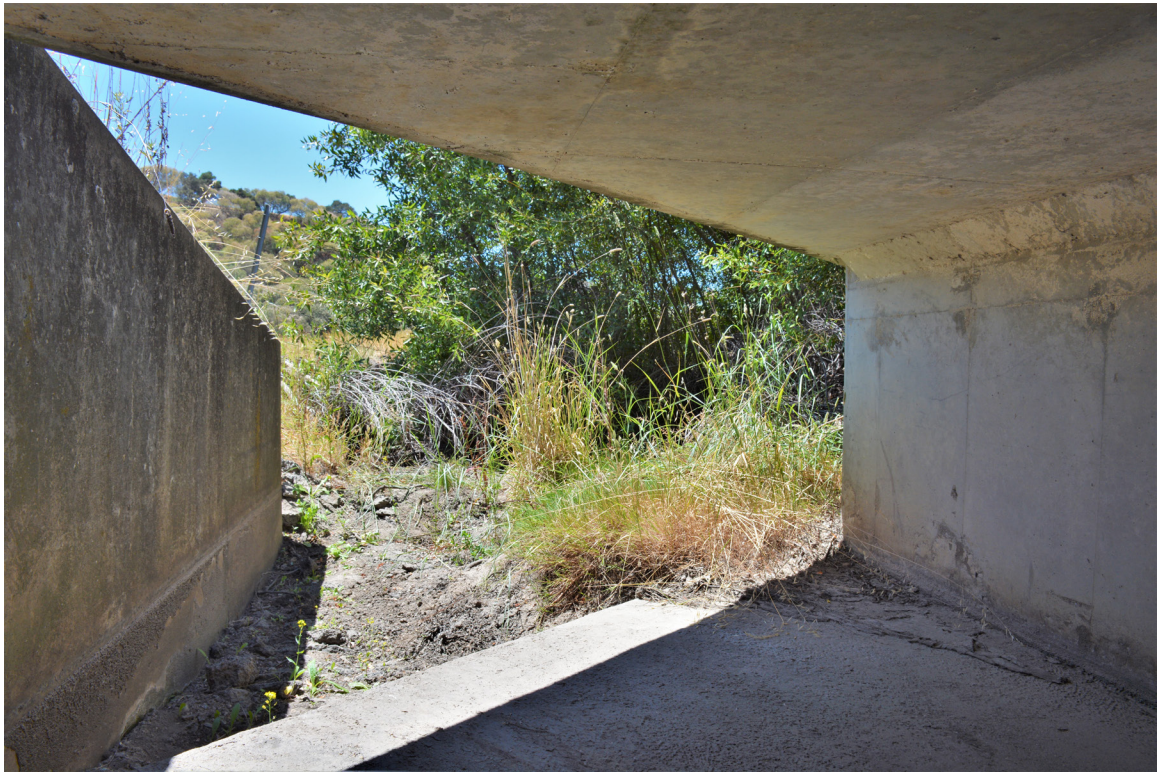
SR 156 Site 5. Example of vegetation at the southwestern opening of western culvert. Photo faces southwest.

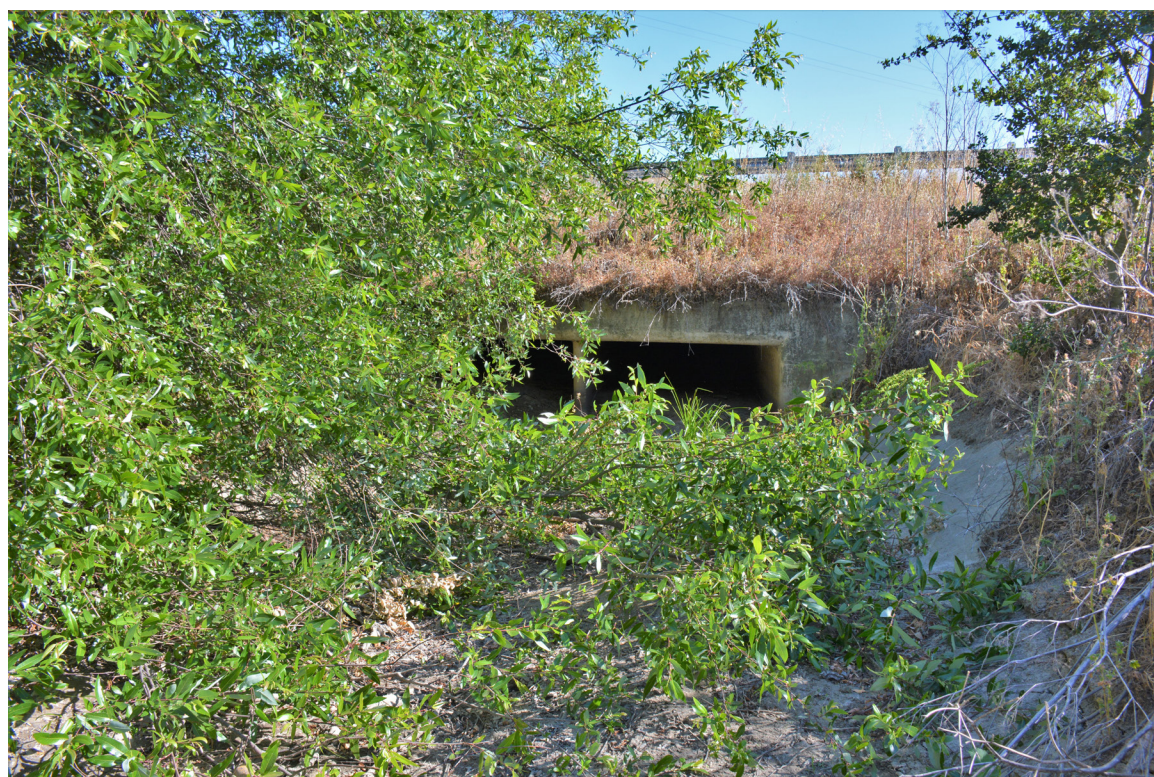
<b>Postmile</b>	SBT, SR 156, PM 2.14
<b>GPS location</b>	Latitude: 36.84612 Longitude: -121.54734
<b>Dimensions</b>	Dual box cement culvert. Western culvert 7' 6" wide, and 3' high. The eastern culvert is 7' 4" wide and 3' 2" high.
<b>Direction</b>	North - south based on direction of decline.
<b>Visibility</b>	Yes. There is visibility from one opening to the other, however the culvert does bend to the east.
<b>Substrate</b>	There is dirt throughout both culverts.
<b>Habitat/land use</b>	Culvert connects open habitat on the south side to riparian habitat on the north side. A nearby levee runs west to east (adjacent to SR 156) connecting to another culvert that is almost constructed as a small bridge to the north. There is housing to the northwest and northeast from the northern opening. A private road leads to the houses. North of the northern opening is another structure resembling a bridge.
<b>Wildlife track and sign</b>	Bobcat, raccoon, and opossum tracks found within the eastern culvert and in the levee.

SR 156 Site 6. Northern opening. Photo faces south.

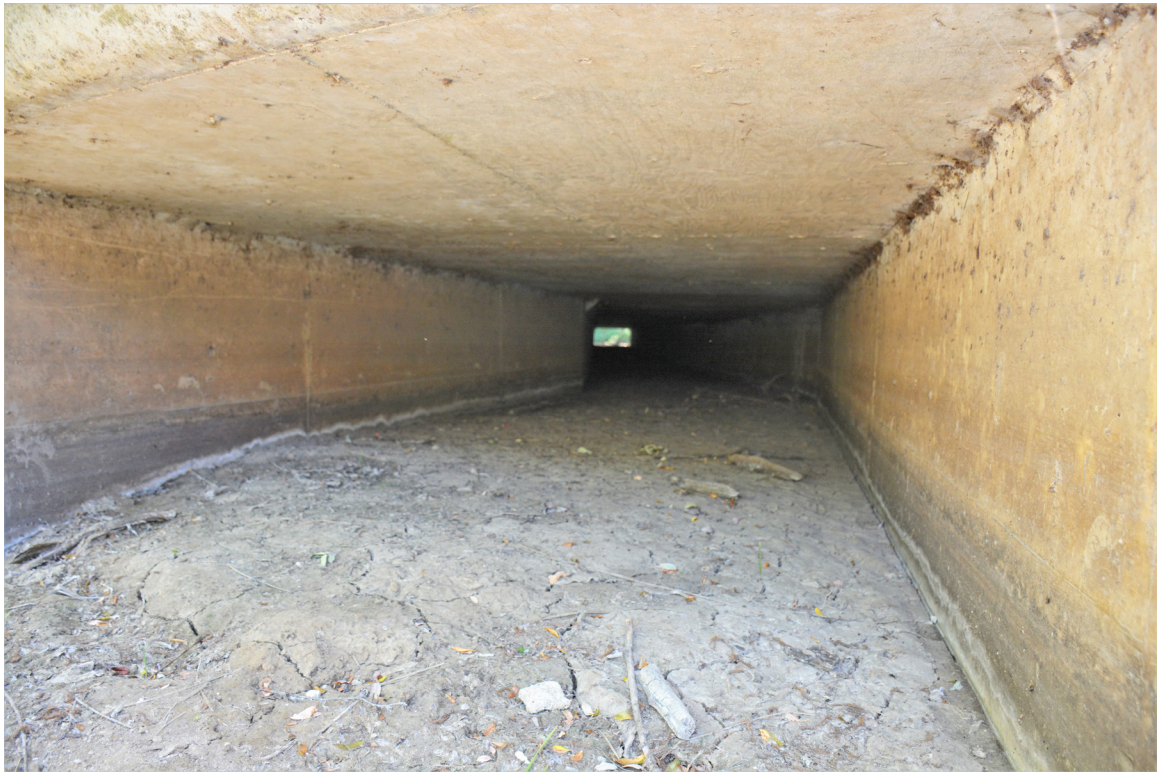
SR 156 Site 6. View from within northern opening of western culvert. The eastern bend toward the southern opening is visible. Photo faces south

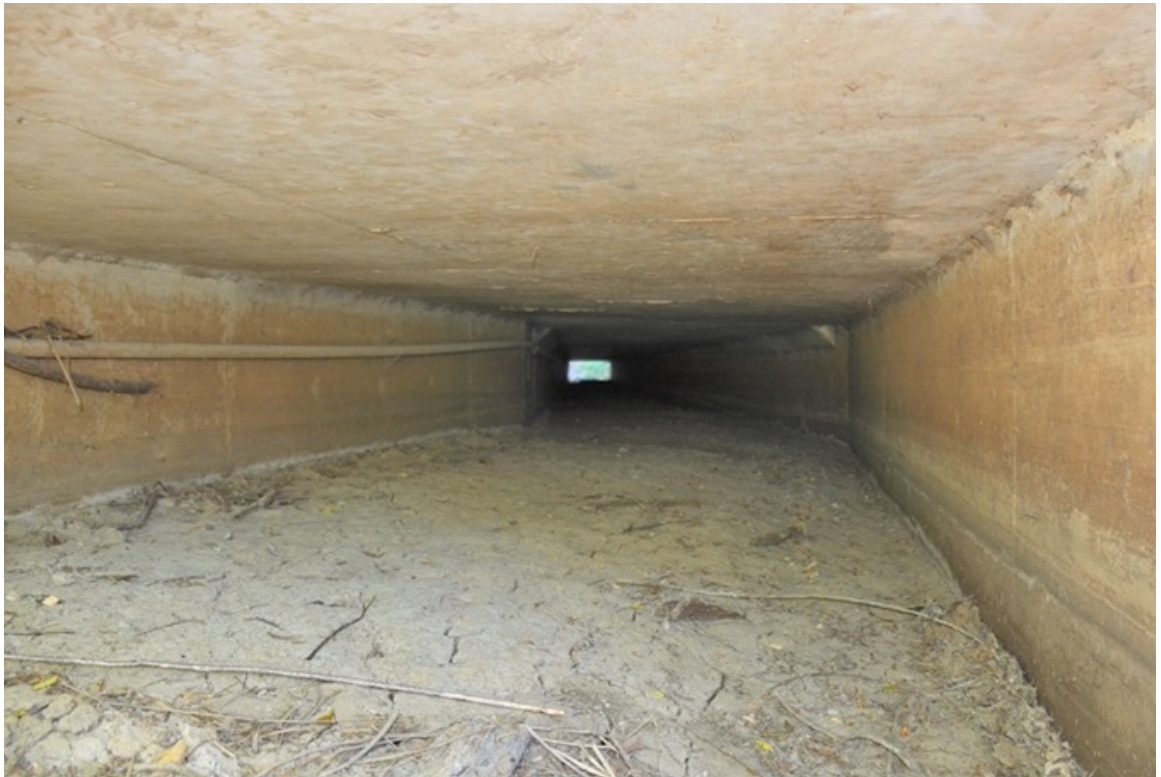
SR 156 Site 6. View from within northern opening of eastern culvert. Eastern bend in culvert identical to western culvert. Photo faces south.

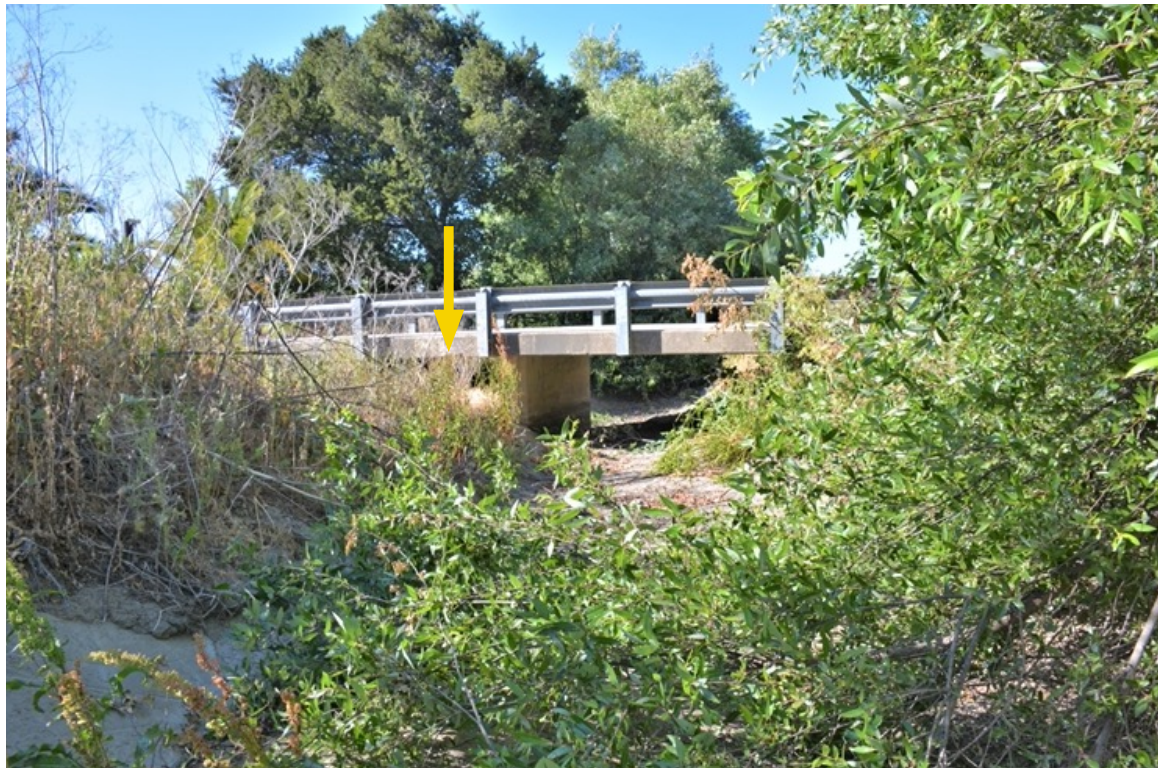
SR 156 Site 6. View of bridge to the north. The levee (indicated by yellow arrow) runs through the western section below the bridge.

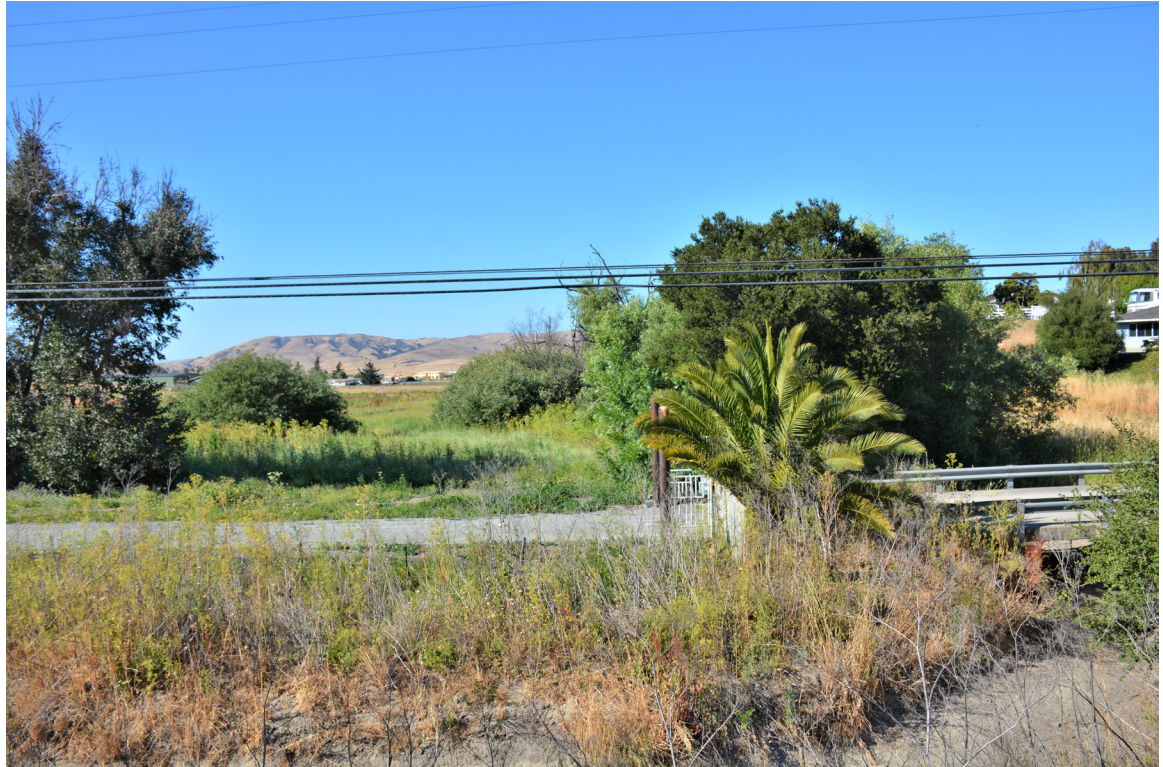
SR 156 Site 6. Example of habitat and housing beyond the northern opening. Photo faces north.

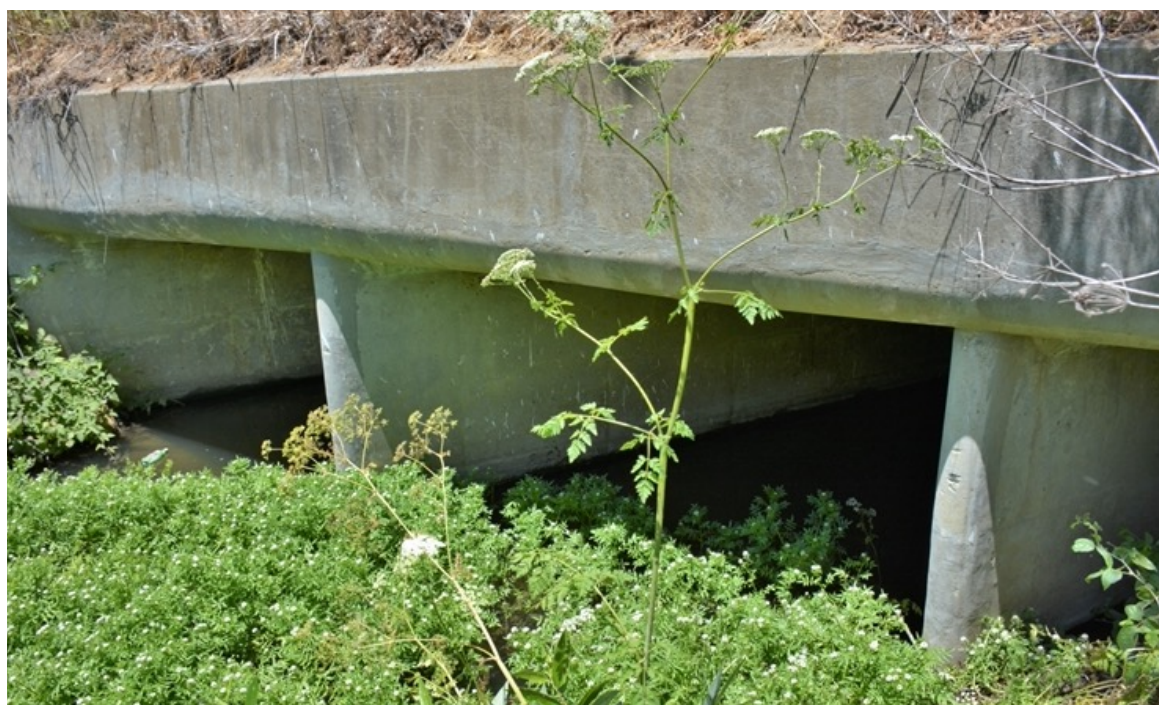
US 101 SITE 1	
<b>Postmile</b>	SBT, US 101, PM 4.92
<b>GPS location</b>	Latitude: 36.8837 Longitude: -121.56221
<b>Dimensions</b>	Medium size triple box culvert with three sections (southern section, center section, and northern section) each approximately 8' wide and 5' high.  Due to active swallows flying to and from their nests, we avoided the three culverts and instead approximated the dimensions.
<b>Direction</b>	Northwest - southeast.
<b>Visibility</b>	Yes. There is visibility through all three sections.
<b>Substrate</b>	There is approximately 2" of water throughout all three sections. At the northwestern opening of the northern section sediment appears to be building up. Other than the water and sediment, the substrate is concrete (bare bottom).
<b>Habitat/land use</b>	San Juan Creek flows through this culvert and very thick and dense riparian vegetation leads from the northwestern and southeastern openings. This structure is one of a series of four that allows San Juan Creek to flow south through the interchange. The habitat to the northwest is open agricultural fields, and to the southeast is the interchange between US 101 and SR 129.

US 101 Site 1. Southeastern opening showing the three sections of the culvert—from left to right, southern, center, and northern sections. Photo faces west.

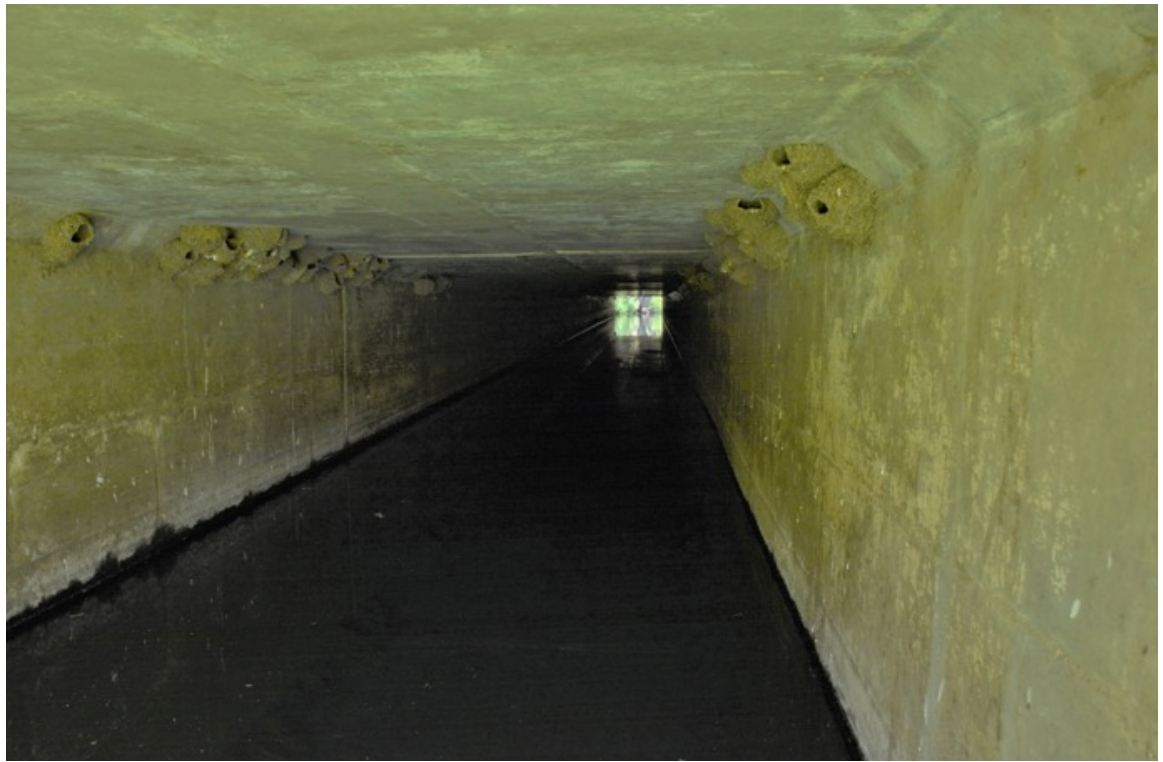
US 101 Site 1. Center section facing northeast.
