# Enhancing ecological connectivity and safe passage for wildlife on highways between the southern Santa Cruz Mountains, Gabilan Range, and Diablo Range in California

Diamond, TD, A Sandoval, NP Sharma, ME Vernon, PD Cowan, AP Clevenger, and SC Lockwood. 2022. *Enhancing ecological connectivity and safe passage for wildlife on highways between the southern Santa Cruz Mountains, Gabilan Range, and Diablo Range in California*. Pathways for Wildlife and Peninsula Open Space Trust, Palo Alto, CA.

AUGUST 2022

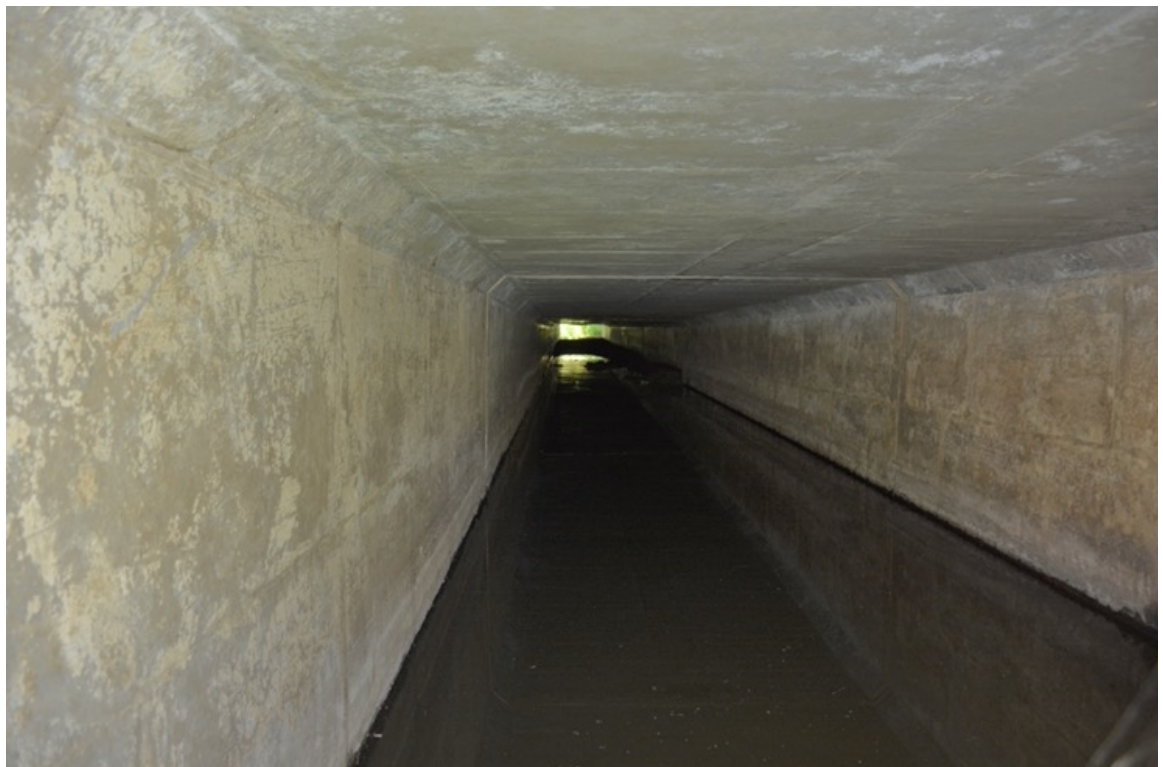
US 101 Site 1. View of northern section showing sediment build-up at the northwestern opening.

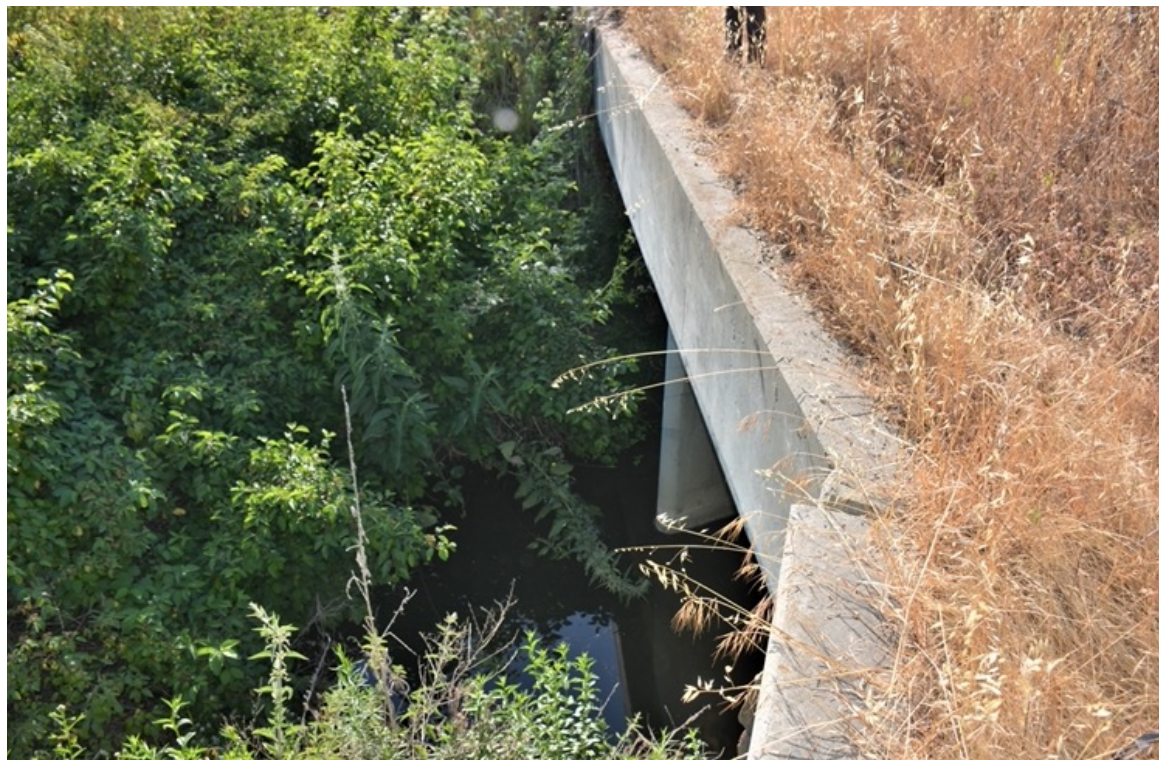
<b>Postmile</b>	SBT, US 101, PM 4.91
<b>GPS location</b>	Latitude: 36.88288 Longitude: -121.5614
<b>Dimensions</b>	Large dual box culvert with both sections 6' wide and 8' high.
<b>Direction</b>	North - south.
<b>Visibility</b>	Yes. There is high visibility through both sections.
<b>Substrate</b>	Both sections have approximately 3" of water throughout. A bank of mud (1' wide and 4' long) extends from the southeastern corner of the eastern section's southern opening. The bank extends north before stopping 4' within the culvert.
<b>Habitat/land use</b>	This structure is in the middle of the US 101-SR 129 interchange and is the second of four structures that allow San Juan Creek to flow south. There is thick and dense riparian habitat to the north and south of this structure. This is an interesting location with wildlife trails and deer scat adjacent on both sides of the creek.
<b>Wildlife track and sign</b>	Three wildlife trails lead to the riparian habitat at the southern opening from the west. Deer ( <i>Odocoileus hemionus</i> ) scat was found to the west of the riparian habitat near one of the wildlife trails. A coyote ( <i>Canis latrans</i> ) track was found on the 1'-wide, 4'-long bank within the southern opening of the eastern section of the culvert.

US 101 Site 2. Northern section showing sediment build-up at the northwestern opening.

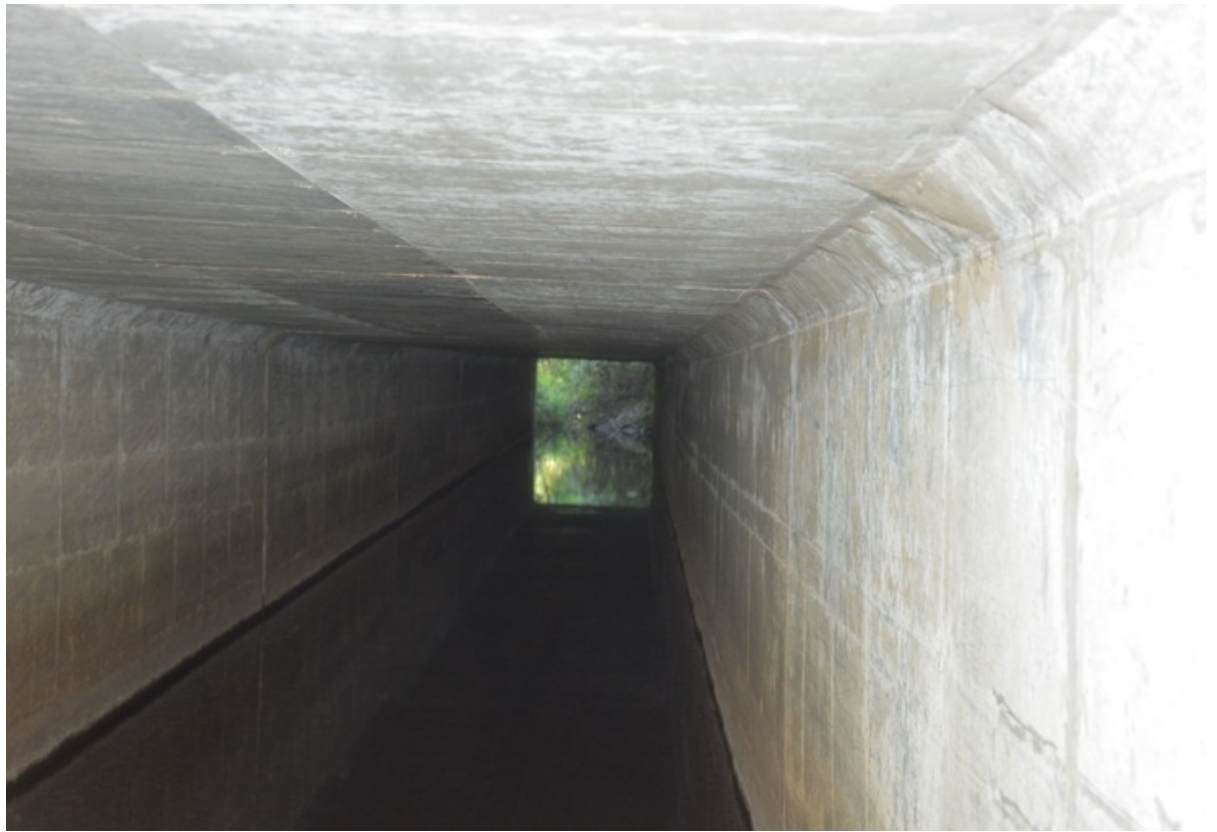
US 101 Site 2. Northern section showing sediment build-up at the northwestern opening.

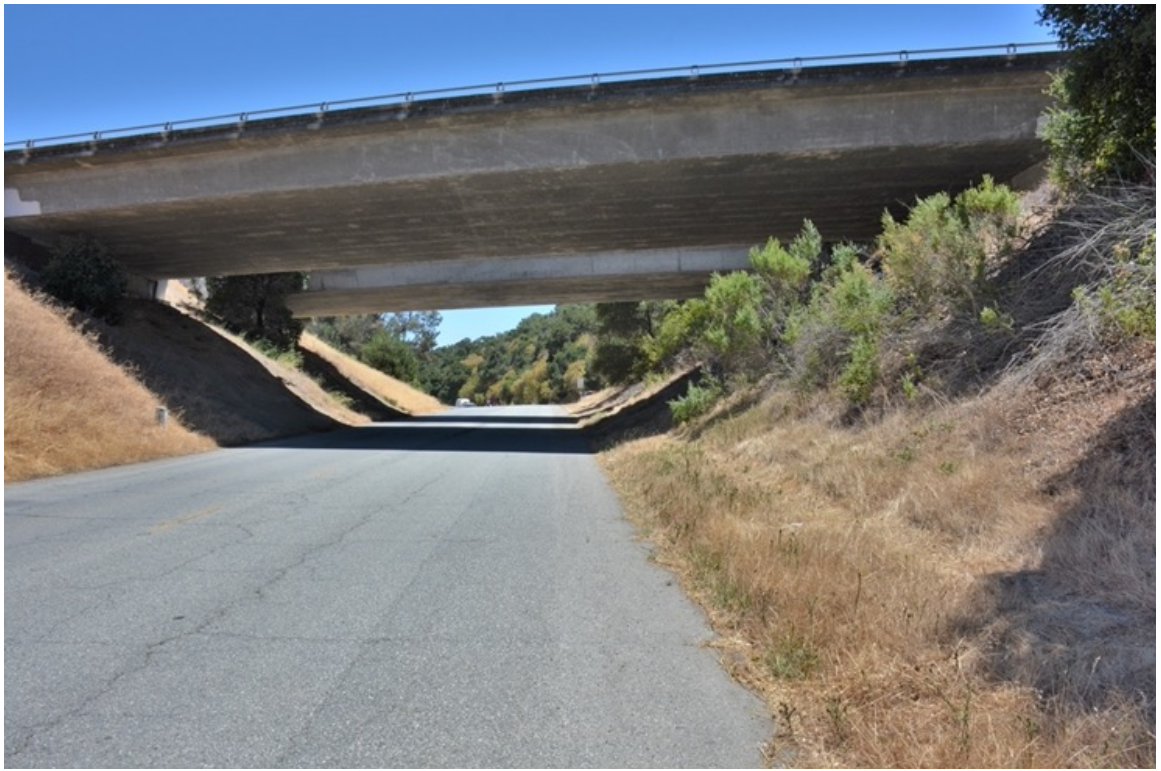
US 101 SITE 4 ANZAR ROAD UNDERPASS	
<b>Postmile</b>	SBT, US 101, PM 4.26
<b>GPS location</b>	Latitude: 36.87599 Longitude: -121.56935
<b>Dimensions</b>	Large underpass (well over 20' high) where Anzar Road runs under US 101.
<b>Direction</b>	West - east
<b>Visibility</b>	Yes. There is high visibility throughout the underpass.
<b>Substrate</b>	There is soft dirt along the northern and southern shoulders and the slopes that lead up to the overpass.
<b>Habitat/land use</b>	Searle Road is to the west, and McAlpine Lake is to the northeast producing a lot of human activity.
<b>Wildlife track and sign</b>	Deer ( <i>O. hemionus</i> ) tracks were found along a pathway at the southern shoulder. Two trails lead north and south through the underpass at both the northern and southern shoulders.
<b>Track and sign transects</b>	The soft soil at both the northern and southern shoulders is highly suitable for tracking transects.

US 101 Site 4 Anzar Road underpass. Photo faces south.

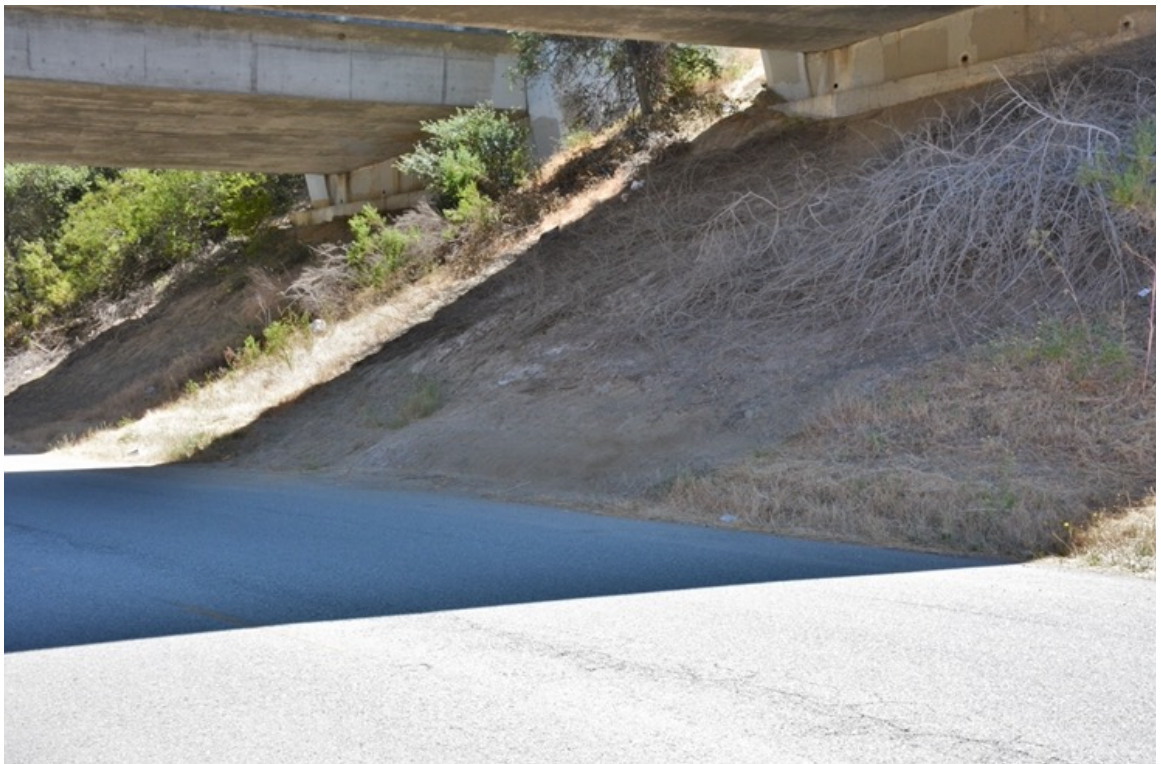
US 101 Site 4 Anzar Road underpass. Southern slope of shoulder leading up to US 101 overpass.

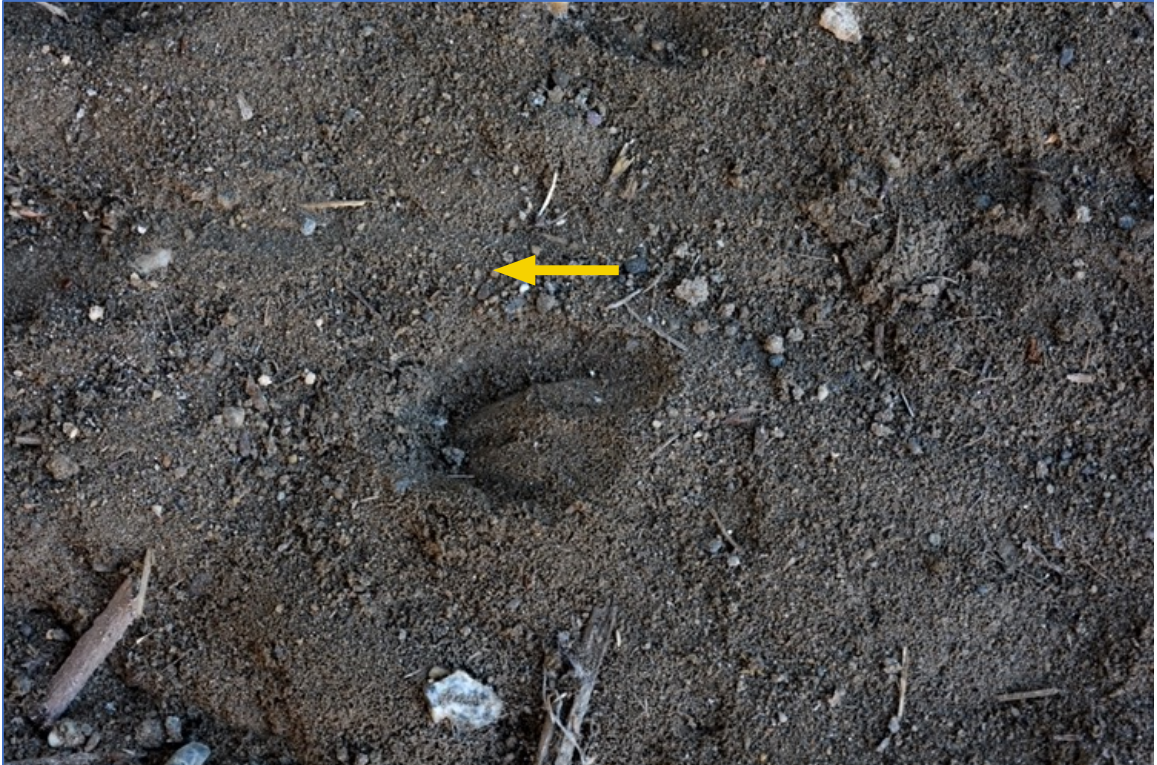
US 101 Site 4 Anzar Road underpass. Deer track located at the southern shoulder heading east. The yellow arrow points in the direction of travel.

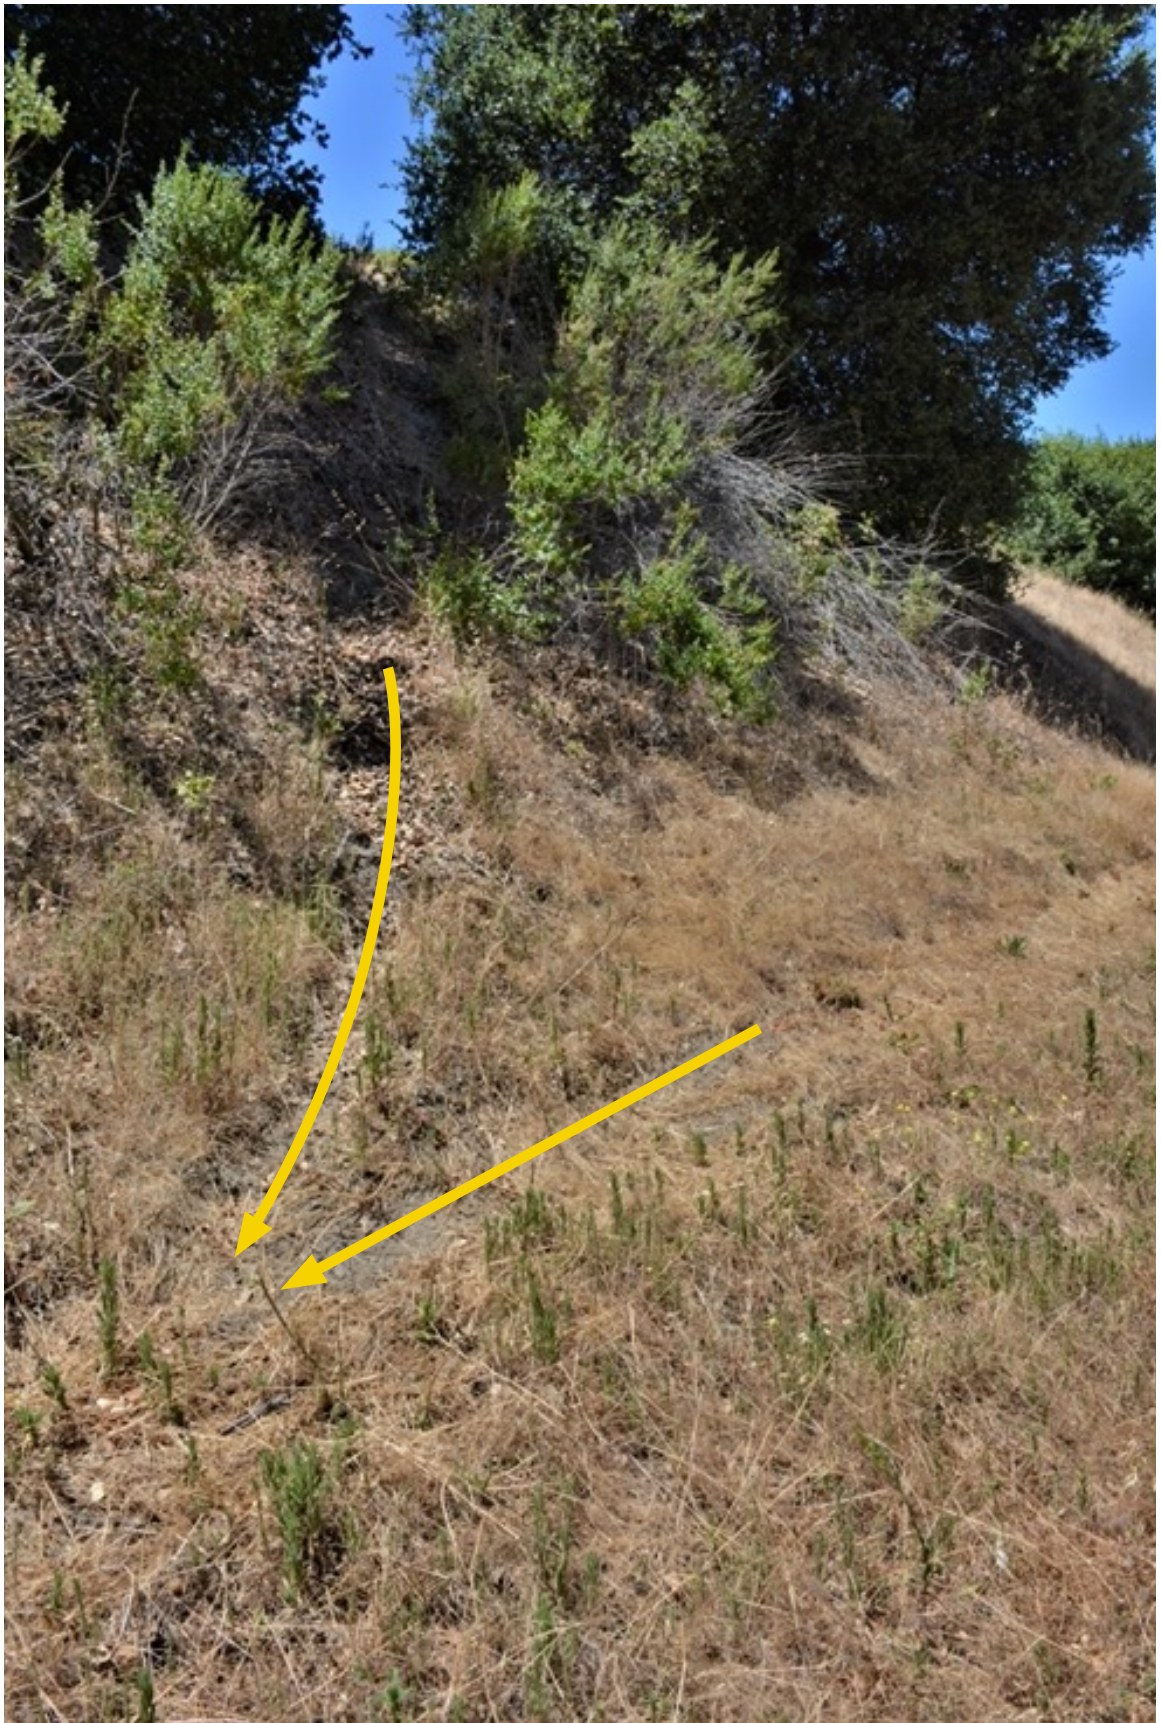
US 101 Site 4 Anzar Road underpass. Example of trails west of the southern shoulder. The yellow arrows highlight the trails and point to where the trails meet.

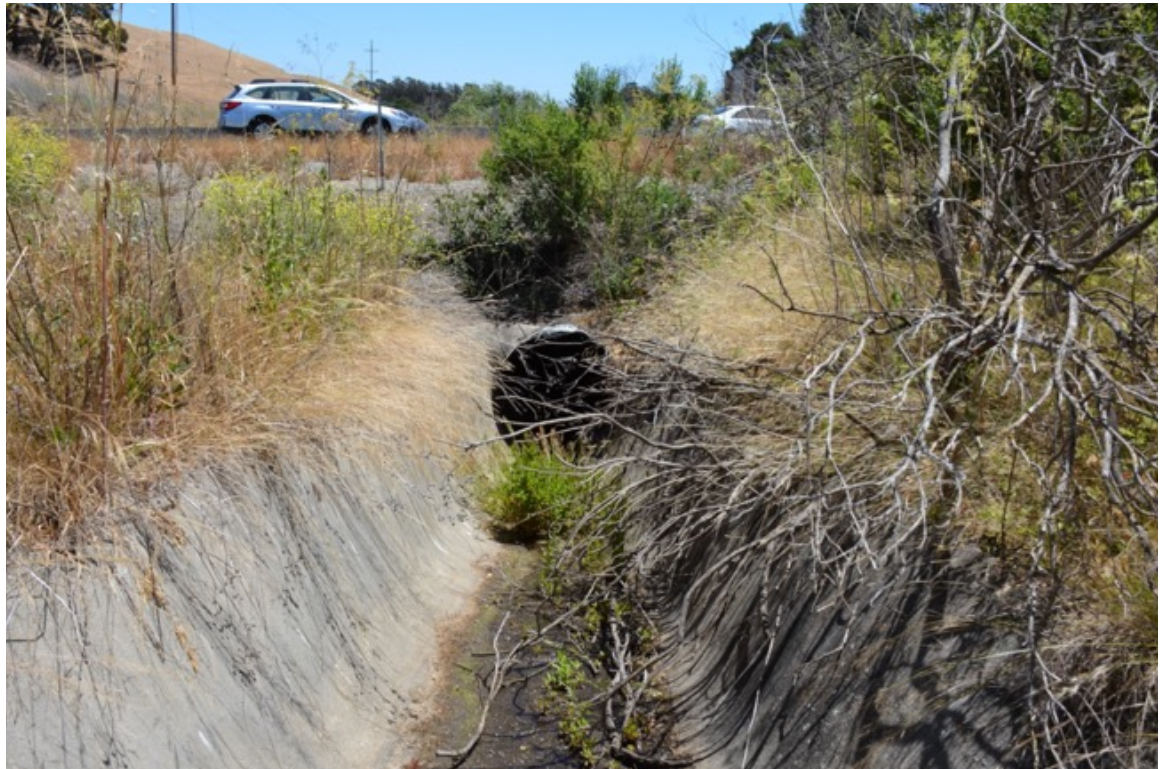
<b>Postmile</b>	SBT, US 101, PM 4.00
<b>GPS location</b>	Latitude: 36.87264 Longitude: -121.57197
<b>Dimensions</b>	Round corrugated pipe culvert 4' in diameter. There is a concrete levee at the northwestern opening.
<b>Direction</b>	Northwest - southeast.
<b>Visibility</b>	Yes. There is visibility through this culvert. A grate in the middle of the culvert allows light in.
<b>Substrate</b>	The steel is corroded at the northwestern opening exposing the earth underneath. Other than the corroded and exposed area, it is corrugated steel (bare bottom) throughout the culvert.
<b>Habitat/land use</b>	This culvert connects a large ravine and opens to the west and east. There is a fence at the end of the levee to the west of the northwestern opening, which is raised.
<b>Wildlife track and sign</b>	A wildlife trail connects the northwestern end of the levee to a lift at the base of the fence to the west.
<b>Track and sign transects</b>	The wildlife trail leading to and from the fence and the muddy substrate in the levee are suitable candidates for tracking transects.

US 101 Site 5. Northwestern opening and concrete levee.

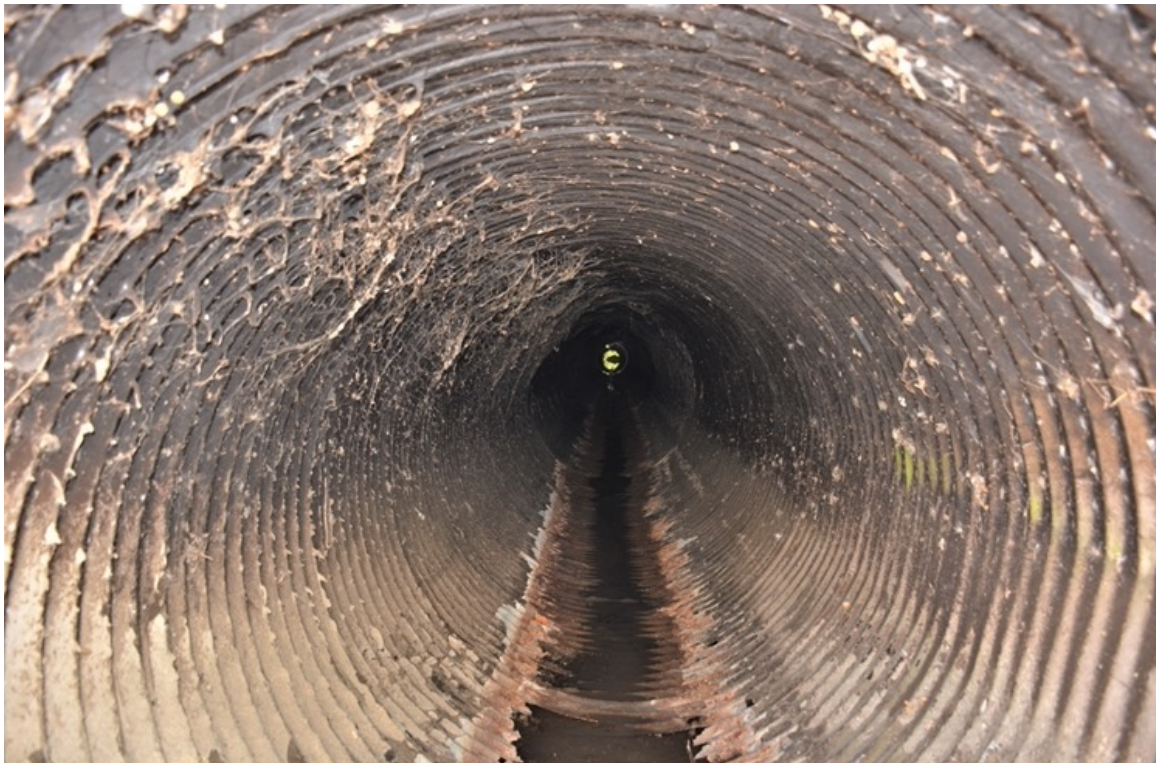
US 101 Site 5. Within northwestern opening, showing the corroded bottom of the culvert.

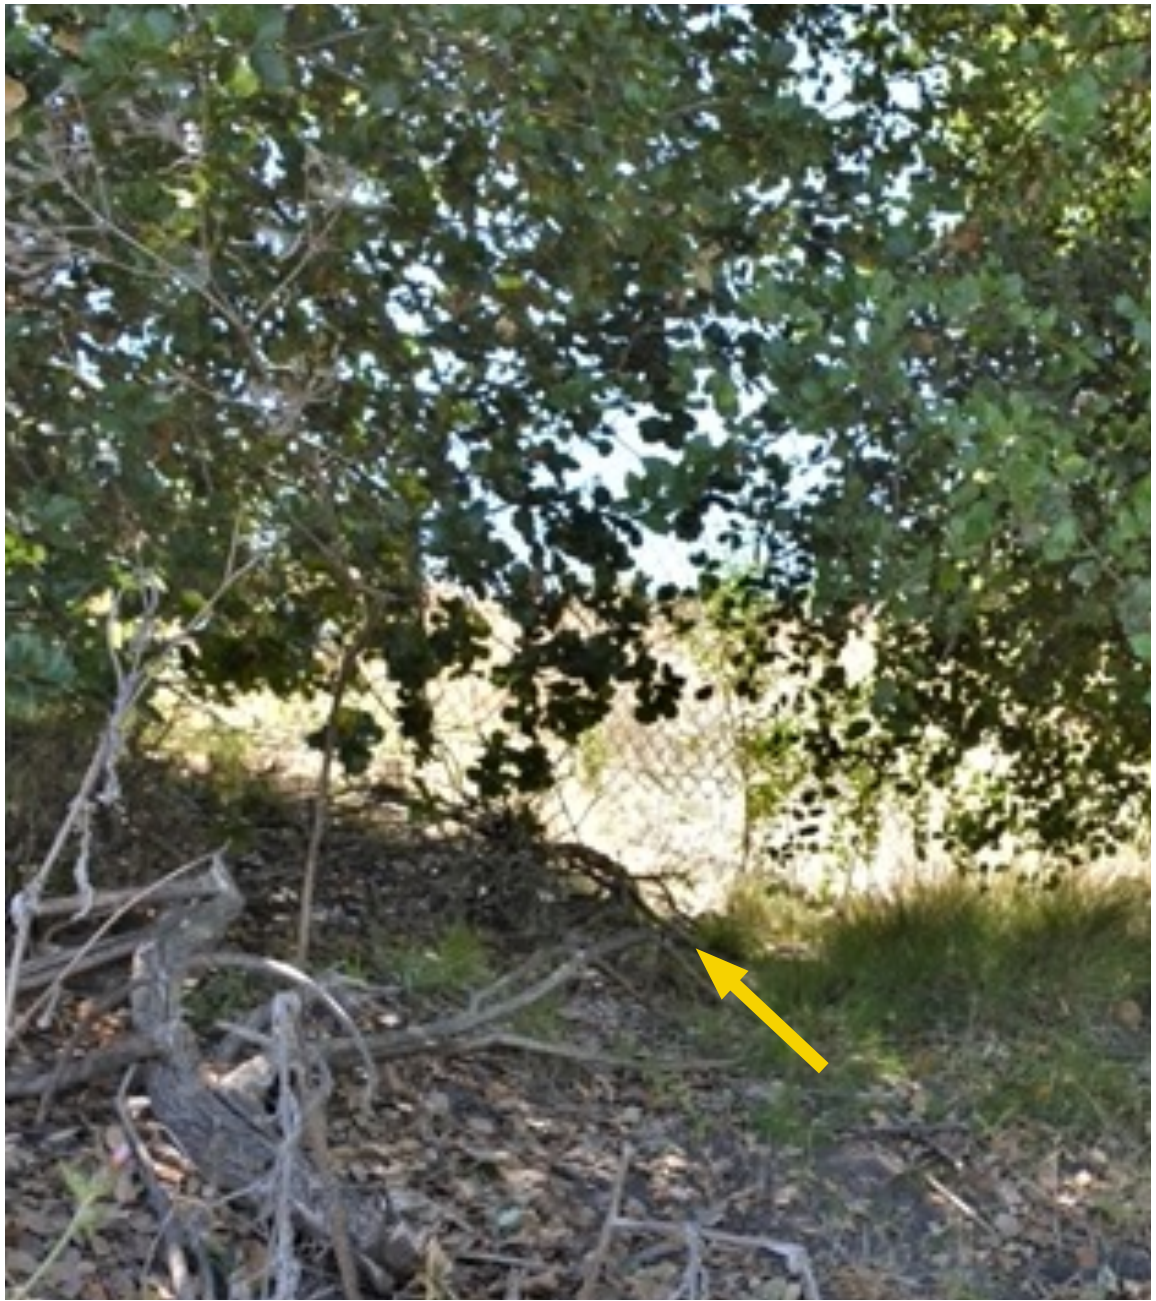
US 101 Site 5. Raised fence and wildlife trail indicated by yellow arrow.

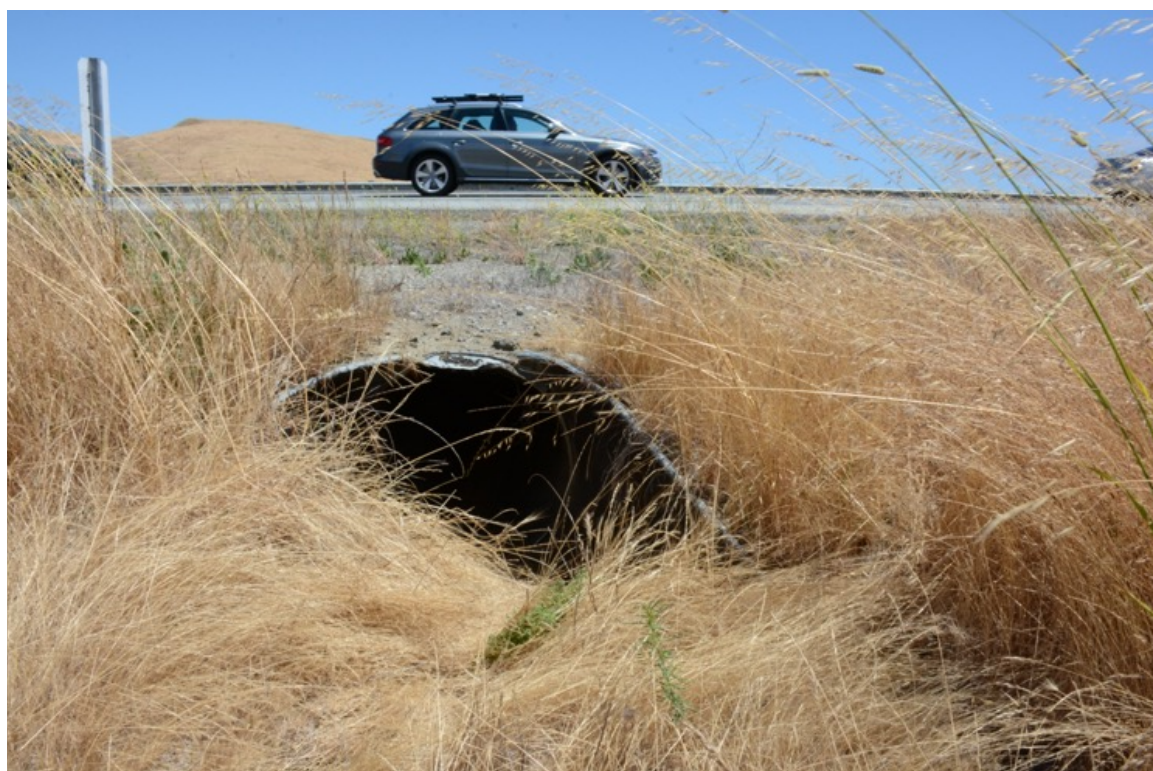
<b>Postmile</b>	SBT, US 101, PM 3.52
<b>GPS location</b>	Latitude: 36.86636 Longitude: -121.57565
<b>Dimensions</b>	Round corrugated culvert 2' 6" in diameter.
<b>Direction</b>	West - east
<b>Visibility</b>	Yes. There is visibility to the other side.
<b>Substrate</b>	Corrugated steel (bare bottom).
<b>Habitat/land use</b>	Culvert connects open habitat on both the west and east sides. There is an additional culvert to the west going under Searle Road, however it is buried and filled in with sediment.
<b>Wildlife track and sign</b>	A deceased long-tailed weasel was found in the western opening of the culvert.
<b>Track and sign transects</b>	None

US 101 Site 6. Northern opening.

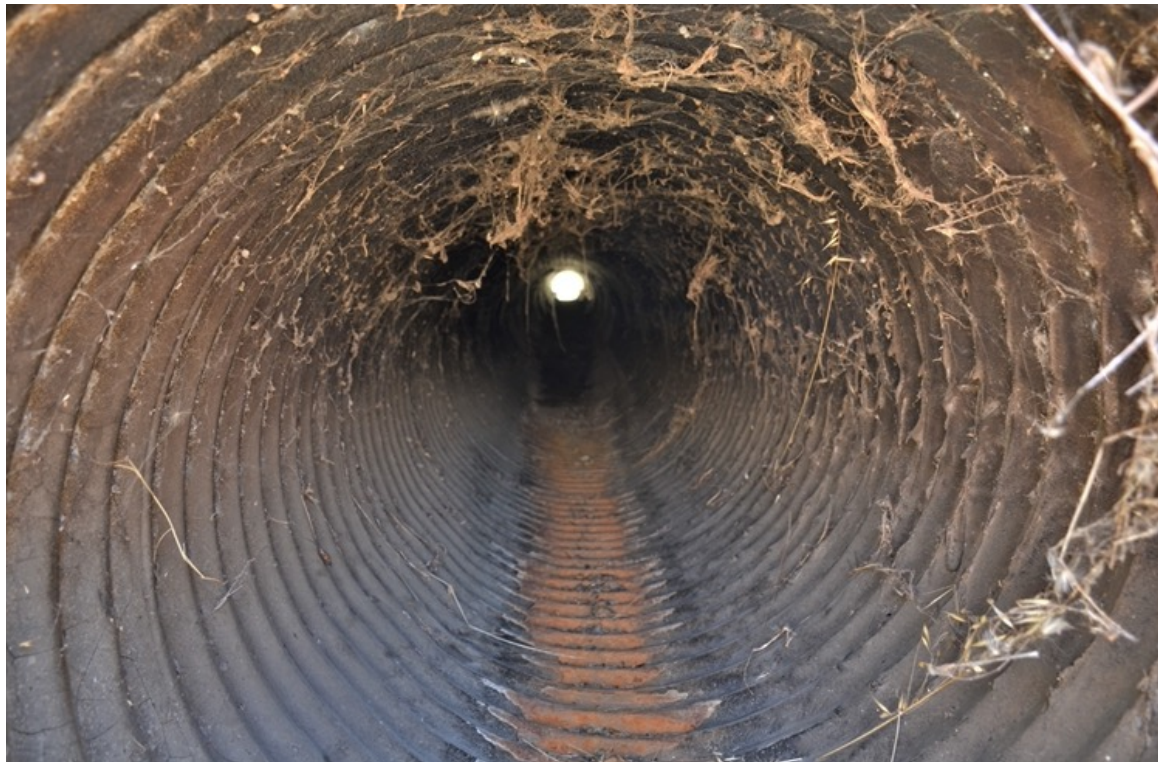
US 101 Site 6. Western opening close-up. Photo faces east.

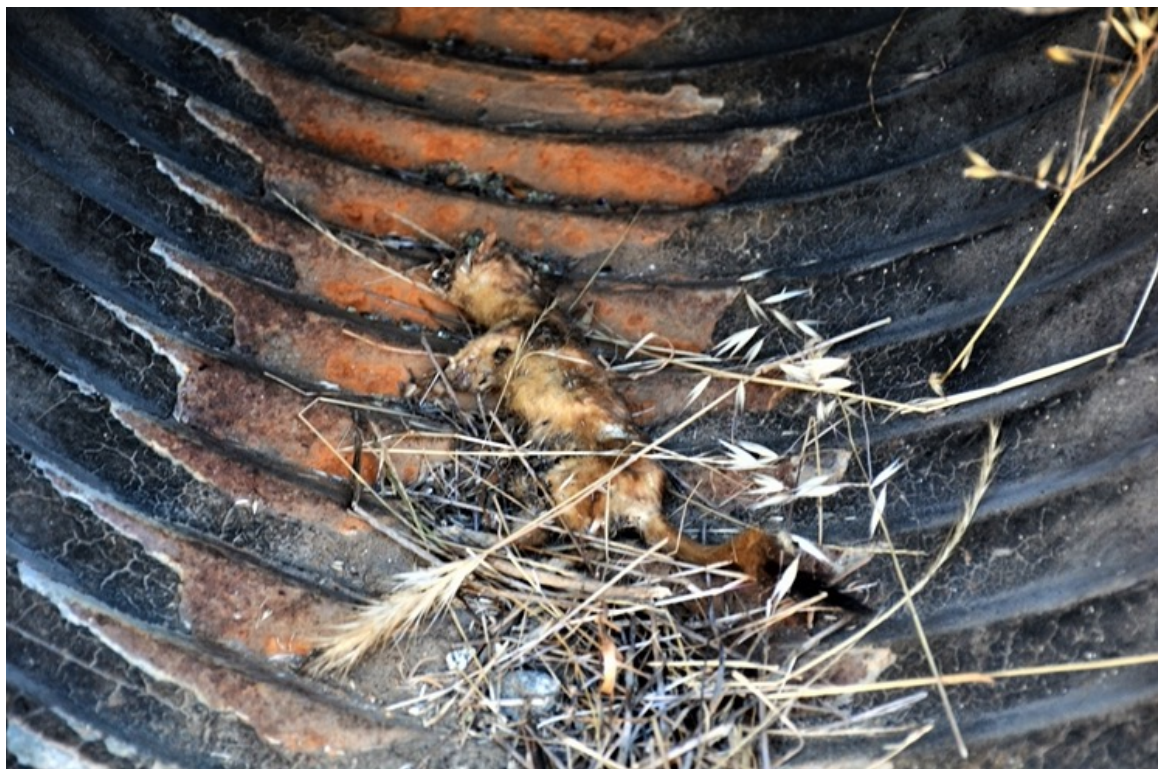
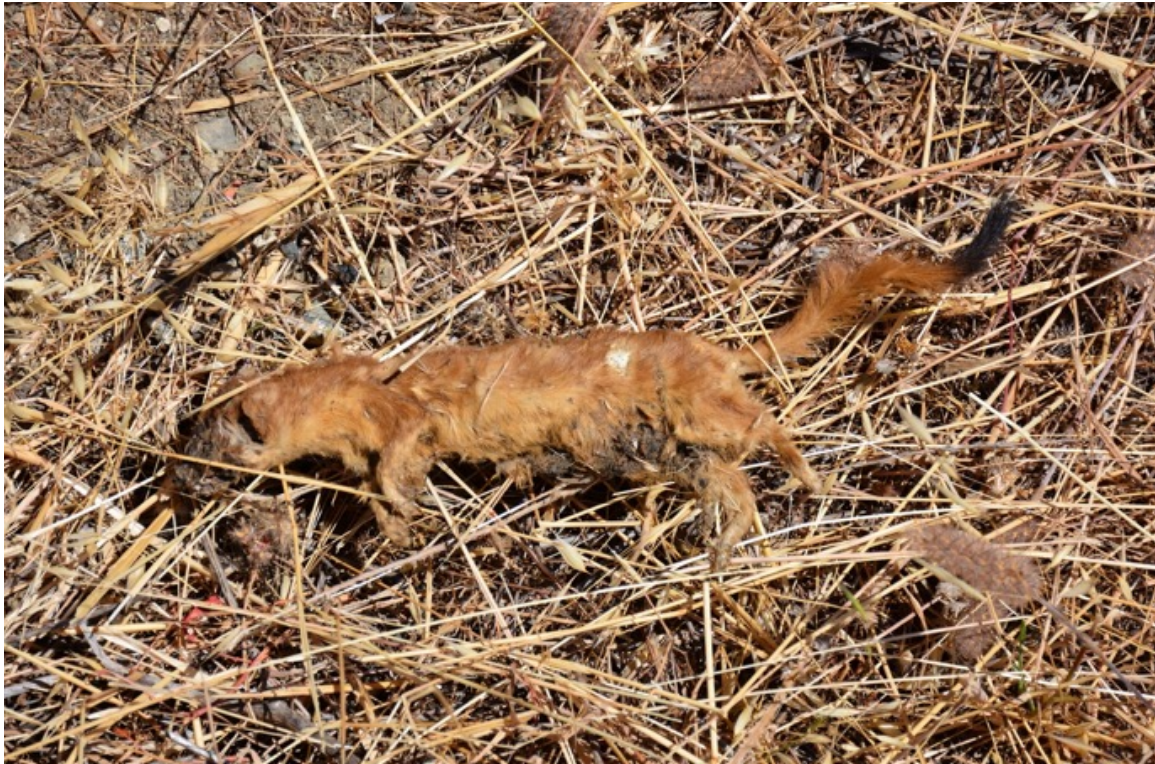
US 101 Site 6. Long-tailed weasel carcass within western opening.

US 101 Site 6. Long-tailed weasel carcass close-up.

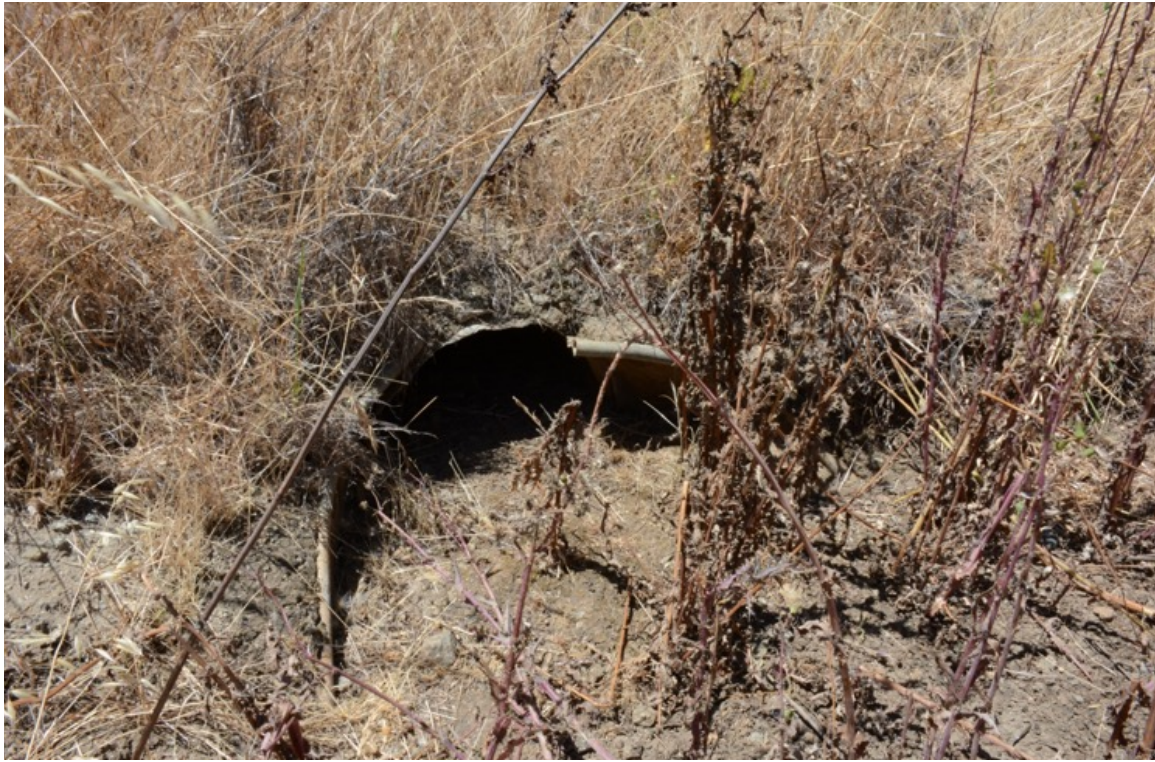
US 101 Site 6. Culvert to the west under Searle Road.

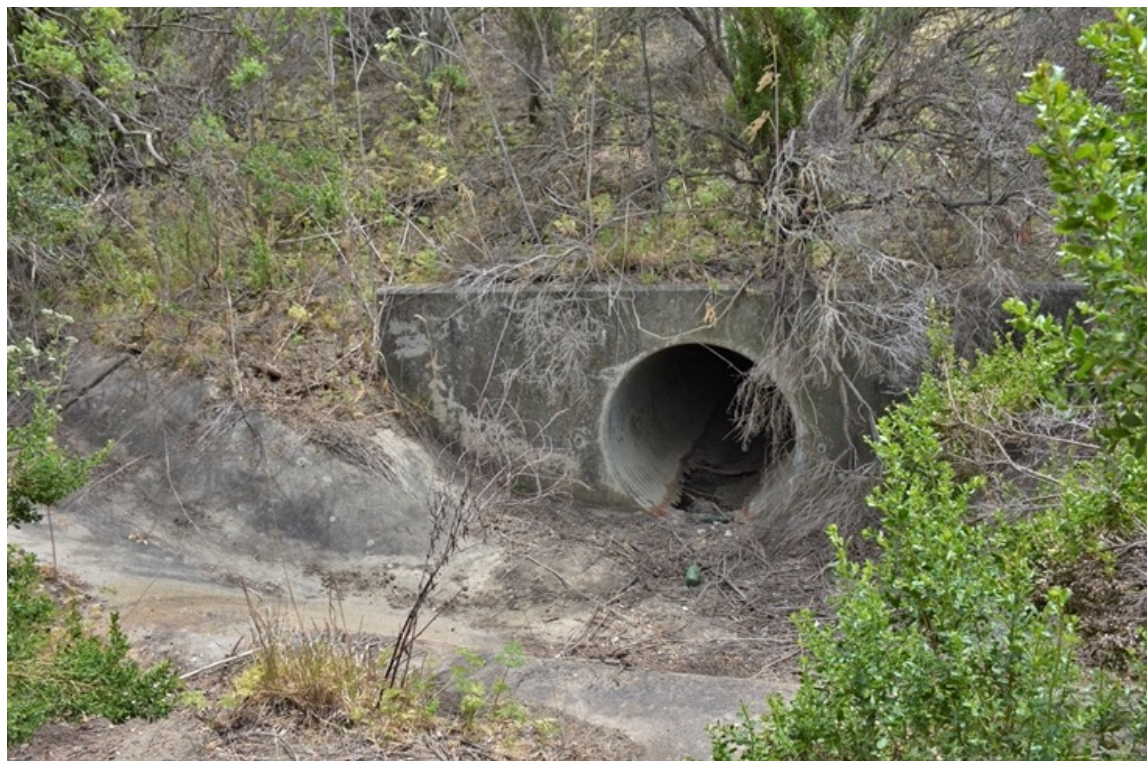
<b>Postmile</b>	SBT, US 101, PM 2.65
<b>GPS location</b>	Latitude: 36.86161 Longitude: -121.58629
<b>Dimensions</b>	Round corrugated pipe culvert 4' in diameter at the northern opening. Midway through the culvert, it changes from a round corrugated culvert to a square box culvert, with dimensions 4' x 4' through to the southern opening. A concrete levee in front of the northern opening extends to the east.
<b>Direction</b>	North - south
<b>Visibility</b>	Yes. There is visibility through the culvert. The square box southern opening can be seen from the northern opening.
<b>Substrate</b>	Concrete (bare bottom)
<b>Habitat/land use</b>	There is open habitat to the north and south with riparian habitat to the north leading to the culvert.
<b>Wildlife track and sign</b>	A wildlife trail can be seen connecting the northern opening with the hole in the fence to the north
<b>Track and sign transects</b>	The wildlife trail is a suitable area for a tracking transect.

US 101 Site 7. Northern opening.

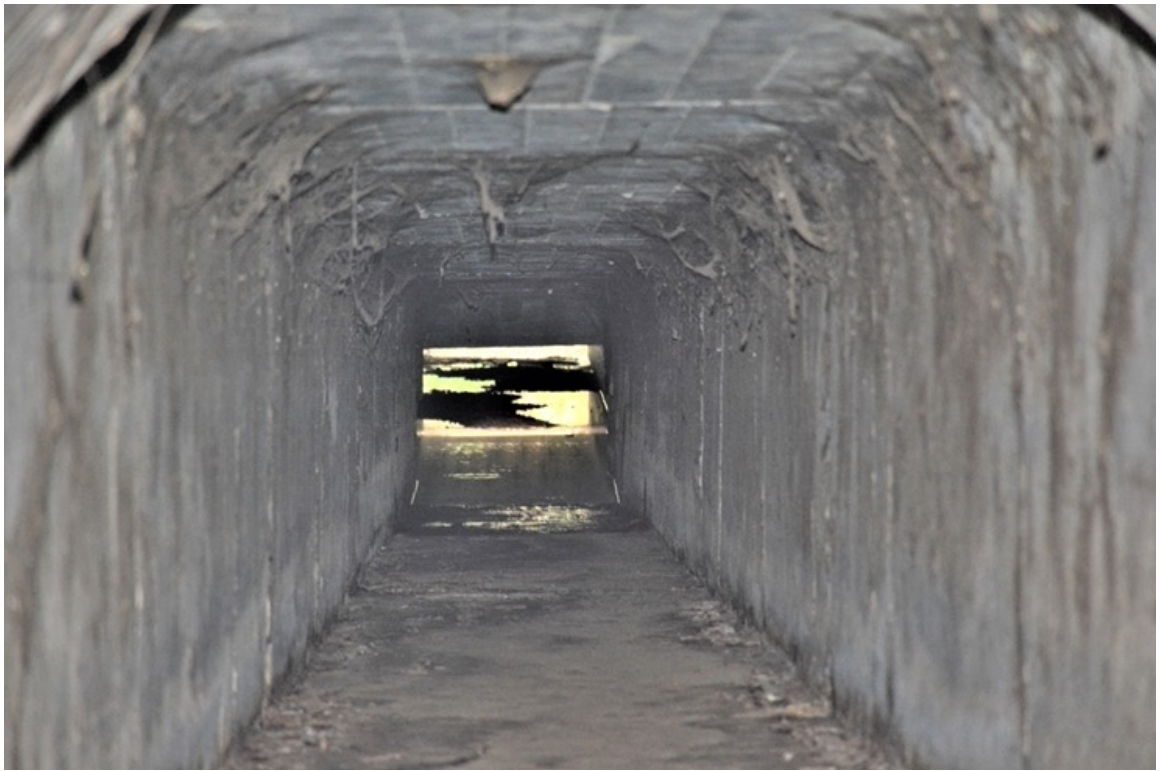
US 101 Site 7. Photo faces the southern opening.

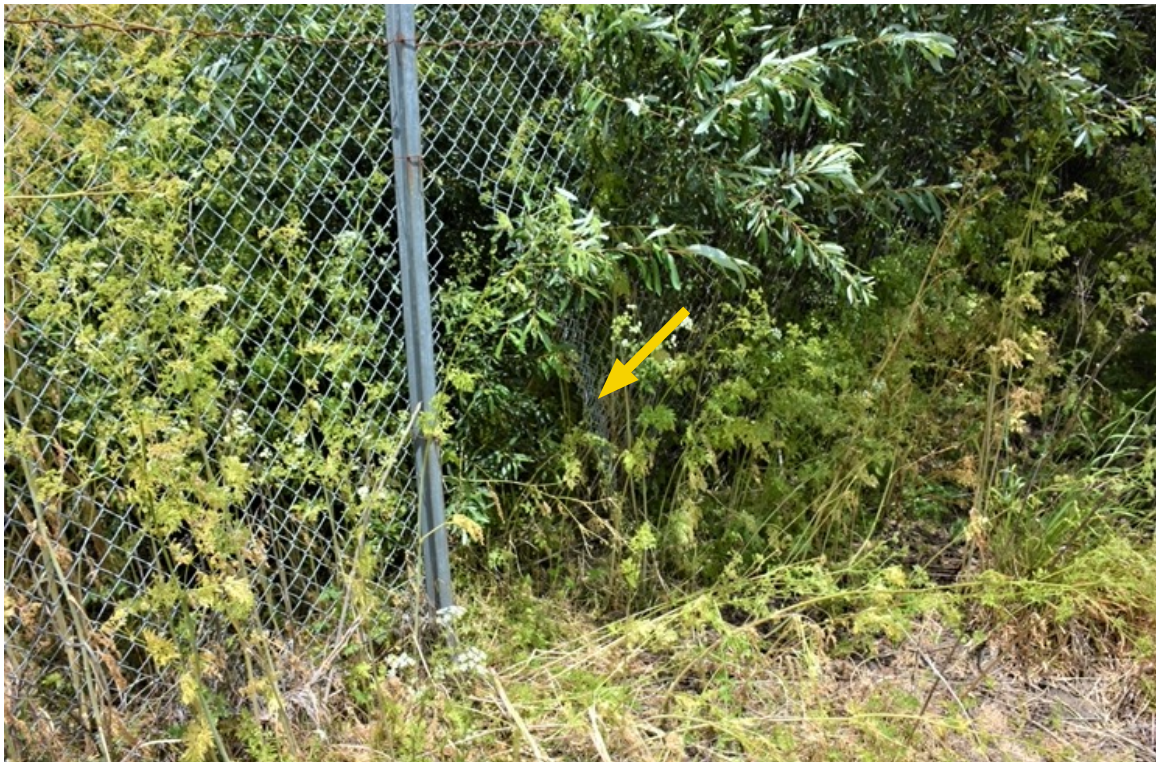
US 101 Site 7. Hole in the fence to the north indicated by yellow arrow.

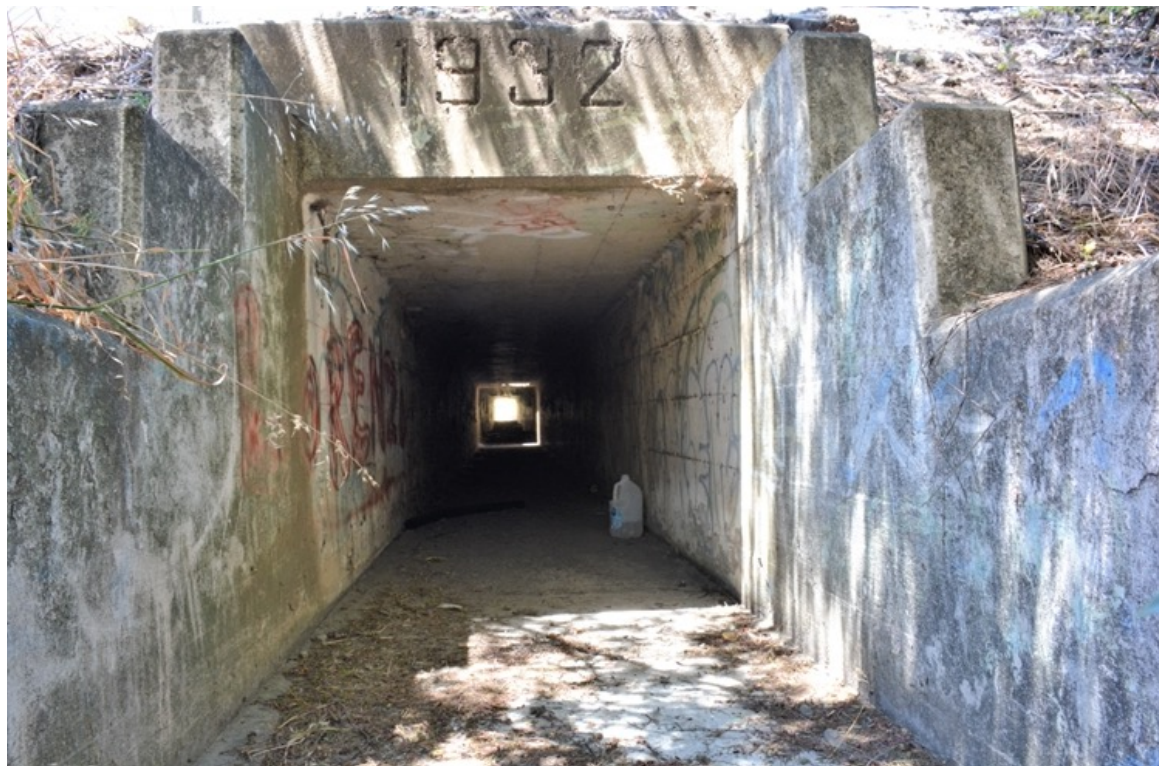
<b>Postmile</b>	SBT, US 101, PM 2.38
<b>GPS location</b>	Latitude: 36.86055 Longitude: -121.59062
<b>Dimensions</b>	Concrete box culvert 4' wide and 4' high. A median grate in the middle of the culvert allows light to shine through. There is also a levee leading east beyond the southern opening.
<b>Direction</b>	Northwest - southeast
<b>Visibility</b>	Yes. There is visibility through the culvert.
<b>Substrate</b>	Concrete (bare bottom)
<b>Habitat/land use</b>	This culvert is large enough to facilitate medium-sized mammal movement, however there are two houses immediately to the southeast of the southern opening. To the north, the nearest homes are between .14 and .25 miles away. There is a ravine to the north for cover.
<b>Wildlife track and sign</b>	None
<b>Track and sign transects</b>	None

US 101 Site 8. Southern opening.

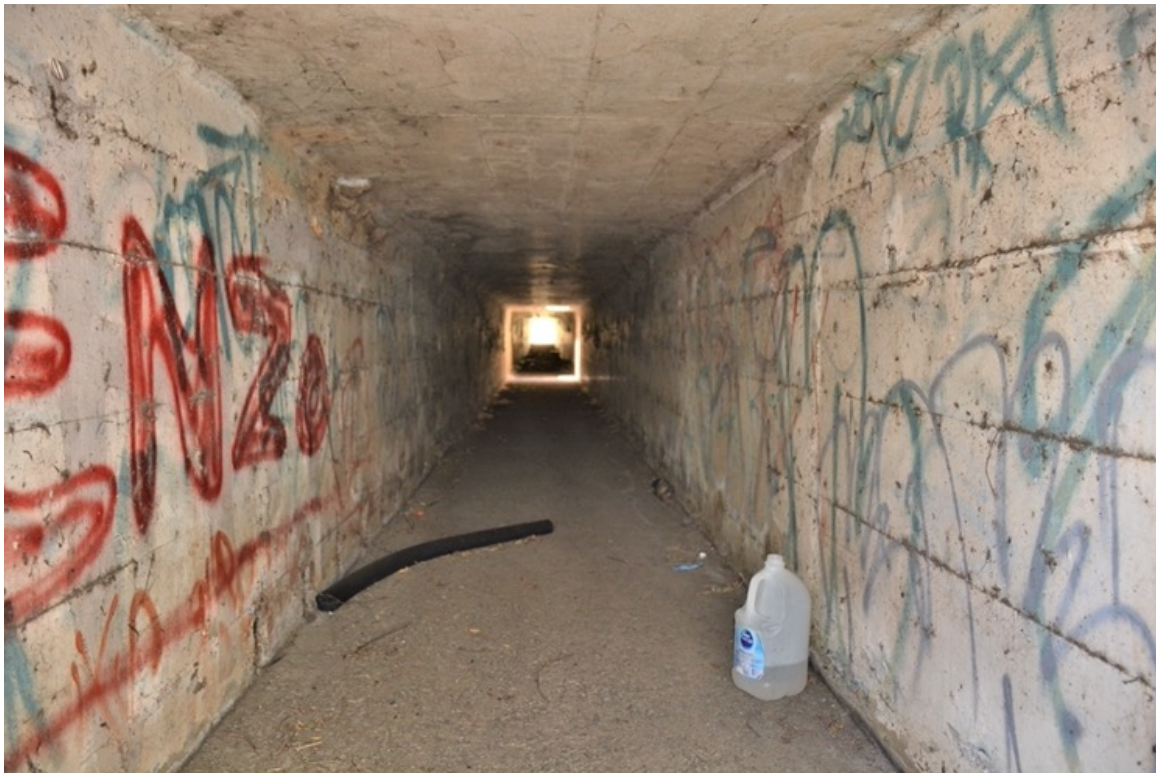
US 101 Site 8. Southern opening close-up. Photo faces north.

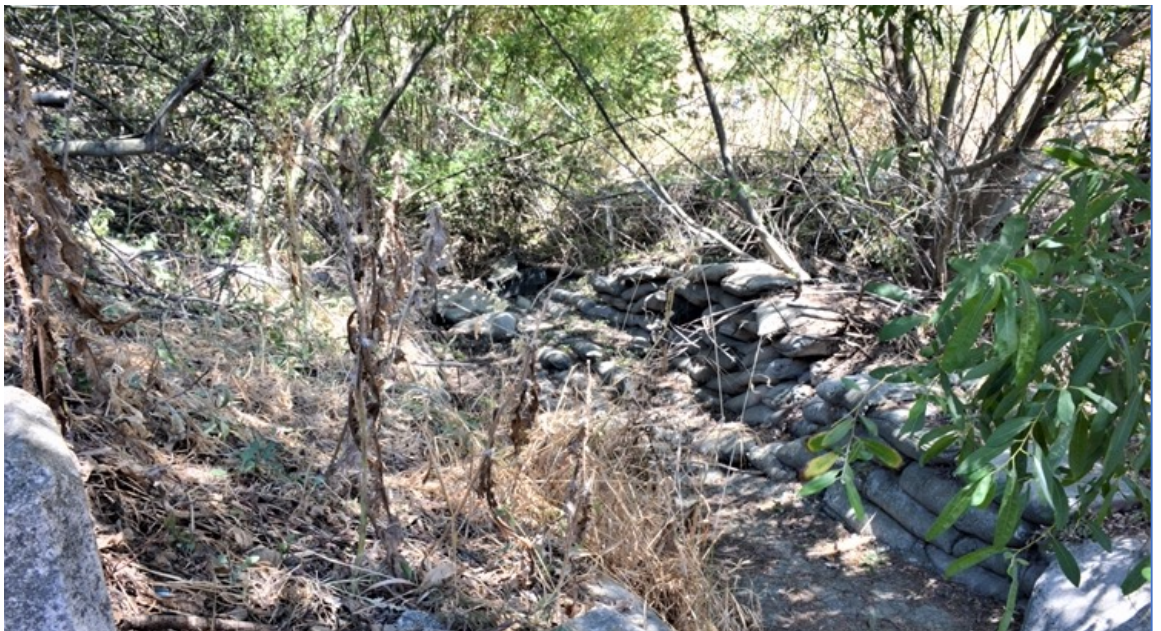
US 101 Site 8. Example of the levee leading to the east.
