# Enhancing ecological connectivity and safe passage for wildlife on highways between the southern Santa Cruz Mountains, Gabilan Range, and Diablo Range in California

Diamond, TD, A Sandoval, NP Sharma, ME Vernon, PD Cowan, AP Clevenger, and SC Lockwood. 2022. *Enhancing ecological connectivity and safe passage for wildlife on highways between the southern Santa Cruz Mountains, Gabilan Range, and Diablo Range in California*. Pathways for Wildlife and Peninsula Open Space Trust, Palo Alto, CA.

AUGUST 2022

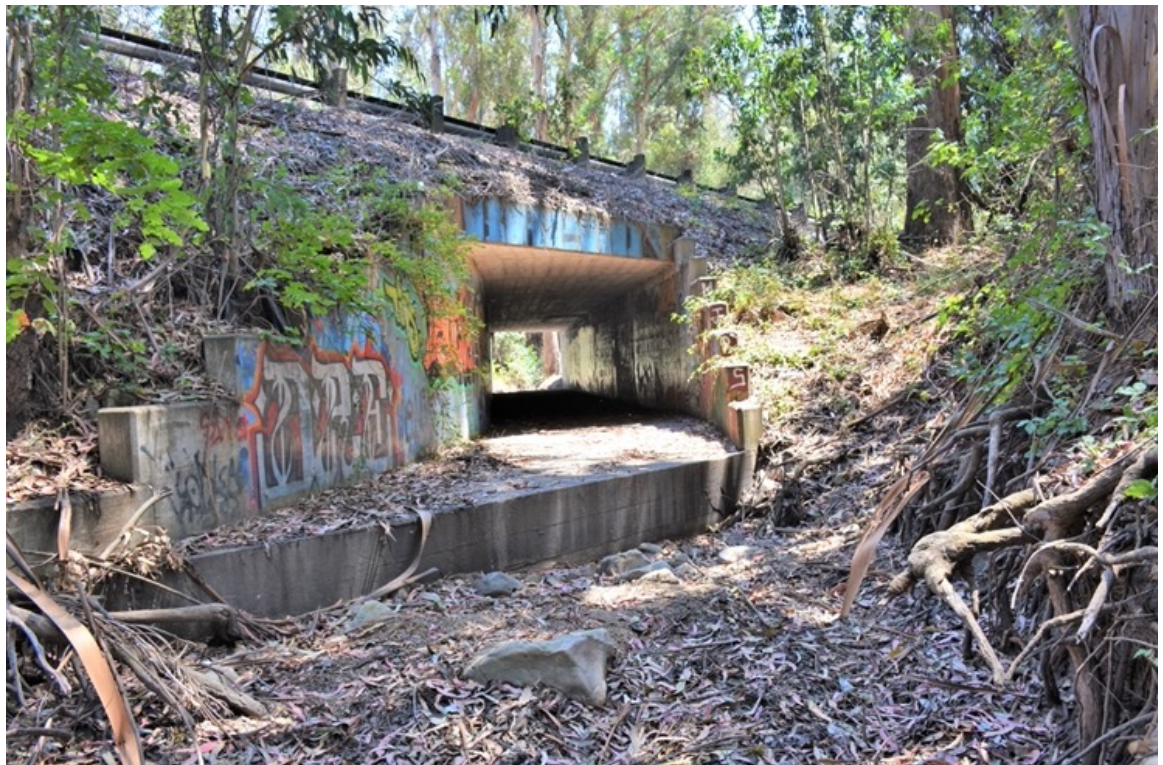
US 101 SITE 9 (Eucalyptus Grove)	
<b>Postmile</b>	SBT, US 101, PM 1.66
<b>GPS location</b>	Latitude: 36.85943 Longitude: -121.60339
<b>Dimensions</b>	Large cement box culvert 8' wide and 10' high
<b>Direction</b>	North - south
<b>Visibility</b>	Yes. There is high visibility throughout the culvert.
<b>Substrate</b>	Concrete (bare bottom)
<b>Habitat/land use</b>	This culvert is large enough to facilitate large mammal movement. This culvert only allows safe passage under the northbound lanes of US 101 to the median habitat; however it is one in a series of three culverts that together cross under both lanes and a ravine with cover connects the three culverts.
<b>Wildlife track and sign</b>	None
<b>Track and sign transects</b>	None

US 101 Site 9. Southern opening (in highway median).

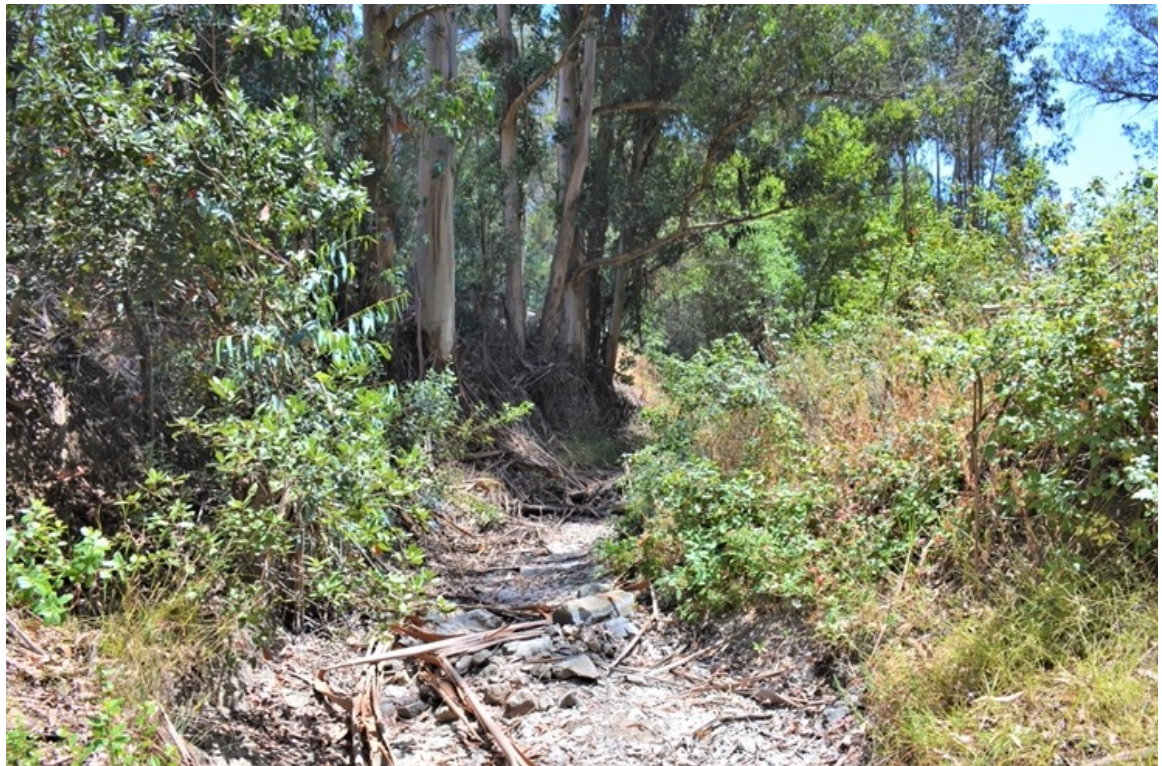
US 101 Site 9. Example of ravine and median habitat to the northeast.

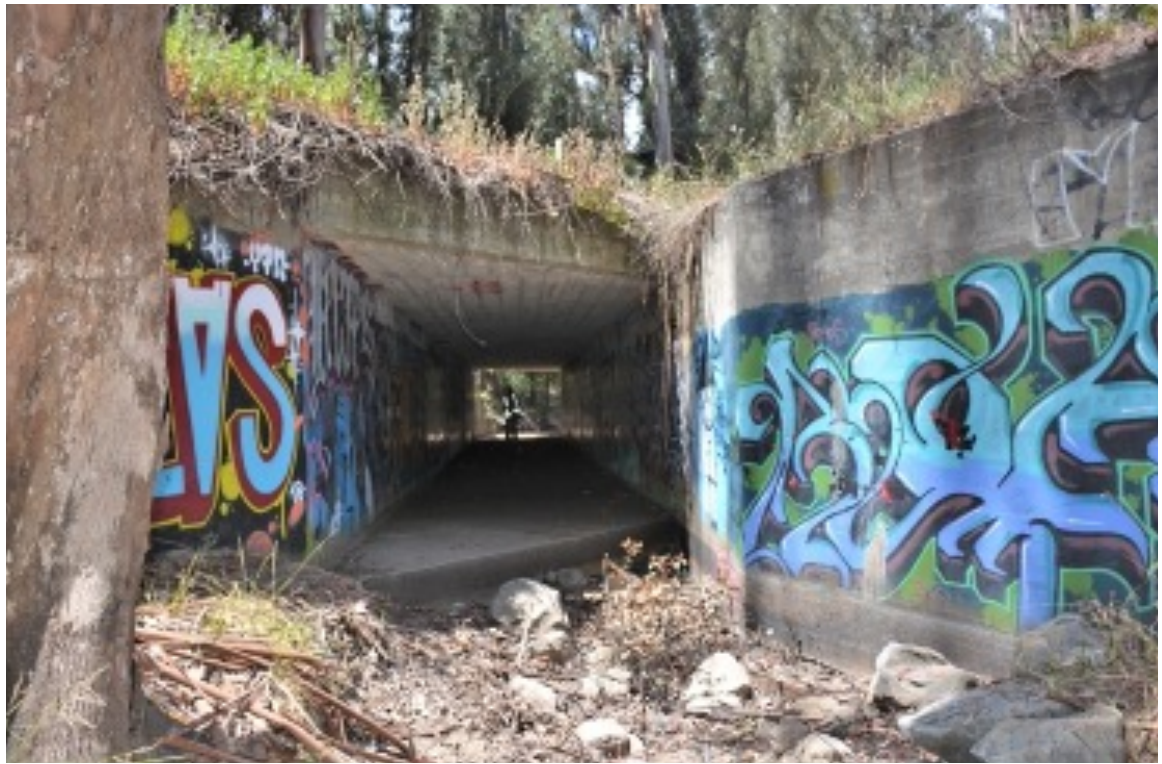
US 101 SITE 10 (Eucalyptus Grove)	
<b>Postmile</b>	SBT, US 101, PM 1.62
<b>GPS location</b>	Latitude: 36.85977 Longitude: -121.60423
<b>Dimensions</b>	Large cement box culvert 8' wide and 10' high.
<b>Direction</b>	Northwest - southeast
<b>Visibility</b>	Yes. There is high visibility throughout the culvert.
<b>Substrate</b>	Concrete (bare bottom)
<b>Habitat/land use</b>	This culvert is large enough to facilitate large mammal movement. This culvert is only under the northbound lanes of US 101, however it is one in a series of three culverts that together cross under both lanes, and a ravine with cover connects the three culverts.
<b>Wildlife track and sign</b>	Deer ( <i>O. hemionus</i> ) tracks embedded in the cement of the southeastern opening.
<b>Track and sign transects</b>	None

US 101 Site 10. Northern opening with 5' 7" tall person standing near southern opening for scale.

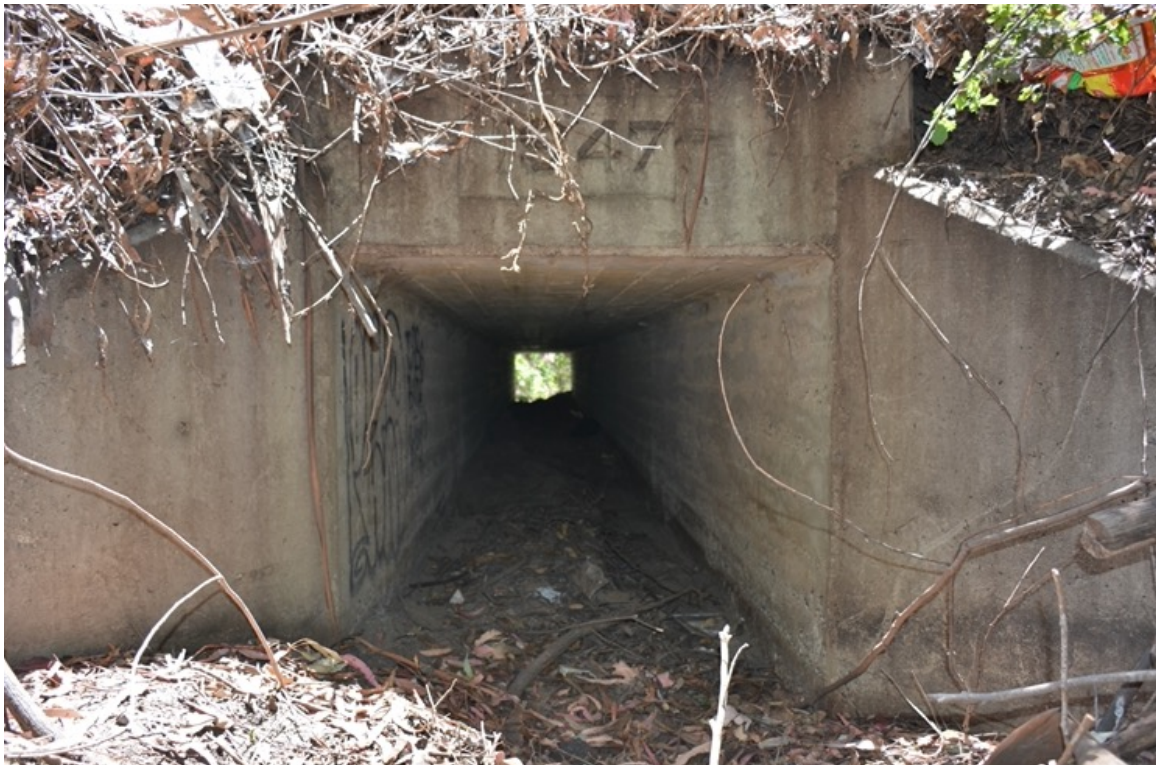
US 101 SITE 11 (Eucalyptus Grove)	
<b>Postmile</b>	SBT, US 101, PM 1.57
<b>GPS location</b>	Latitude: 36.86008 Longitude: - 121.605065
<b>Dimensions</b>	Concrete square/box culvert 4' wide and 4' high. Built in 1947.
<b>Direction</b>	North - south
<b>Visibility</b>	Yes. There is visibility through the culvert.
<b>Substrate</b>	Soft substrate throughout the culvert made up of fine dirt.
<b>Habitat/land use</b>	This culvert is large enough to facilitate medium-sized mammals. It is the third in a series of three culverts that together cross under US 101. This culvert crosses only under the southbound lanes of US 101 toward the median habitat to the south. The habitat to the north is eucalyptus groves mixed with oak woodland.
<b>Wildlife track and sign</b>	This culvert was previously monitored for the Big Sur Land Trust's Central Coast Wildlife Connectivity study from 2013 to 2014. Species recorded traveling through the culvert include: bobcat, raccoon, skunk, and opossum.

US 101 Site 11. Northern opening.

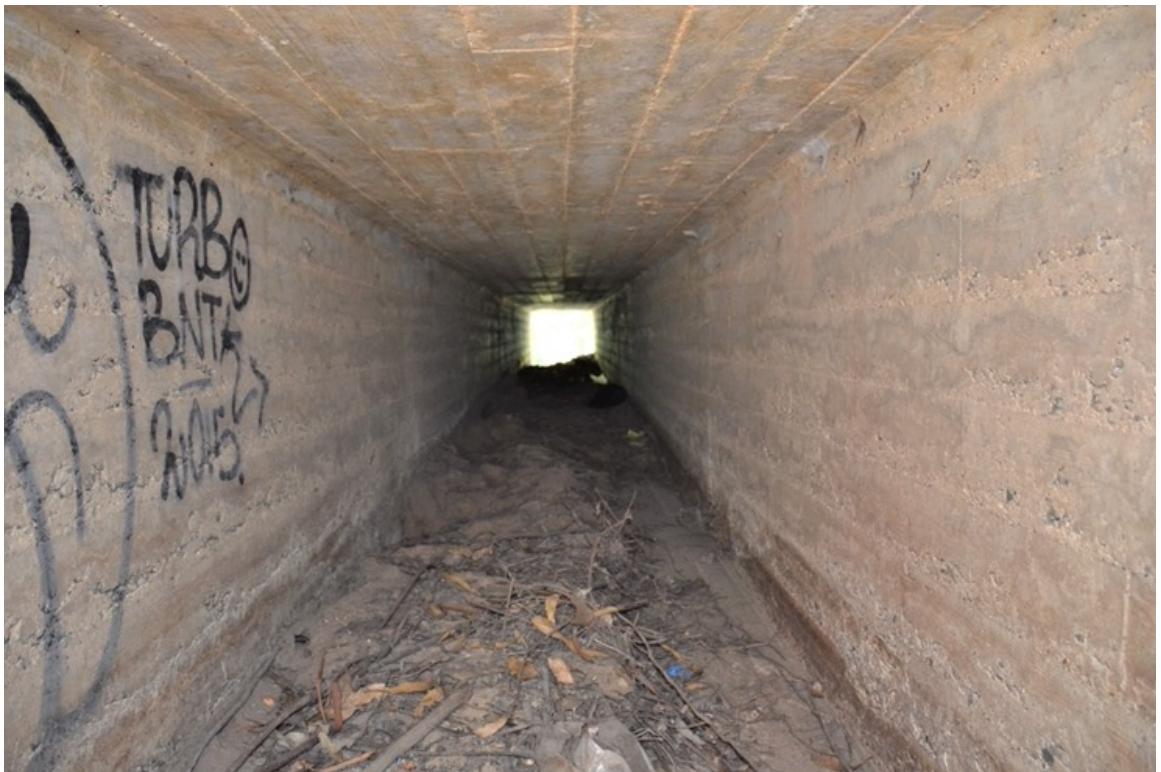
US 101 Site 11. Close-up view facing southern opening.

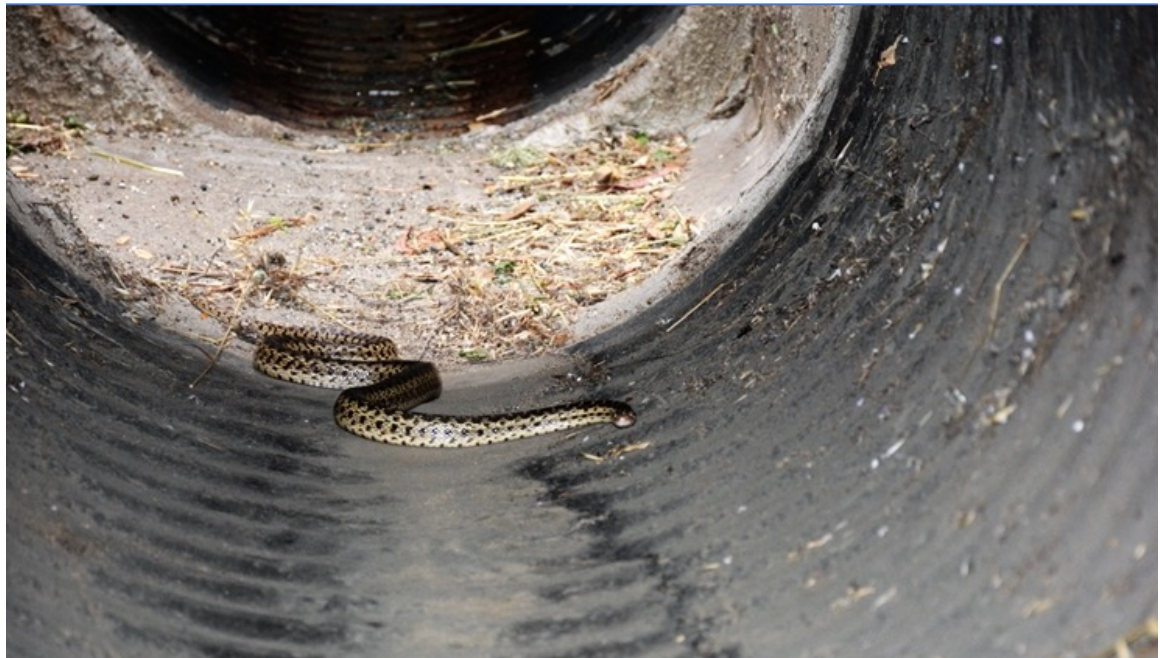
<b>Postmile</b>	SBT, US 101, PM 1.12
<b>GPS location</b>	Latitude: 36.86226 Longitude: -121.61215
<b>Dimensions</b>	Round corrugated pipe culvert 3' in diameter.
<b>Direction</b>	North - south
<b>Visibility</b>	Yes. The opposite opening of the culvert is visible when looking through, however the culvert does have a slight dip in the middle. This dip creates a slight incline toward each opening. A grate near the northern opening allows light to enter.
<b>Substrate</b>	The substrate at the northern opening is a smooth slick black coating over the corrugated steel. The southern opening is corrugated steel (bare bottom).
<b>Habitat/land use</b>	Adjacent business to the north with perimeter barbed wire fence and an RV community to the southeast. A large eucalyptus grove to the south provides cover and other than the business, there is oak woodland to the northeast.
<b>Wildlife track and sign</b>	Site assessors encountered a gopher snake stuck in the middle of the culvert and unable to exit because it could not grip onto the slick coating in the culvert.

US 101 Site 13. Northern opening with Pacific gopher snake (*Pituophis catenifer catenifer*).

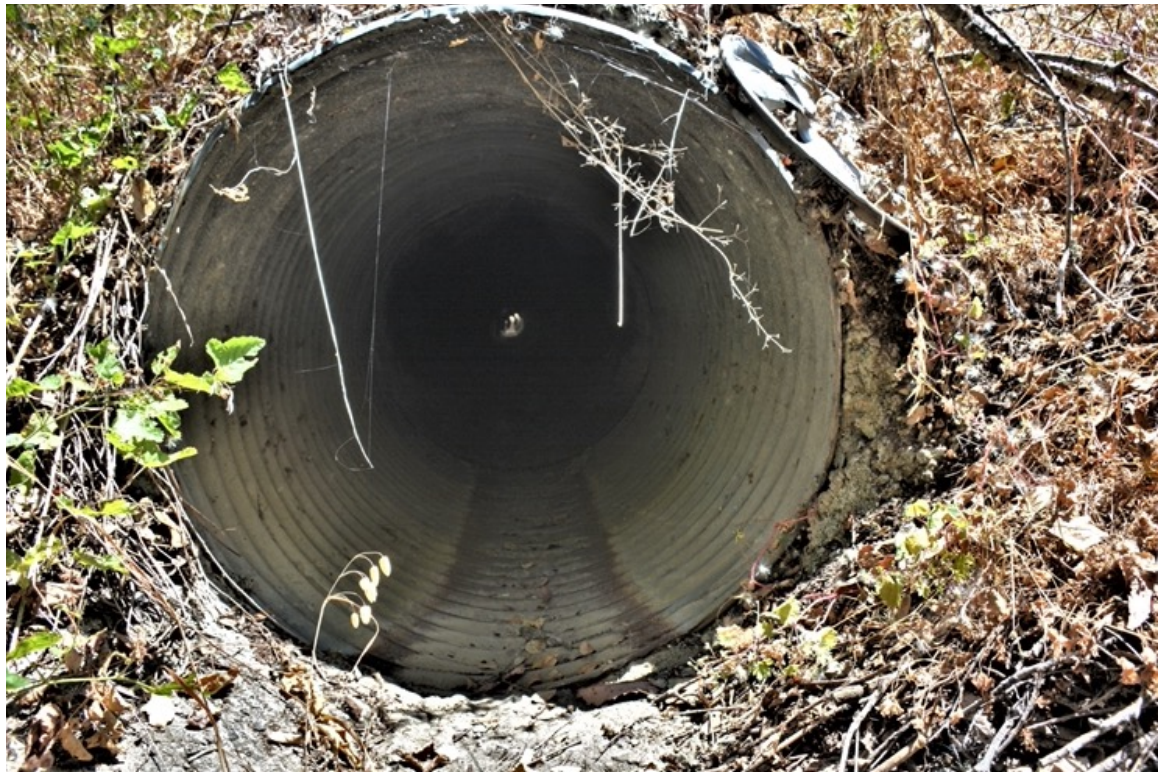
US 101 Site 13. Southern opening.

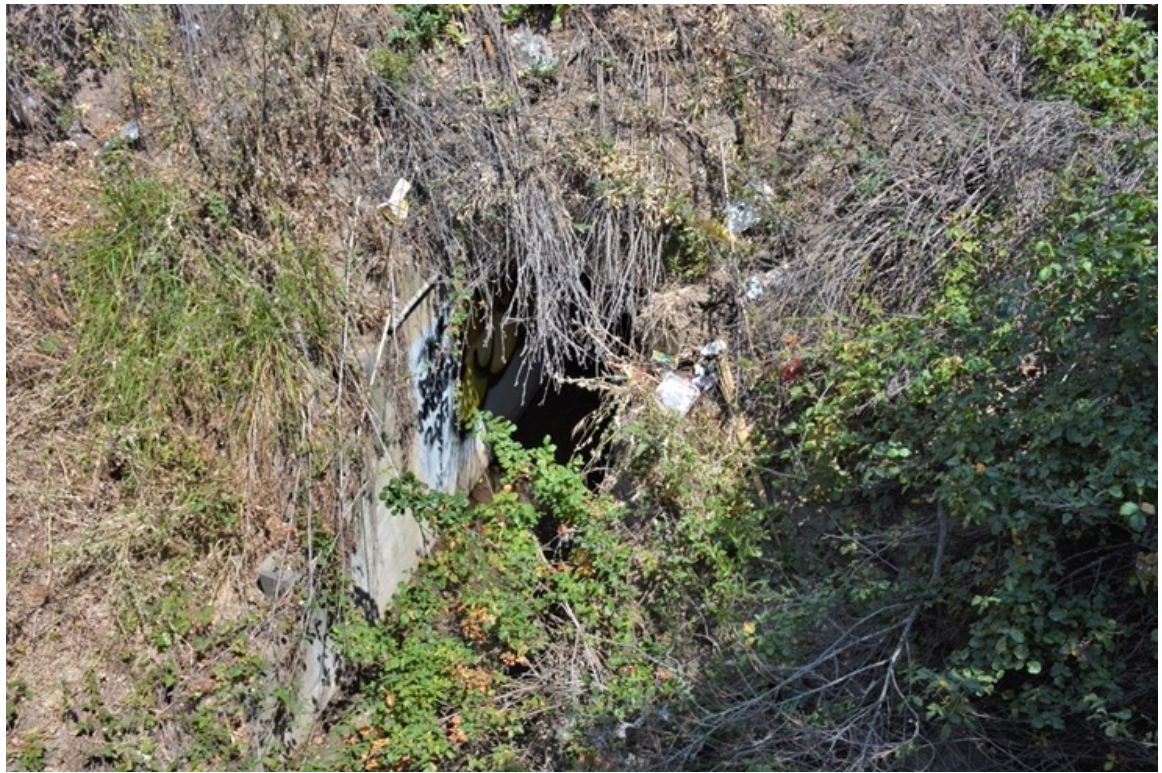
US 101 SITE 14	
<b>Postmile</b>	SBT, US 101, PM 1.02
<b>GPS location</b>	Latitude: 36.86262 Longitude: -121.61382
<b>Dimensions</b>	Tall concrete rectangular culvert 3' wide and 7' high.
<b>Direction</b>	North - south
<b>Visibility</b>	Yes
<b>Substrate</b>	Muddy bottom.
<b>Habitat/land use</b>	This culvert runs only under the northbound lane of US 101 and connects the median habitat to the north to the eucalyptus grove to the south. The southern opening leads into a creek and riparian strip that flows through the RV community parking lot.
<b>Wildlife track and sign</b>	None
<b>Track and sign transects</b>	None

US 101 Site 14. Southern opening.

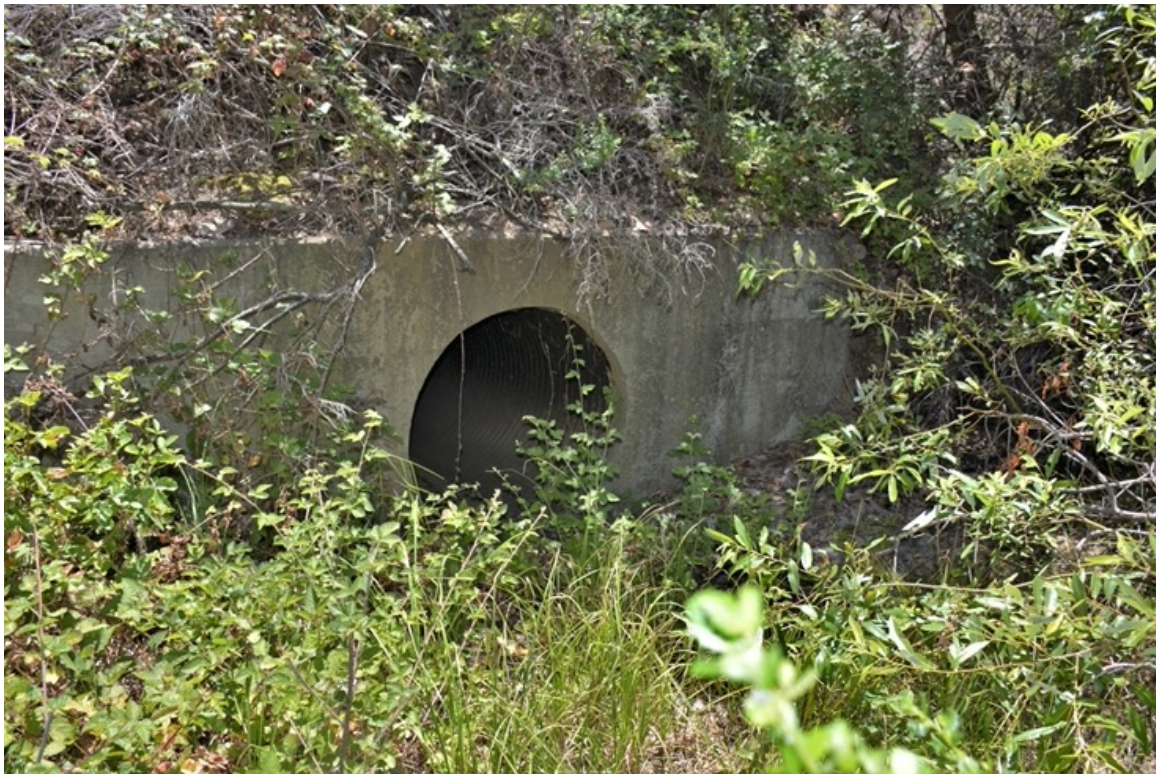
US 101 SITE 15 (Habitat Island)	
<b>Postmile</b>	SBT, US 101, PM 0.82
<b>GPS location</b>	Latitude: 36.86353 Longitude: -121.61749
<b>Dimensions</b>	Round corrugated pipe culvert 3' 10" wide and 4' high
<b>Direction</b>	North - south
<b>Visibility</b>	Yes. The other opening is visible when looking through.
<b>Substrate</b>	Corrugated steel (bare bottom).
<b>Habitat/land use</b>	Culvert connects open habitat on the north side and opens up into the median habitat island which spans the north and southbound lanes. This culvert runs only under the southbound lane.
<b>Wildlife track and sign</b>	Previously monitored from 2013 to 2014 for the Big Sur Land Trust Central Coast Connectivity Study. Species recorded traveling through the culvert include bobcat, raccoon, and skunk. Bobcat and deer scat recorded on wildlife trail leading to the culvert. Deer carcass recorded just off the southbound shoulder on the northern side.

US 101 Site 15. Northern opening.

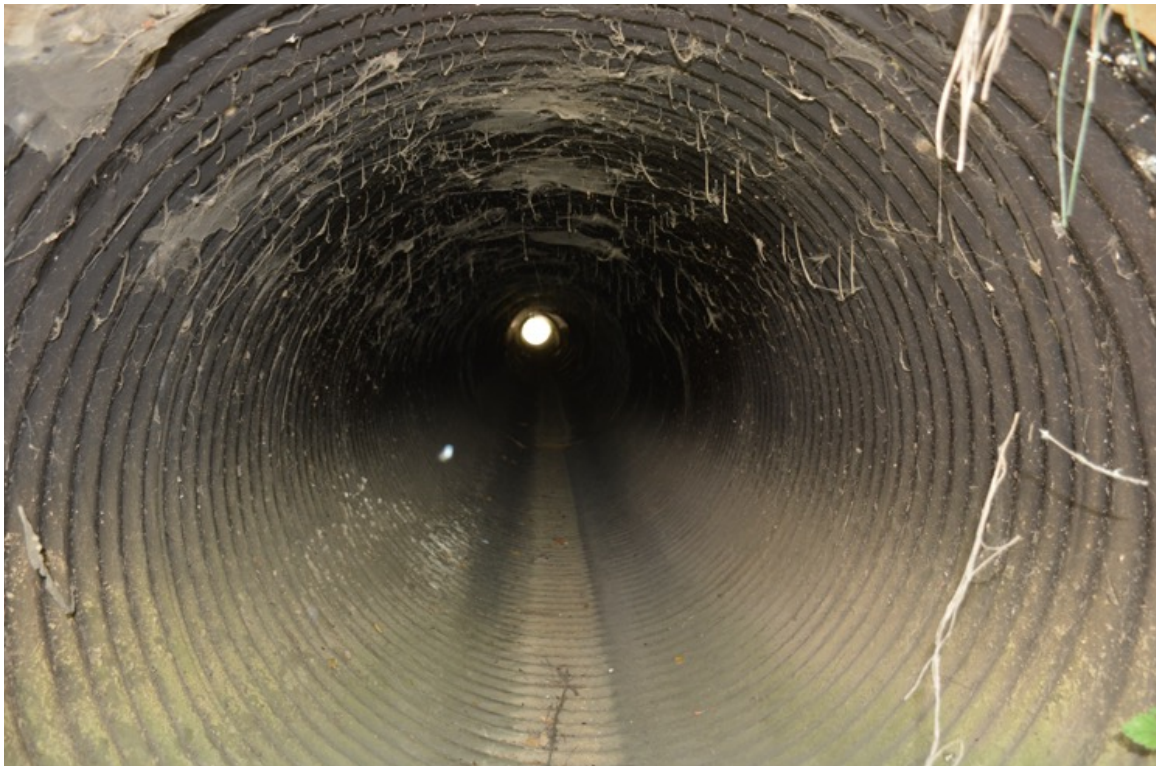
US 101 Site 15. Northern opening close-up.

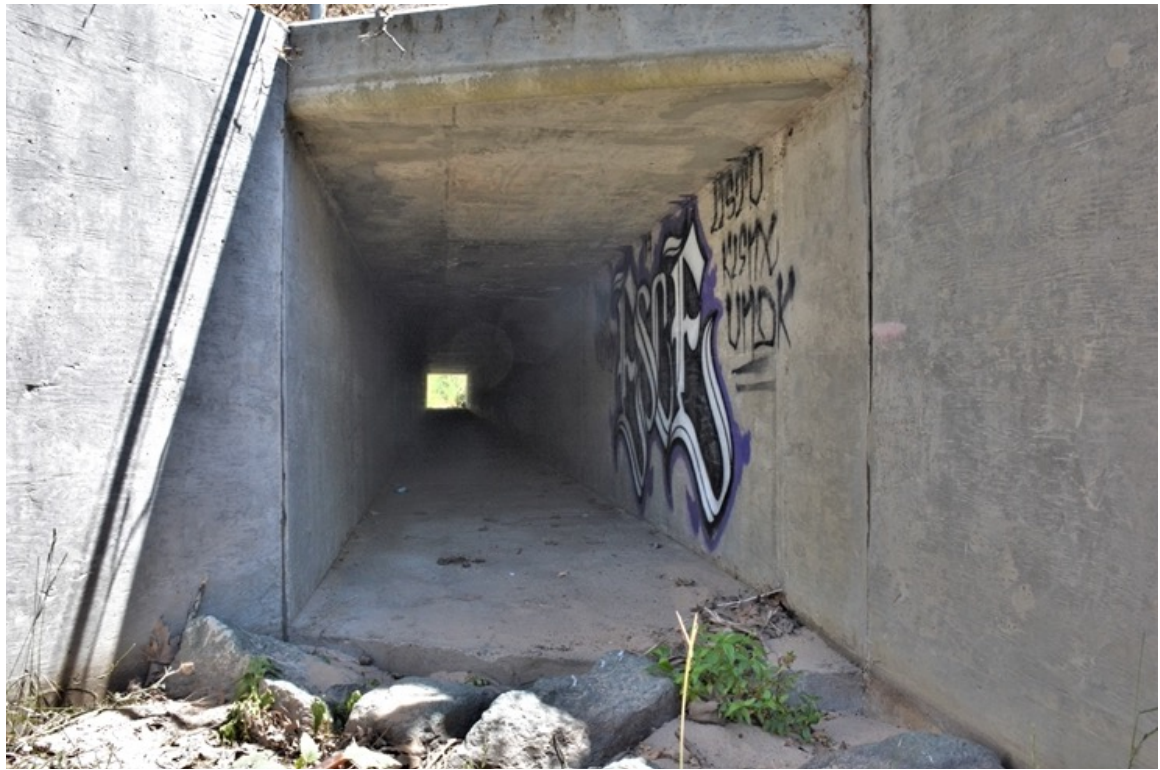
US 101 SITE 16 (Habitat Island)	
<b>Postmile</b>	SBT, US 101, PM 0.49
<b>GPS location</b>	Latitude: 36.86084 Longitude: -121.62256
<b>Dimensions</b>	Large concrete box culvert 6' wide and 6' high.
<b>Direction</b>	Northeast - southwest
<b>Visibility</b>	Yes. There is high visibility throughout this culvert.
<b>Substrate</b>	Sand throughout the culvert.
<b>Habitat/land use</b>	This culvert runs only under the southbound lanes, however is possibly large enough to facilitate large mammal movement. It connects open habitat on the north side via a small riparian strip and opens into the habitat median island leading to a dual box culvert.
<b>Wildlife track and sign</b>	Multiple species tracks including bobcat, racoon, and skunk throughout the substrate within the culvert.
<b>Track and sign transects</b>	The sand within and beyond the southern entrance is suitable for tracking transects.

US 101 Site 16. Northeastern opening.

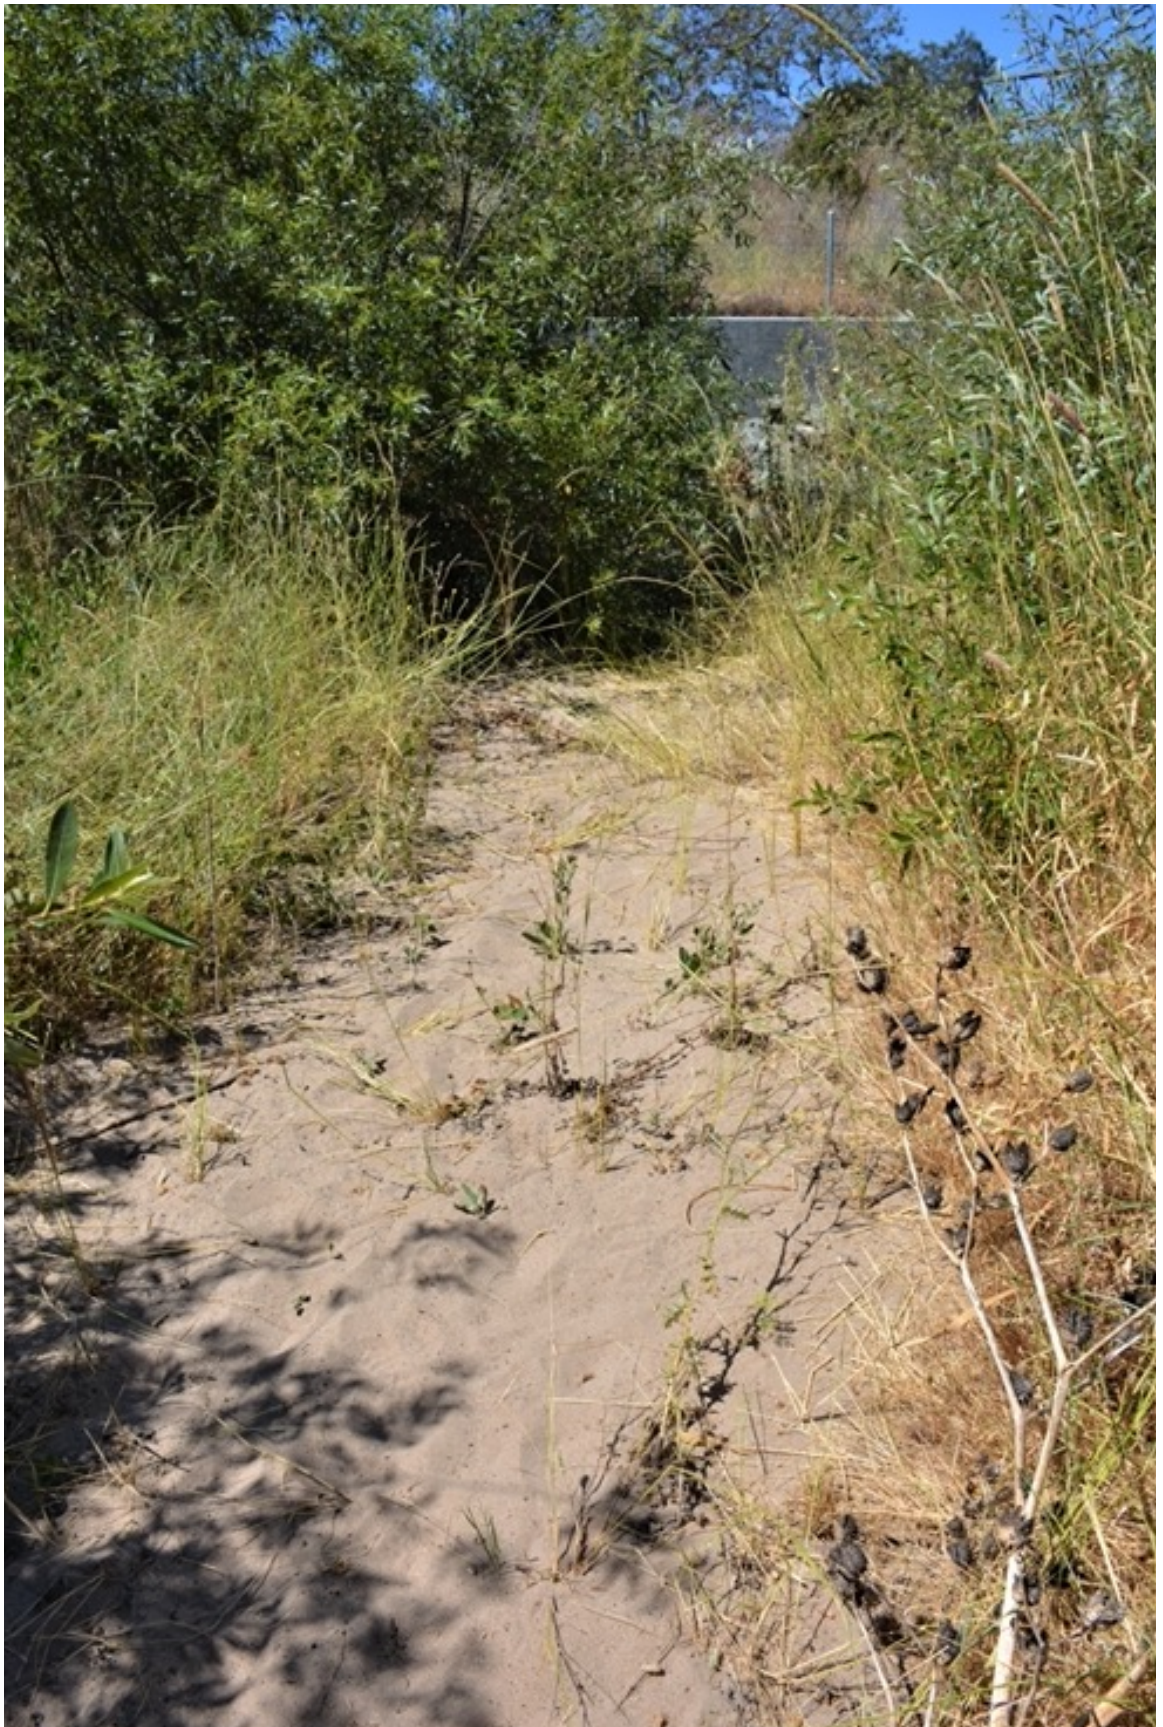
US 101 Site 16. Example of sandy substrate beyond southwestern opening.

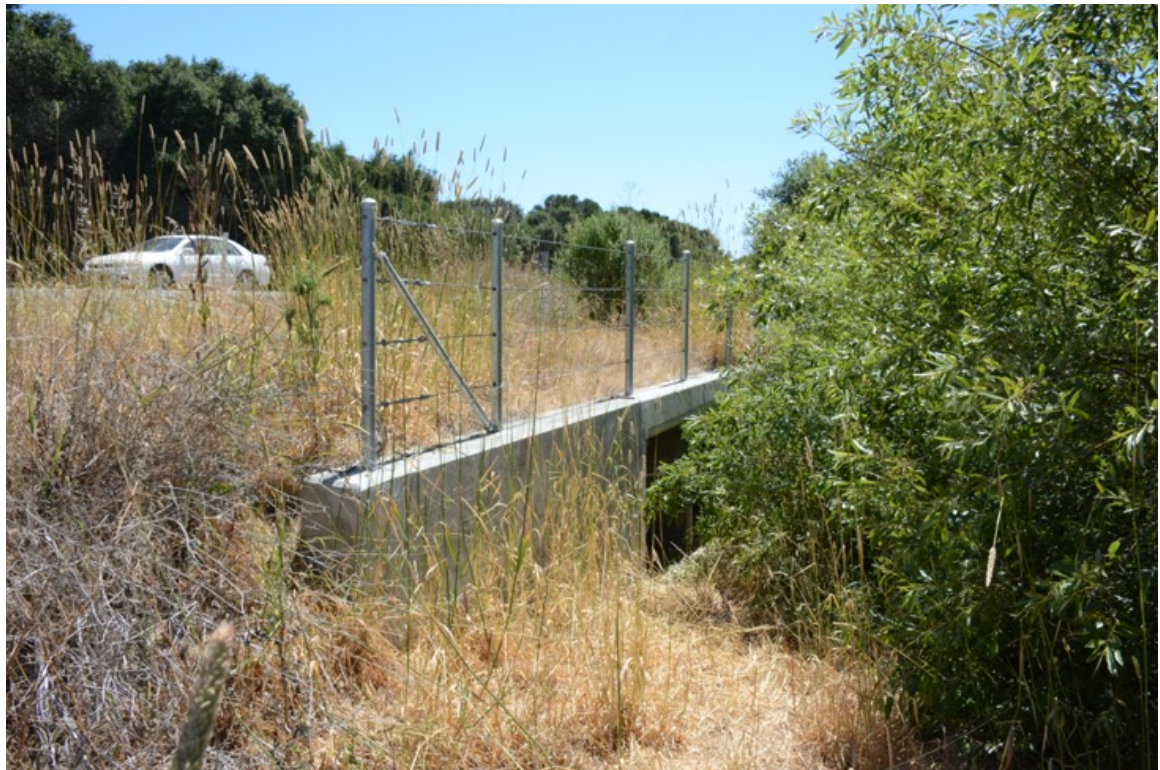
US 101 SITE 17 (Habitat Island)	
<b>Postmile</b>	SBT, US 101, PM 0.43
<b>GPS location</b>	Latitude: 36.86003 Longitude: -121.62255
<b>Dimensions</b>	Concrete dual box culverts with the western section 4' 11" wide and 3' 10" high, and the eastern section 4' 3" wide and 5' high.
<b>Direction</b>	North - south
<b>Visibility</b>	Yes. Moderate visibility. The culvert can be seen through to each end. At the southern opening extended barriers angle to the west. There is thick vegetation at the northern opening.
<b>Substrate</b>	Sandy substrate throughout both sections.
<b>Habitat/land use</b>	Culvert connects the northern habitat median island to the southern riparian habitat leading to large tracts of open habitat of the Gabilan Range. This culvert runs only under the northbound lanes of US 101.
<b>Wildlife track and sign</b>	Multiple species tracks including bobcat, racoon, and skunk. A mountain lion was hit by a vehicle near the culvert on the northbound lane closest to the median habitat island on May 23, 2018. This culvert was monitored from 2013-2014 for the Big Sur Land Trust's Central Coast Wildlife Connectivity Study. Species recorded traveling through this culvert include: bobcat, gray fox, raccoon, and skunk.

US 101 Site 17. Northern opening with thick vegetation.

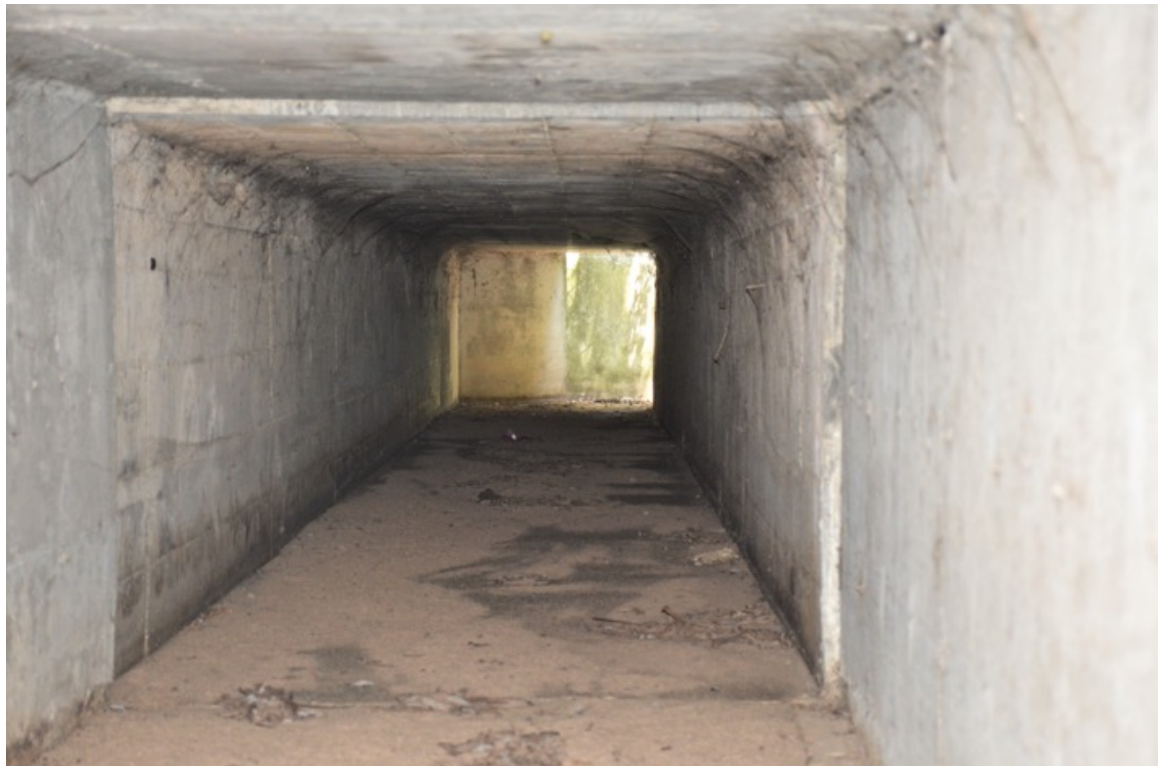
US 101 Site 17. Example from within western section of angle at southern opening. Photo faces south.

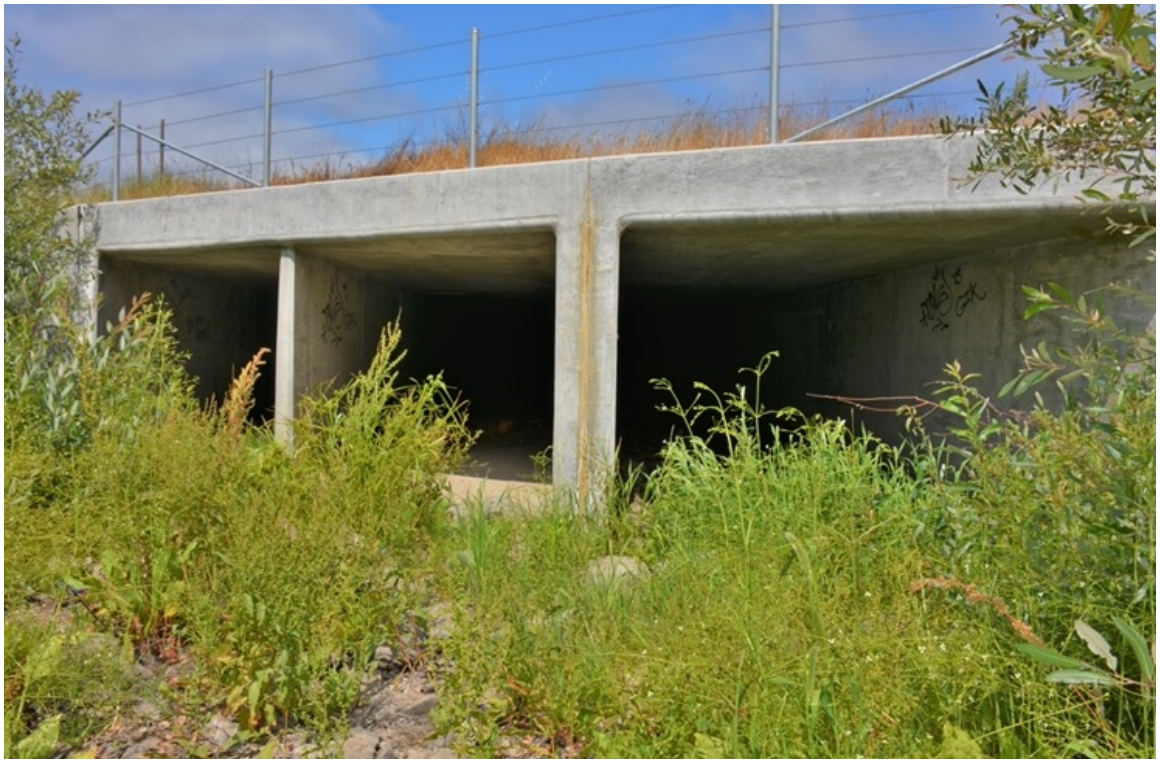
US 101 SITE 19	
<b>Postmile</b>	MON, US 101, PM 100.95
<b>GPS location</b>	Latitude: 36.85359 Longitude: -121.63467
<b>Dimensions</b>	Large concrete triple box culvert. The northern section is 8' wide and 5' 10" high; the center section is 8' wide and 5' 9" high, and the southern section is 10' wide and 6' high.
<b>Direction</b>	Northwest - southeast
<b>Visibility</b>	There is no visibility through the western or center sections as they both have two bends within them. The eastern section is straight and has visibility to the other side.
<b>Substrate</b>	All three sections have muddy sand substrate toward the northern openings. The southern openings are concrete (bare bottom).
<b>Habitat/land use</b>	Culvert connects riparian habitat on either side.
<b>Wildlife track and sign</b>	Multiple species tracks were found within all three sections. The eastern culvert had tracks for American beaver ( <i>Castor canadensis</i> ), bobcat, and raccoon.

US 101 Site 19. Southeastern opening of triple box culvert.

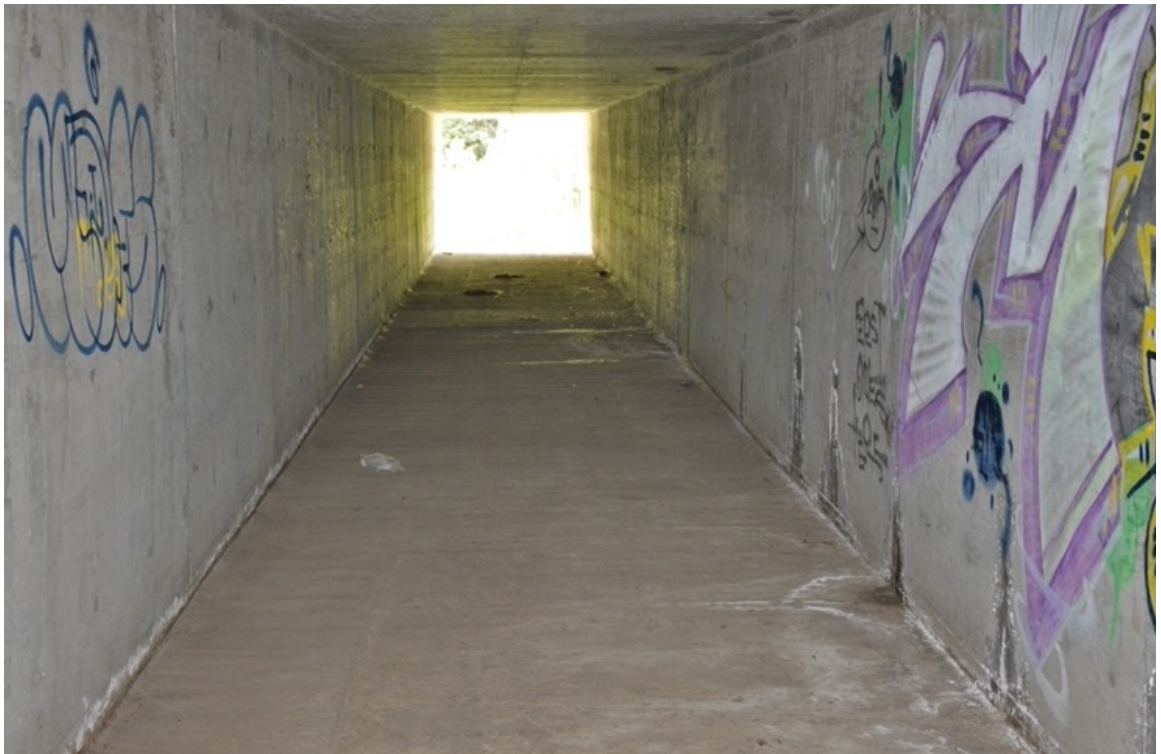
US 101 Site 19. Facing toward southeastern opening.

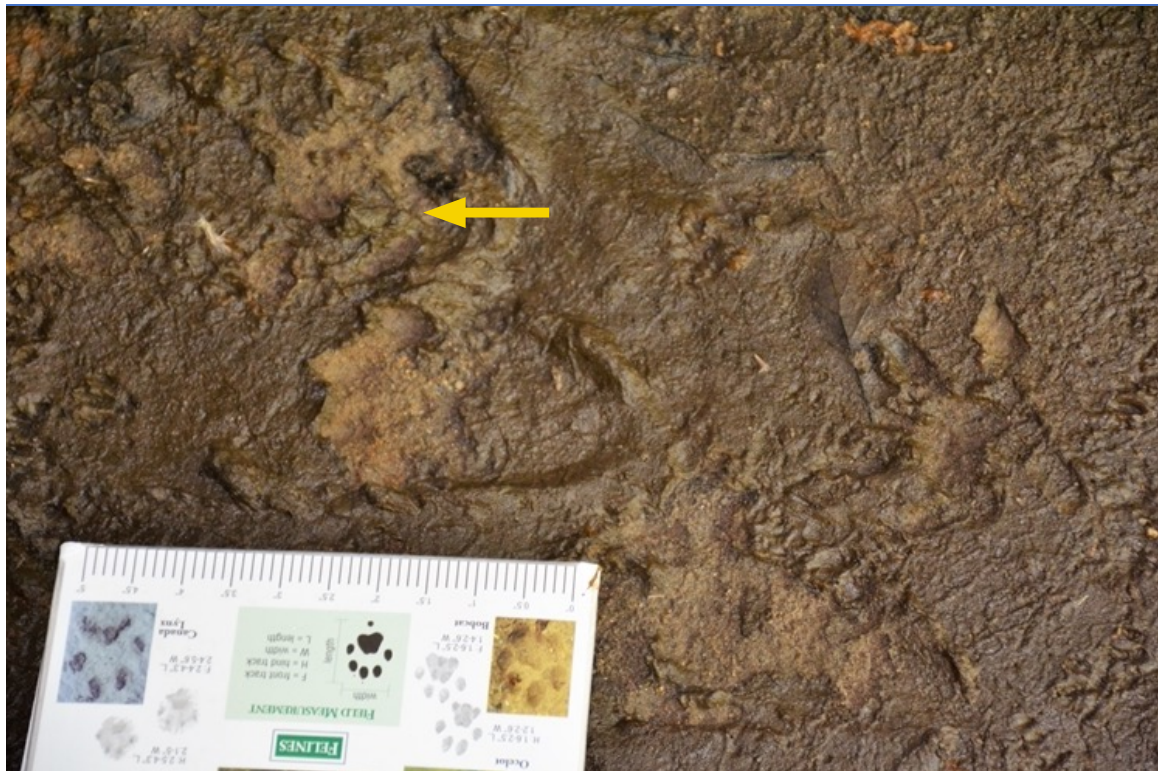
US 101 Site 19. American beaver rear track within culvert. Yellow arrow indicates the direction of travel.

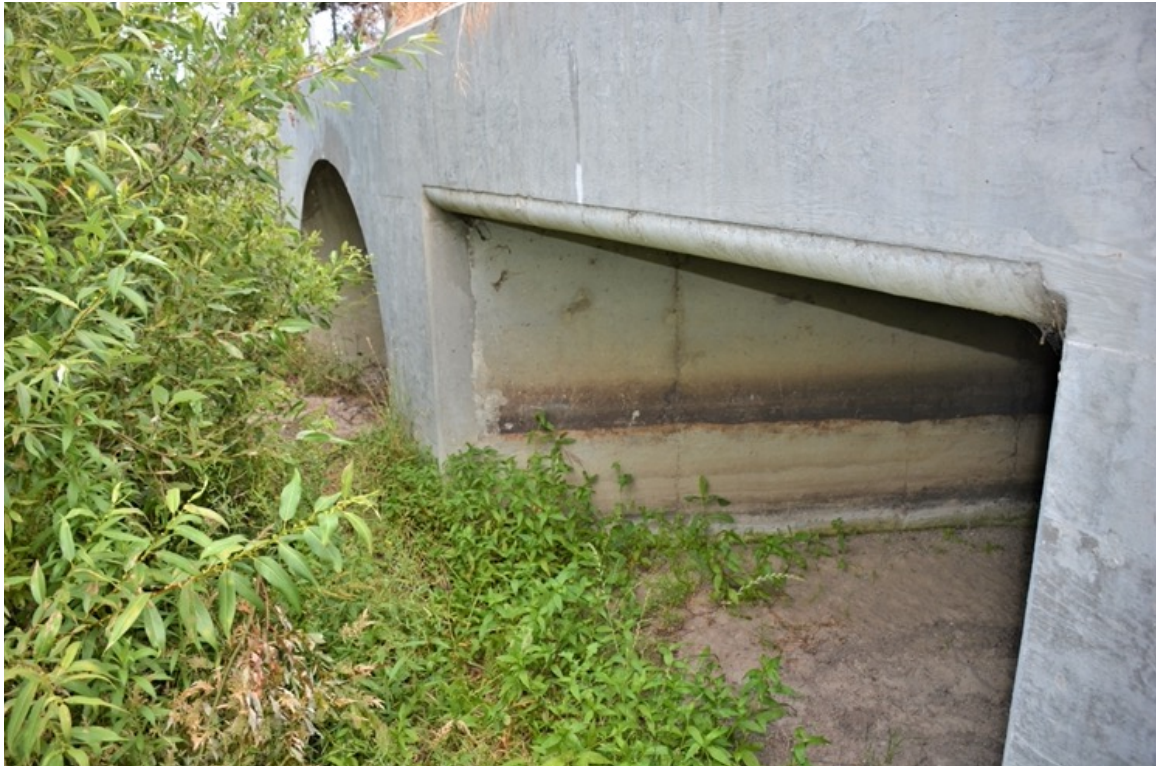
US 101 SITE 20A	
<b>Postmile</b>	MON, US 101, PM 100.89
<b>GPS location</b>	Latitude: 36.85271 Longitude: -121.63529
<b>Dimensions</b>	This site has two sections: a large round culvert to the north (20A), and a large box culvert to the south (20B). Site 20A is a round culvert 8' 7" wide and 6' 7" high.
<b>Direction</b>	West - east
<b>Visibility</b>	Yes. There is high visibility throughout the culvert.
<b>Substrate</b>	Sandy substrate throughout.
<b>Habitat/land use</b>	Culvert connects riparian habitat with plenty of cover on either side.
<b>Wildlife track and sign</b>	Multiple species tracks inside the culvert including deer and coyote ( <i>Canis latrans</i> ). Also, deer, coyote, and bobcat scat identified on a wildlife trail leading down to the culvert.
<b>Track and sign transects</b>	The sandy substrate and wildlife trails are highly suitable candidates for tracking transects.

US 101 Site 20A. Northwestern opening of both sections.

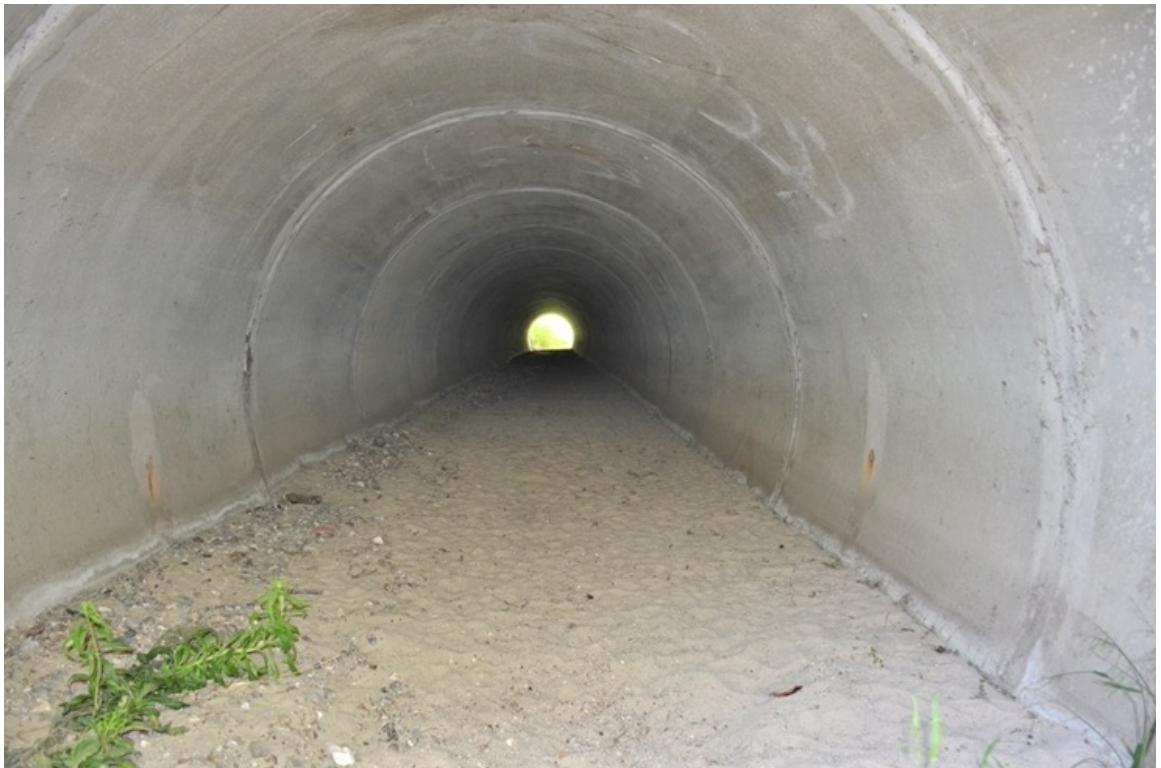
US 101 Site 20A. Within round culvert. Photo faces east.

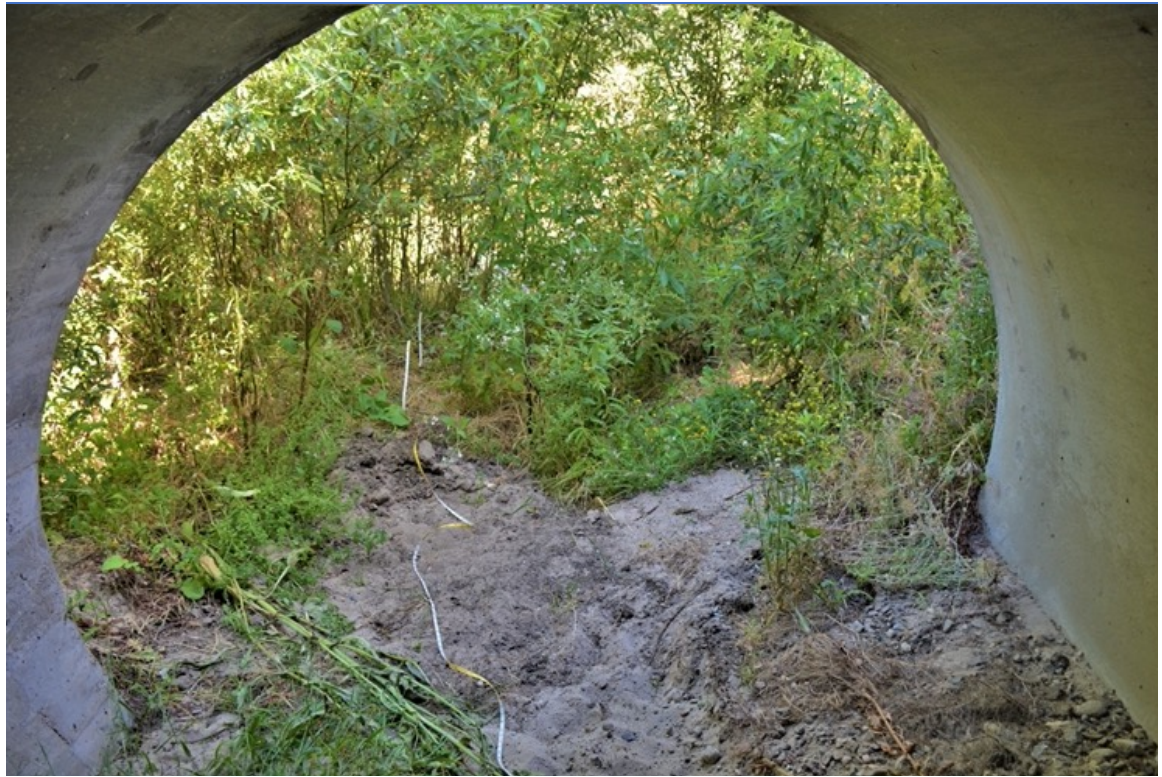
US 101 Site 20A. Western opening showing wildlife trail (indicated by measuring tape).

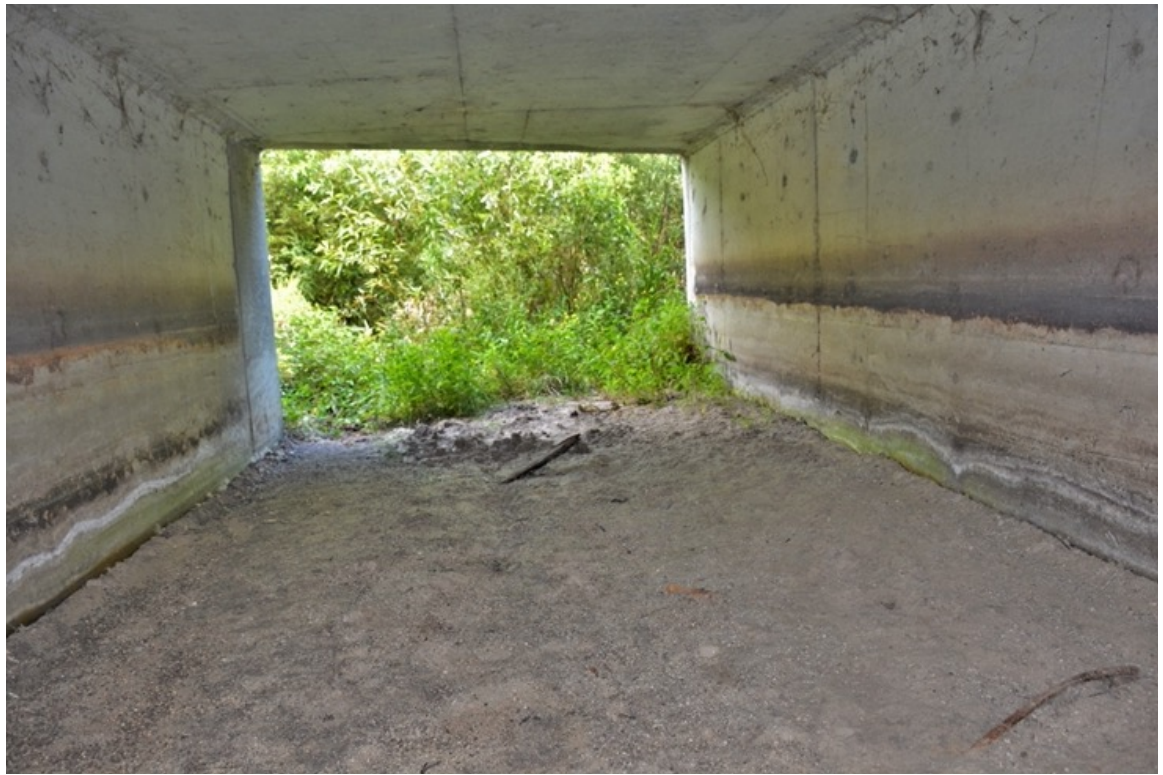
US 101 SITE 20B	
<b>Postmile</b>	MON, US 101, PM 100.89
<b>GPS location</b>	Latitude: 36.85271 Longitude: -121.63529
<b>Dimensions</b>	This site has two sections: a large round culvert to the north (20A), and a large box culvert to the south (20B). Site 20B is a large cement box culvert 9' 10" wide and 6' high.
<b>Direction</b>	Northwest - southeast
<b>Visibility</b>	Yes. There is high visibility throughout the culvert.
<b>Substrate</b>	Sandy substrate throughout culvert.
<b>Habitat/land use</b>	Culvert connects riparian habitat on either side with plenty of cover.
<b>Wildlife track and sign</b>	Multiple species tracks identified within culvert including bobcat and raccoon. Deer, coyote, and bobcat scat found on wildlife trails leading down to the culvert.
<b>Track and sign transects</b>	The trails leading to the western opening and the substrate throughout the culvert are highly suitable for tracking transects.

US 101 Site 20B. Western opening.
