# Enhancing ecological connectivity and safe passage for wildlife on highways between the southern Santa Cruz Mountains, Gabilan Range, and Diablo Range in California

Diamond, TD, A Sandoval, NP Sharma, ME Vernon, PD Cowan, AP Clevenger, and SC Lockwood. 2022. *Enhancing ecological connectivity and safe passage for wildlife on highways between the southern Santa Cruz Mountains, Gabilan Range, and Diablo Range in California*. Pathways for Wildlife and Peninsula Open Space Trust, Palo Alto, CA.

AUGUST 2022

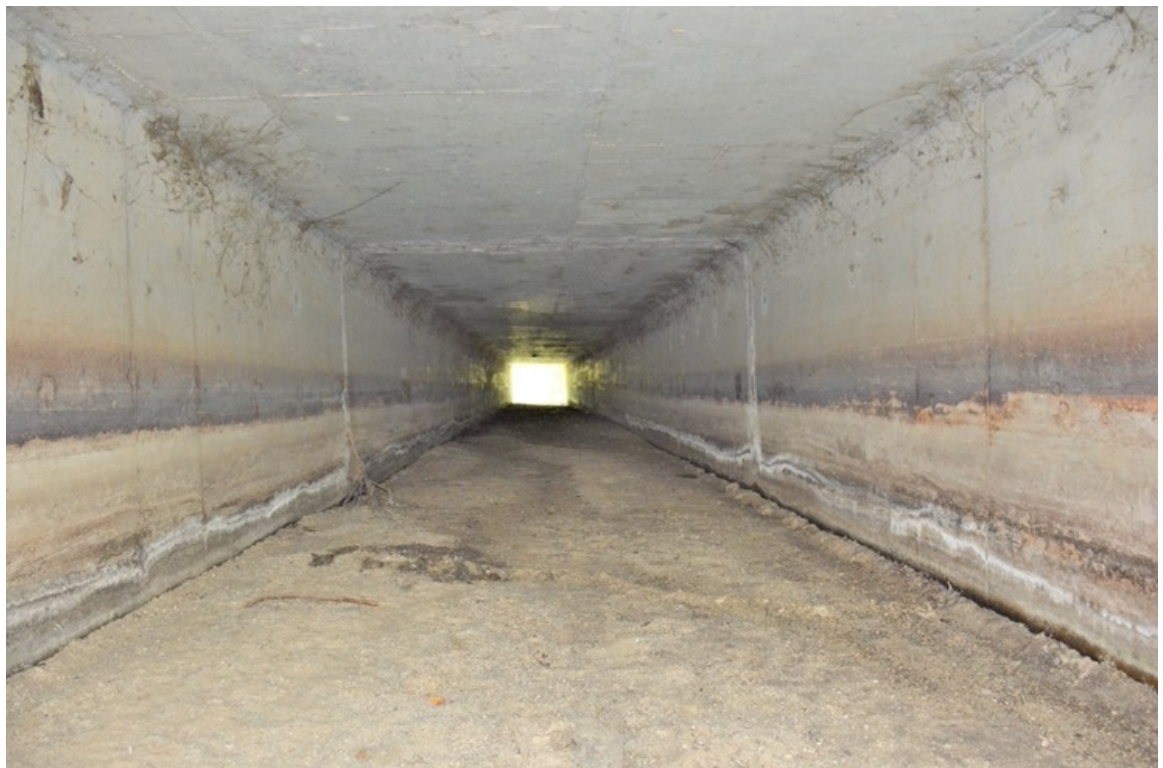
US 101 Site 20B. Within western opening facing east.

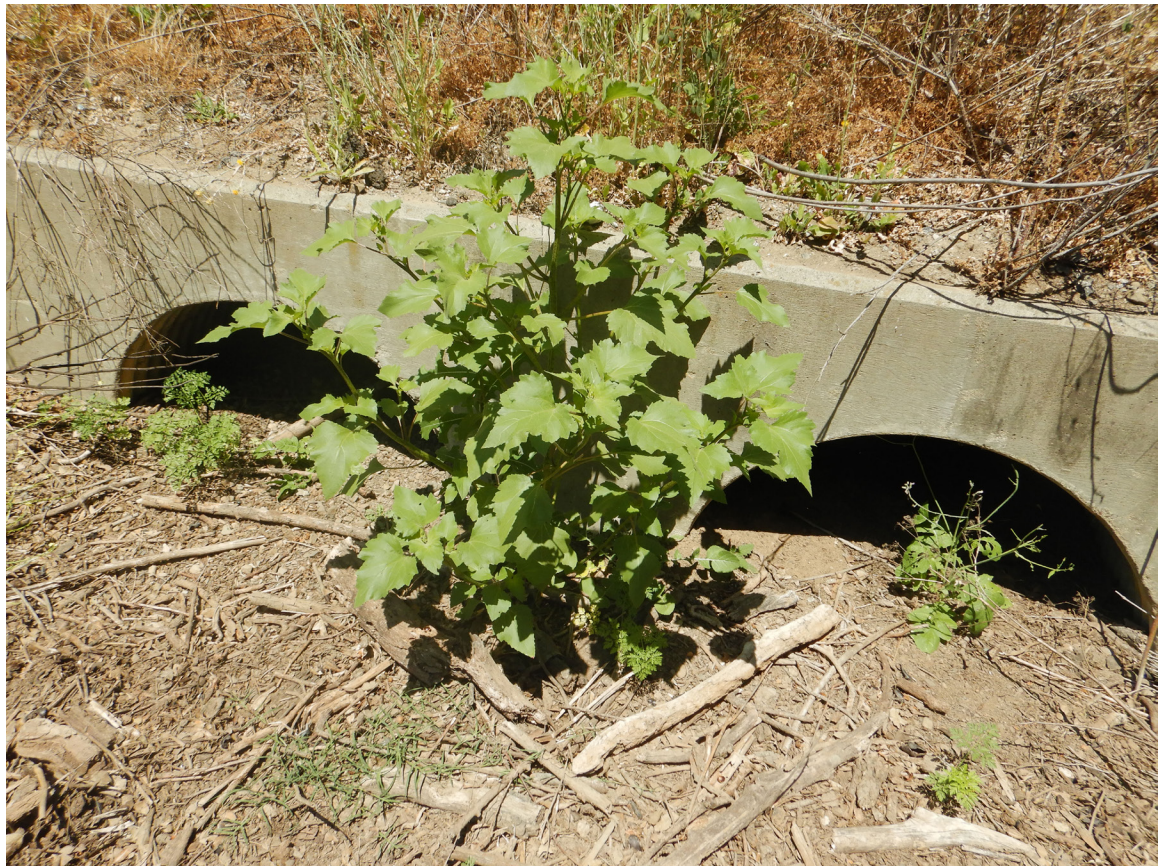
SR 152 SITE 1 SAN FELIPE LAKE DUAL ROUND CULVERTS	
<b>Postmile</b>	SCL, SR 152, PM 16.58
<b>GPS location</b>	Latitude: 36.98539 Longitude: -121.46276
<b>Dimensions</b>	Double round culvert; each culvert is approximately 4' in diameter.
<b>Direction</b>	Northwest - southeast
<b>Visibility</b>	Yes. Visibility from one side to the other.
<b>Substrate</b>	Both round culverts have approximately 2' of sediment throughout the entire length.
<b>Habitat/land use</b>	San Felipe Lake to the south and expansive open grassland habitat to the north.
<b>Wildlife track and sign</b>	No notes taken.
<b>Track and sign transects</b>	The substrate approaching the culvert is somewhat suitable for tracking transects depending on seasonality.

SR 152 Site 1 San Felipe Lake dual round culverts. Photo faces northwest towards culvert entrance on SR 152 eastbound side.

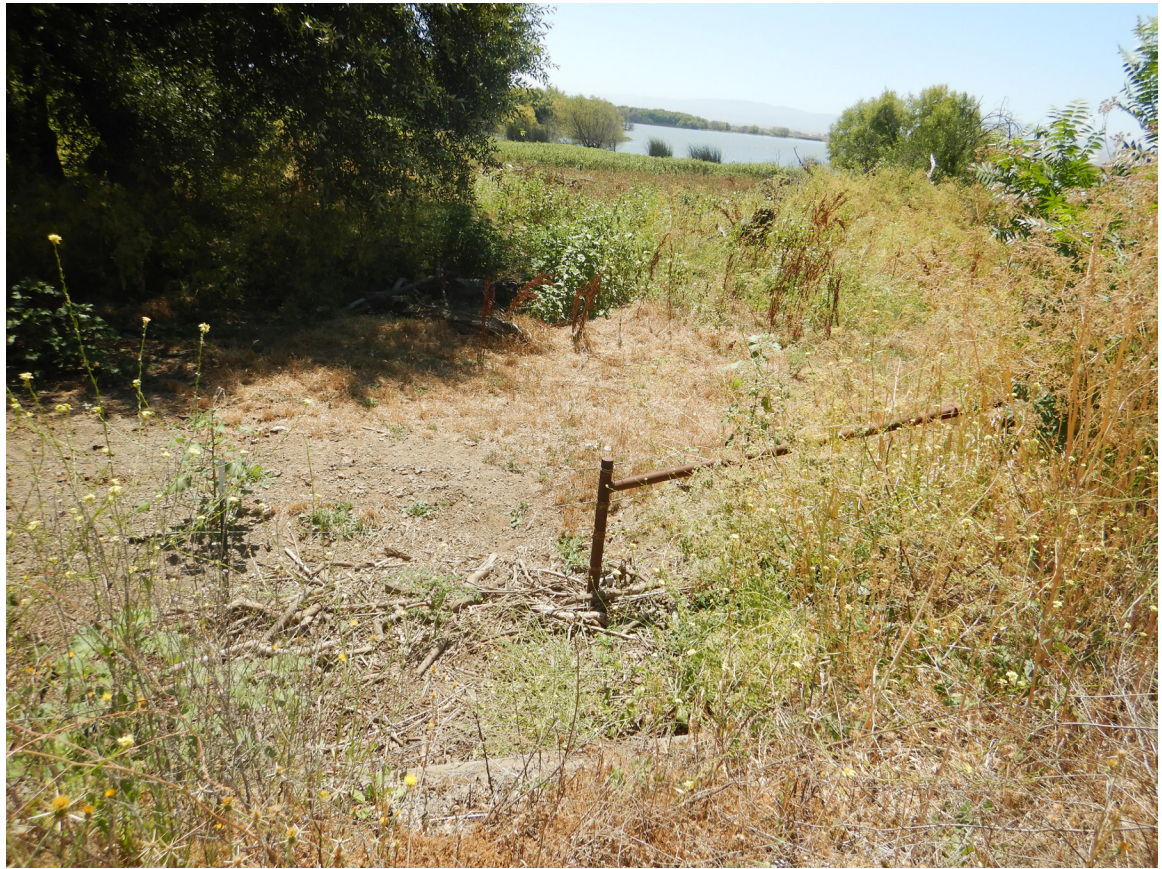
SR 152 Site 1 San Felipe Lake dual round culverts. Photo faces southeast away from the culvert entrance on the SR 152 eastbound side.

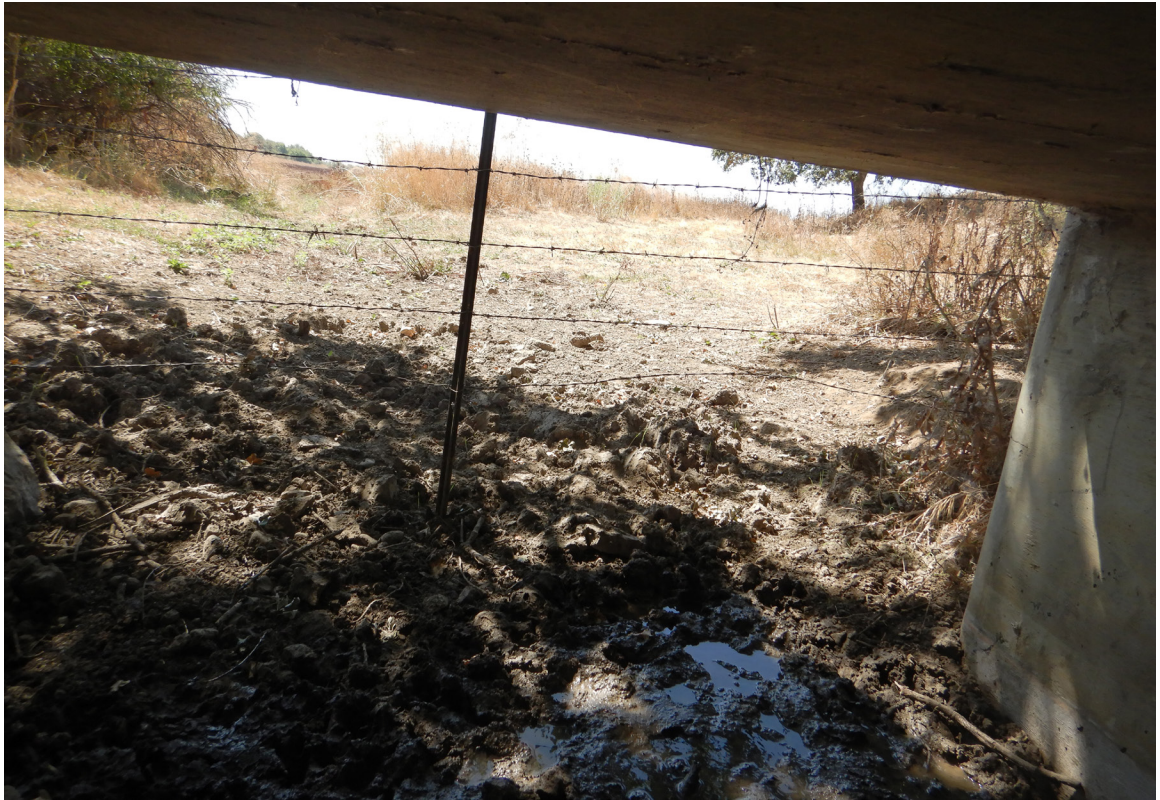
SR 152 SITE 2 SAN FELIPE LAKE BOX CULVERT	
<b>Postmile</b>	SCL, SR 152, PM 17.24
<b>GPS location</b>	Latitude: 36.98883 Longitude: -121.45172
<b>Dimensions</b>	Single box culvert approximately 6' wide and 4' tall.
<b>Direction</b>	Northwest - southeast
<b>Visibility</b>	Yes. Visibility from one side to the other.
<b>Substrate</b>	Concrete bottom throughout culvert; a couple inches of sediment have been deposited on top of it.
<b>Habitat/land use</b>	San Felipe Lake to the south and expansive open grassland habitat to the north.
<b>Wildlife track and sign</b>	Numerous tracks observed.
<b>Track and sign transects</b>	Site is suitable for tracking transects.

SR 152 Site 2 San Felipe Lake box culvert. Photo faces southeast away from the culvert entrance on the SR 152 eastbound side.

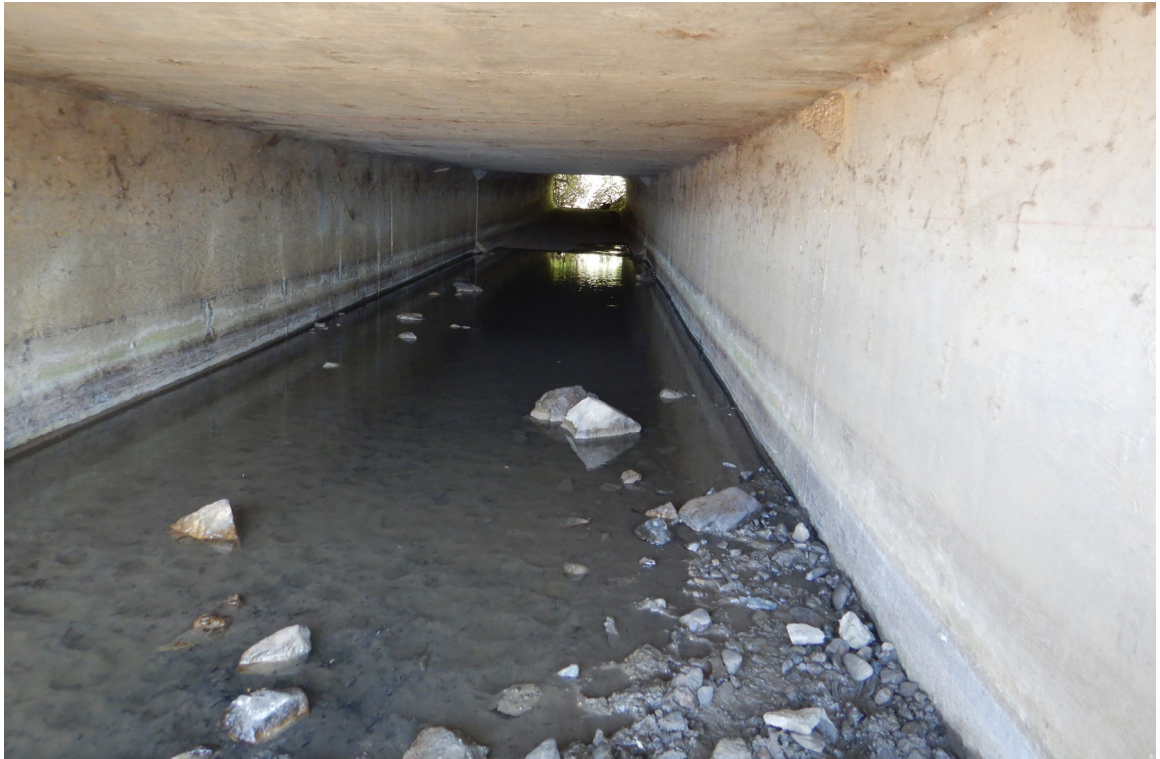
SR 152 Site 2 San Felipe Lake box culvert. Photo faces northwest through the culvert from the SR 152 eastbound side.

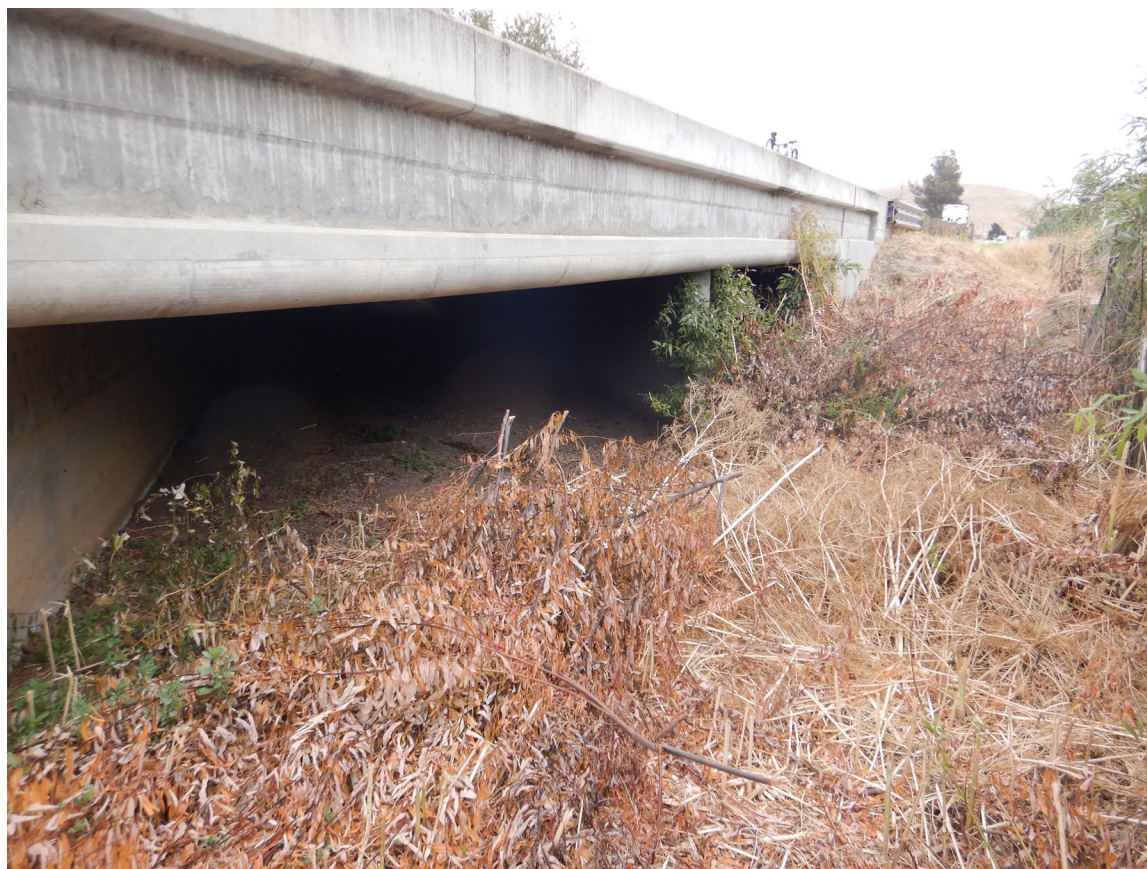
SR 152 Site 3 Ortega Creek Bridge. Photo taken from the SR 152 eastbound side of the bridge facing northeast.

<b>Postmile</b>	SCL, SR 152, PM 19.32
<b>GPS location</b>	Latitude: 36.97282 Longitude: -121.42469
<b>Dimensions</b>	Small bridge with single middle pier dividing two sections. Bridge is approximately 8' tall and each section is approximately 15' wide.
<b>Direction</b>	Northeast - southwest. Direction is based on the alignment of Ortega Creek (also known as Hornstein Creek).
<b>Visibility</b>	Yes. Visibility from one side to the other.
<b>Substrate</b>	Bridge bottom/foundation is concrete, but sediment has deposited throughout most of the foundation.
<b>Habitat/land use</b>	Fragmented, intensive land use on south side, open grassland on north.
<b>Wildlife track and sign</b>	Numerous tracks observed under the bridge.
<b>Track and sign transects</b>	The substrate under the bridge is suitable for a wildlife tracking transect.

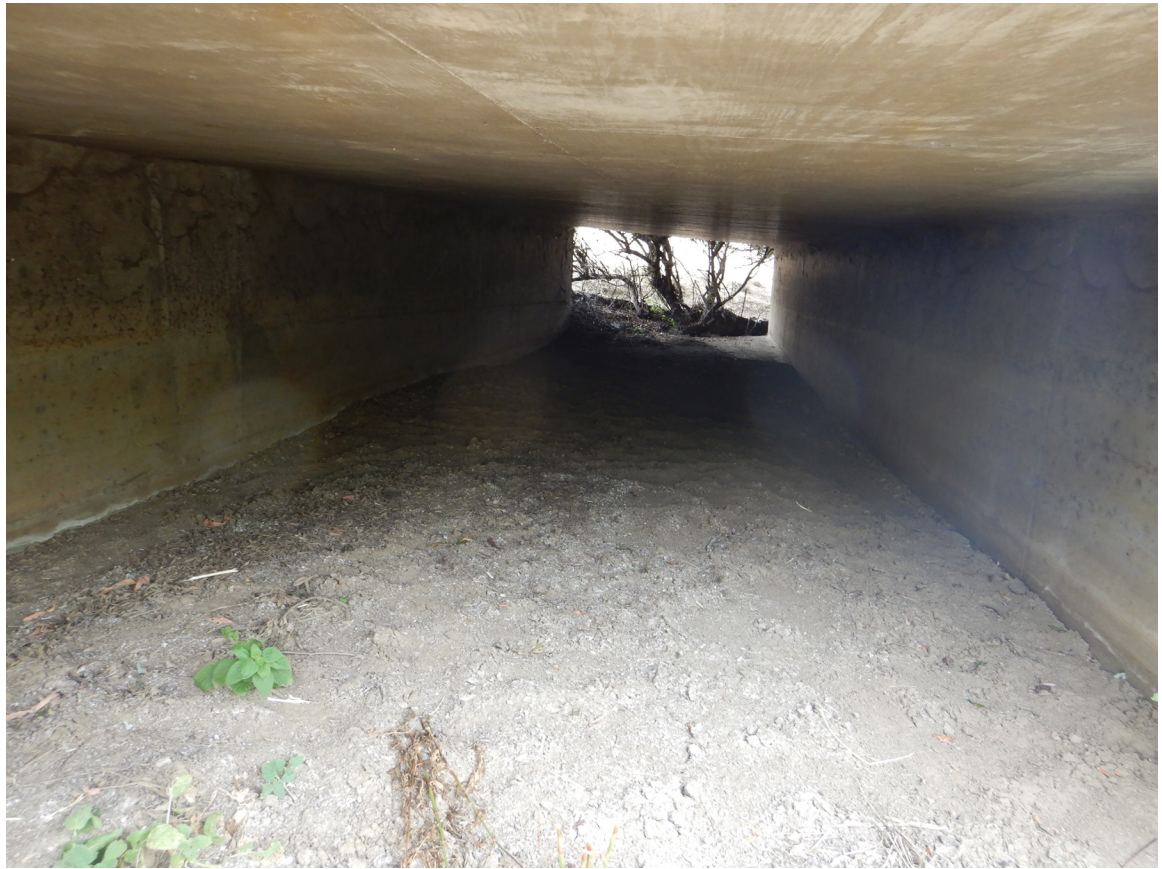
SR 152 Site 3 Ortega Creek Bridge. Photo from the SR 152 eastbound side of the bridge facing northeast.

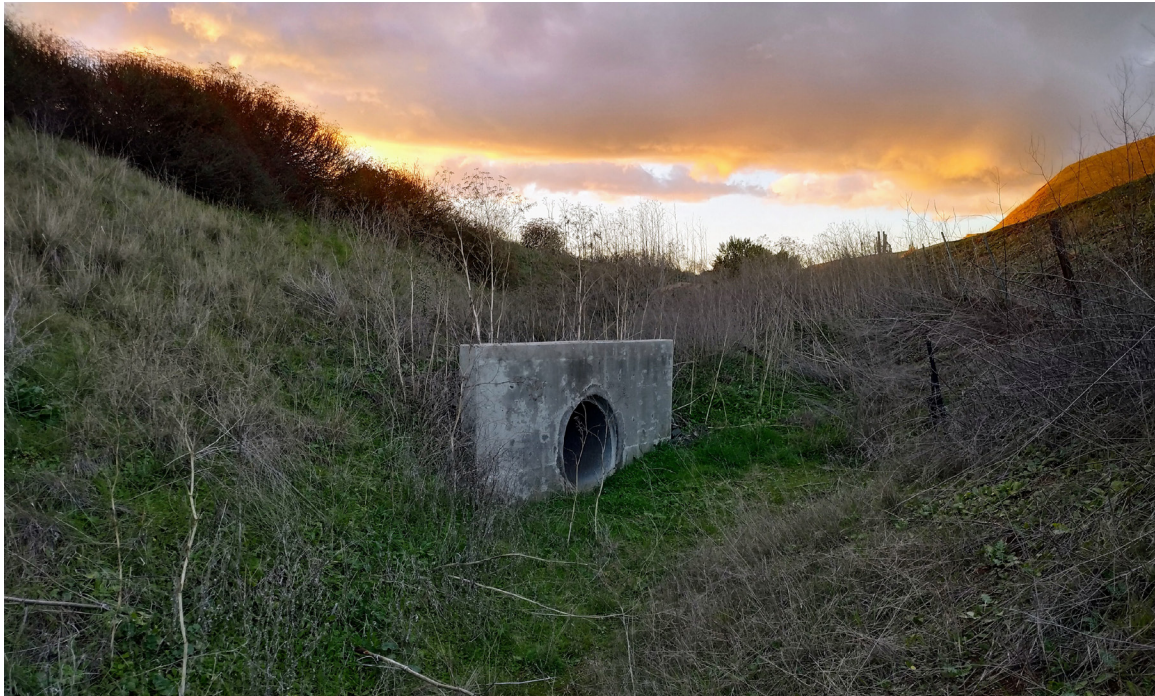
SR 152 Site 4 Coyote and Badger culvert. Photo of culvert entrance on SR 152 westbound side.

SR 152 SITE 4 COYOTE AND BADGER CULVERT	
<b>Postmile</b>	SCL, SR 152, PM 20.32
<b>GPS location</b>	Latitude: 36.96545 Longitude: -121.40928
<b>Dimensions</b>	Cement round culvert 4' in diameter.
<b>Direction</b>	Northeast - southwest
<b>Visibility</b>	Yes. High visibility from one side to the other.
<b>Substrate</b>	Concrete bottom without sediment.
<b>Habitat/land use</b>	Grassland habitat on both sides of the culvert.
<b>Wildlife track and sign</b>	None
<b>Track and sign transects</b>	The site is not suitable for tracking transects due to the substrate.

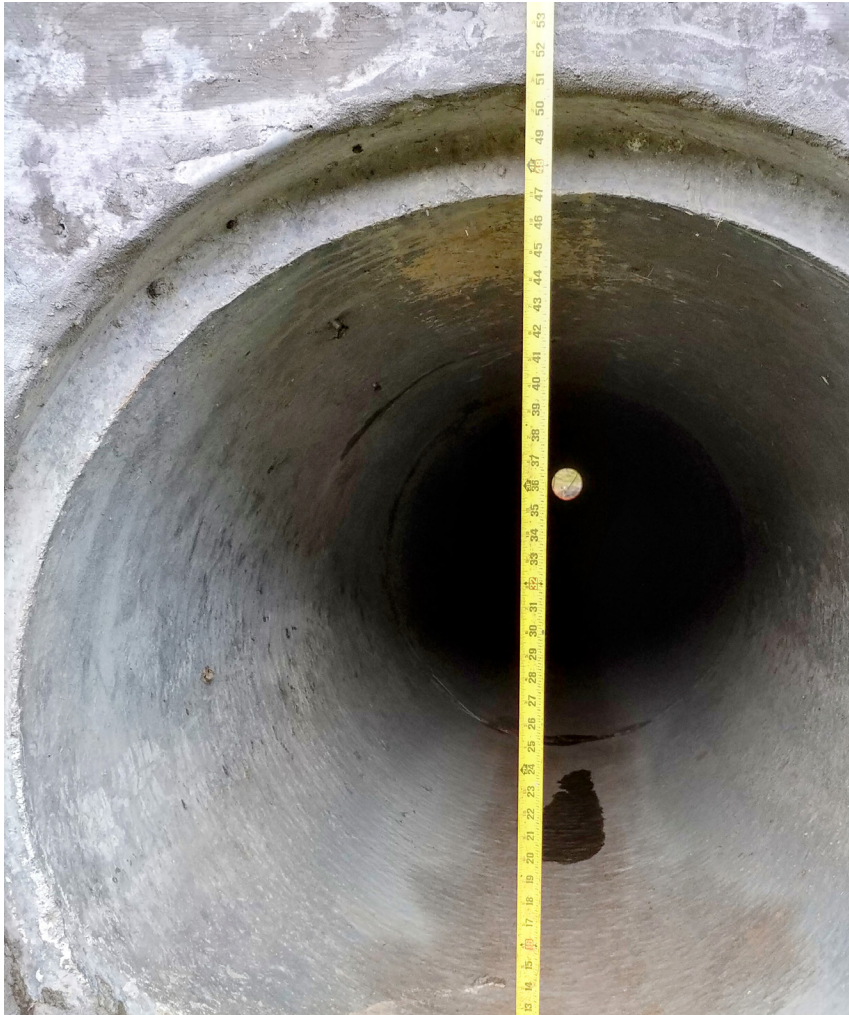
SR 152 Site 4 Coyote and Badger culvert. Photo taken from culvert entrance on SR 152 westbound side.

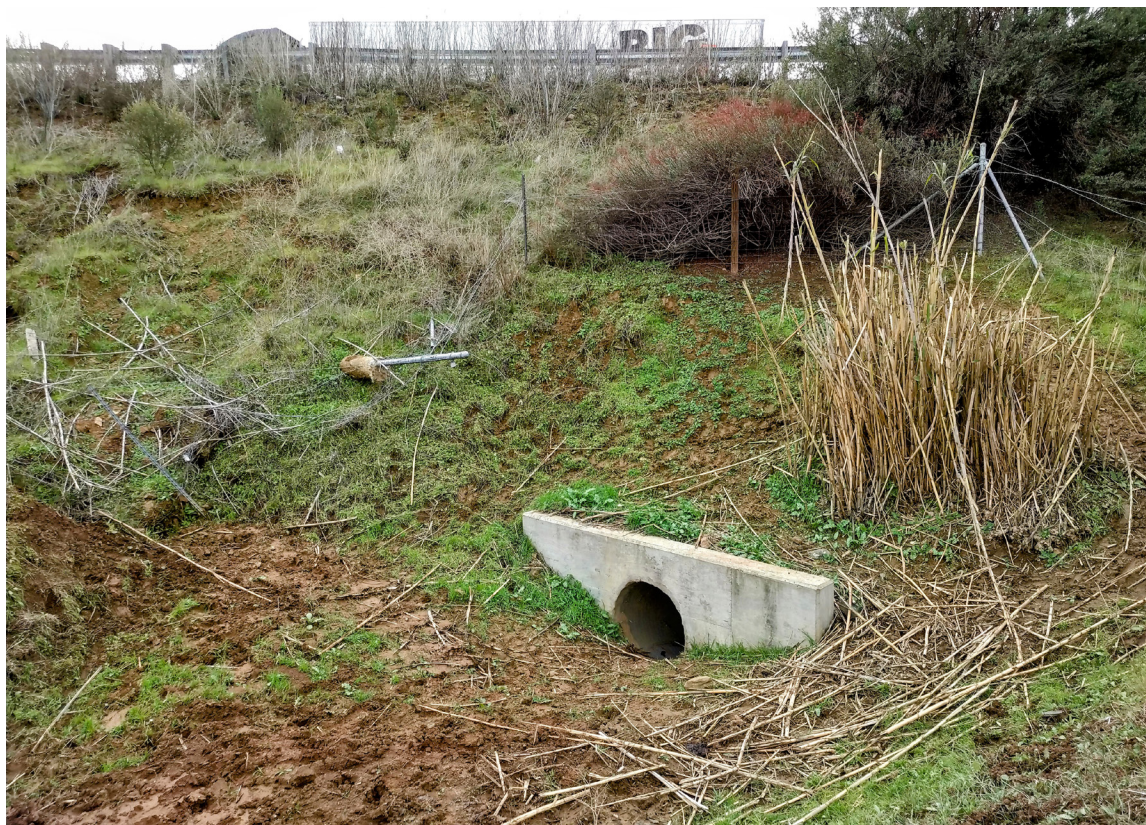
SR 152 Site 5 Coyote Puppy culvert. Photo of entrance on SR 152 westbound side.

<b>Postmile</b>	SCL, SR 152, PM 20.74
<b>GPS location</b>	Latitude: 36.96143 Longitude: -121.40347
<b>Dimensions</b>	Cement round culvert approximately 30" in diameter.
<b>Direction</b>	Southwest - northeast
<b>Visibility</b>	Yes. Visibility from one side to the other.
<b>Substrate</b>	Concrete bottom without sediment.
<b>Habitat/land use</b>	Grassland habitat on both sides of the culvert.
<b>Wildlife track and sign</b>	None
<b>Track and sign transects</b>	The site is not suitable for tracking transects due to the substrate.

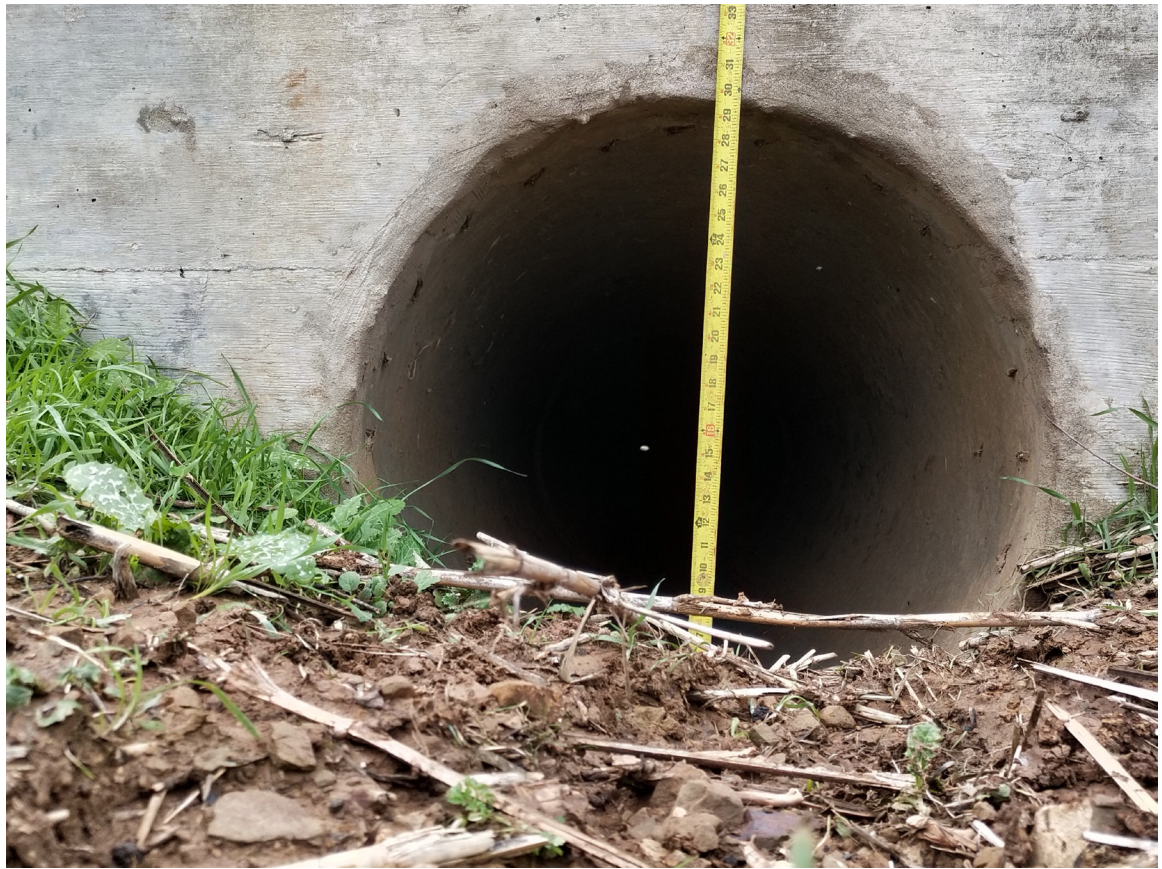
SR 152 Site 5 Coyote Puppy culvert. Photo of culvert entrance on SR 152 westbound side.

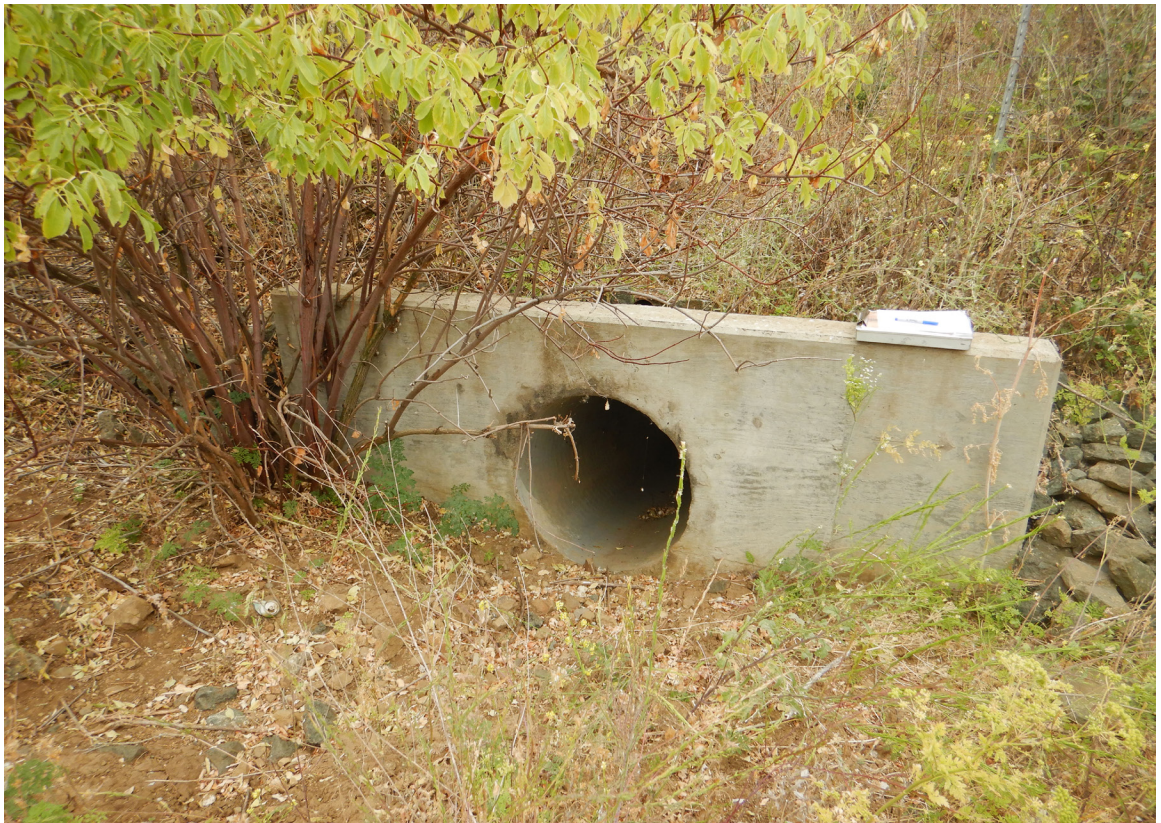
SR 152 Site 6 Tree round culvert. Photo of culvert entrance on SR 152 westbound side.

SR 152 SITE 6 TREE ROUND CULVERT	
<b>Postmile</b>	SCL, SR 152, PM 20.85
<b>GPS location</b>	Latitude: 36.96109 Longitude: -121.40189
<b>Dimensions</b>	Cement round culvert approximately 30" in diameter.
<b>Direction</b>	Southwest - northeast
<b>Visibility</b>	Yes. Visibility from one side to the other.
<b>Substrate</b>	Concrete bottom without sediment.
<b>Habitat/land use</b>	Grassland habitat on both sides of the culvert.
<b>Wildlife track and sign</b>	None
<b>Track and sign transects</b>	The site is not suitable for tracking transects due to the substrate.

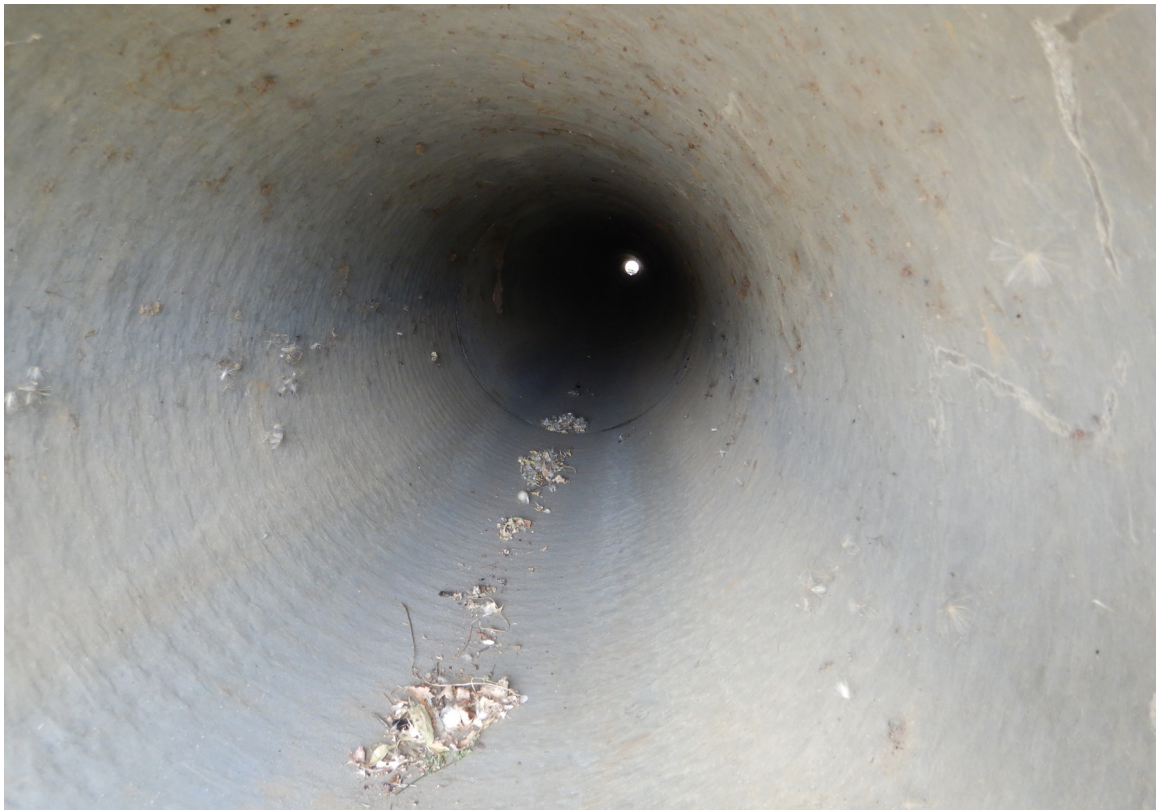
SR 152 Site 6 Tree round culvert. Photo taken from culvert entrance on SR 152 westbound side.

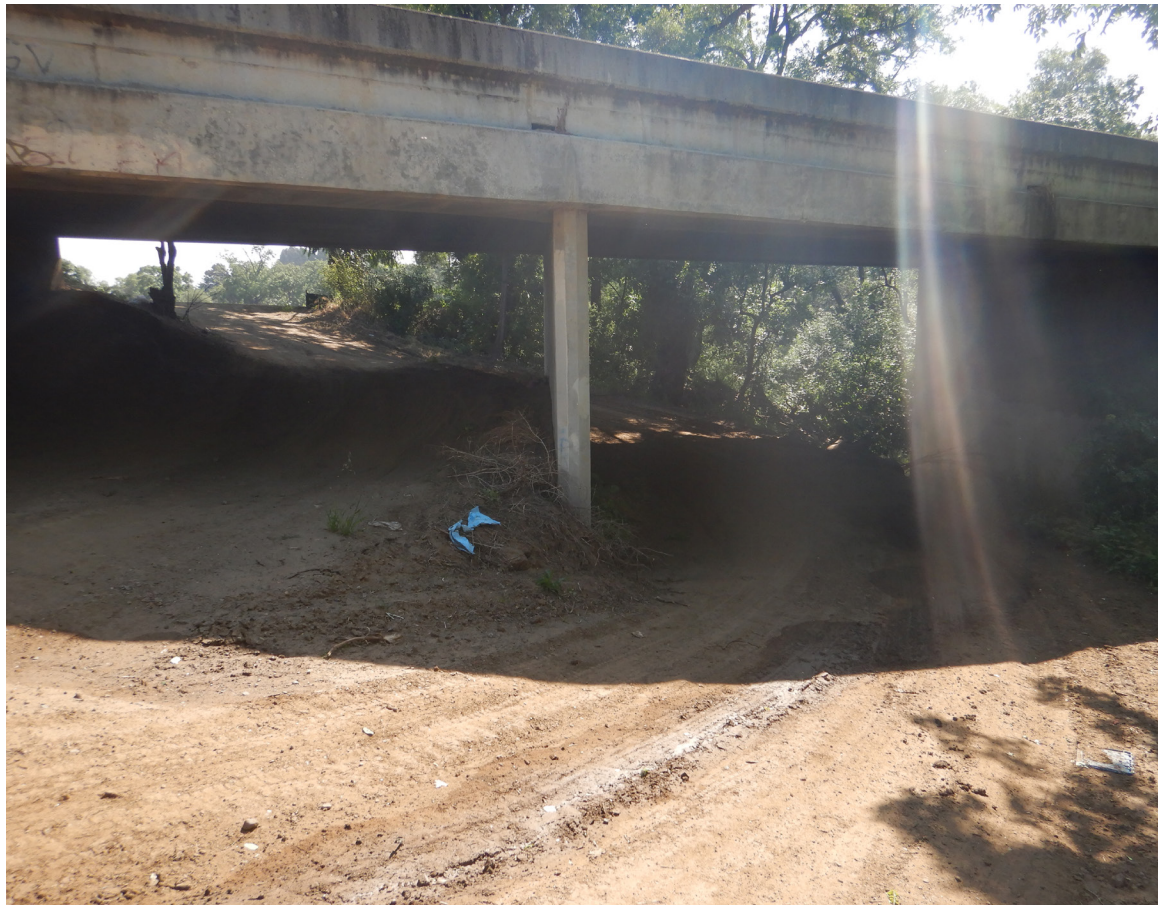
SR 25 Site 1 Carnadero Creek Bridge. Photo faces northeast along the west bank.

SR 25 SITE 1 CARNADERO CREEK BRIDGE	
<b>Postmile</b>	SCL, SR 152, PM 1.55
<b>GPS location</b>	Latitude: 36.95997 Longitude: -121.53468
<b>Dimensions</b>	Moderate-sized bridge where Carnadero Creek (also known as Uvas-Carnadero Creek) runs under SR 25. Bridge is 20'+ tall directly over the creek. Two agricultural dirt roads run under the bridge on the west bank.
<b>Direction</b>	Northeast – southwest. Direction is based on the alignment of Carnadero Creek.
<b>Visibility</b>	Yes. High visibility under the bridge from one side to the other.
<b>Substrate</b>	Substrate is primarily dirt/soil. No hardscape under the bridge except for a small amount of rock armoring the banks of the creek.
<b>Habitat/land use</b>	Agricultural land adjacent to riparian corridor
<b>Wildlife track and sign</b>	No notes taken
<b>Track and sign transects</b>	The substrate under the bridge is suitable for tracking transects.

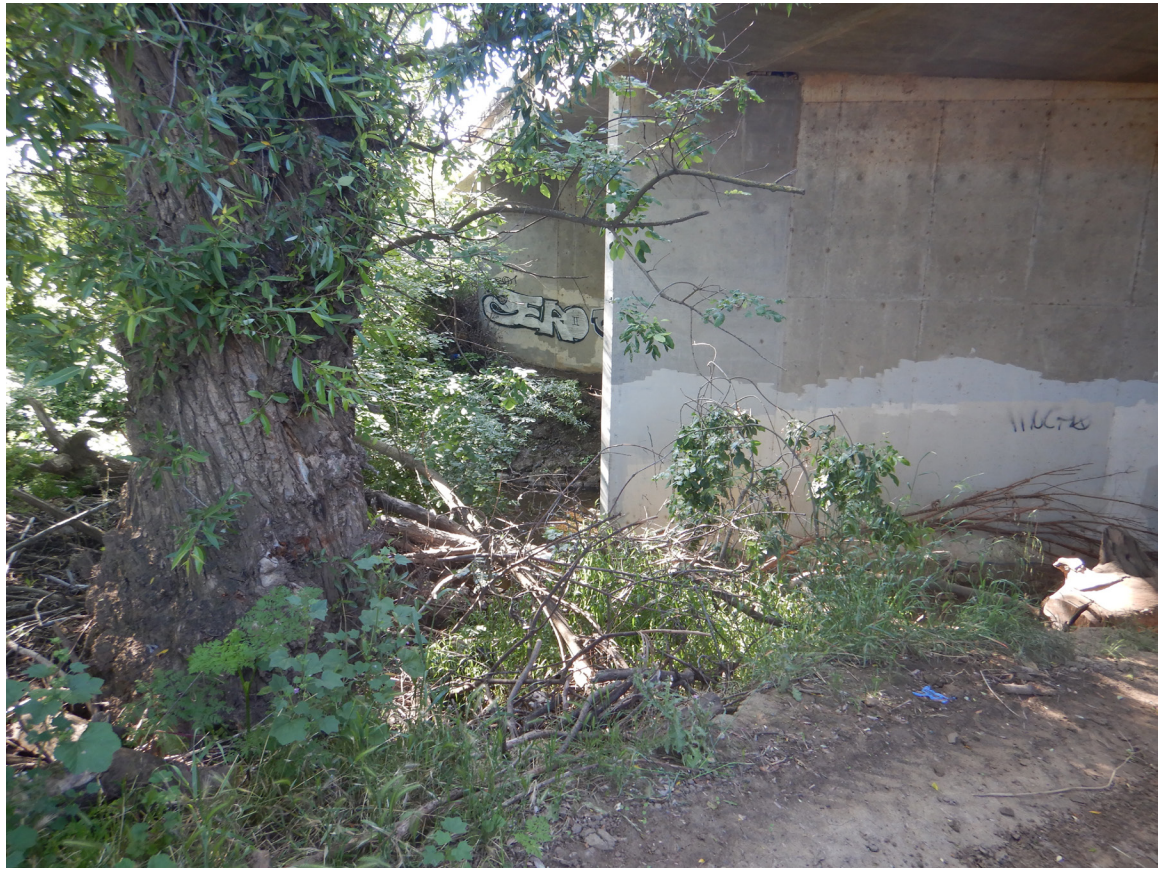
SR 25 Site 1 Carnadero Creek Bridge. Photo from west bank facing southeast towards the east bank.

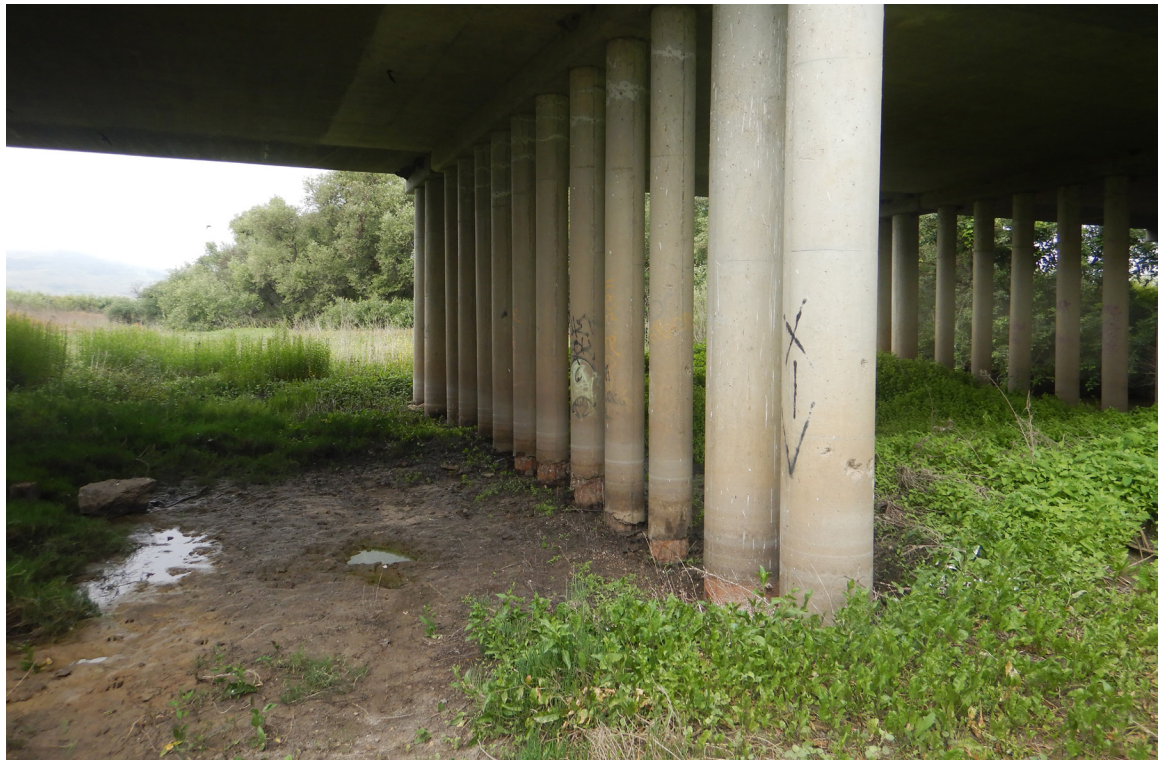
SR 25 Site 2 Pajaro River Bridge. Photo faces northeast along the west bank.

SR 25 SITE 2 PAJARO RIVER BRIDGE	
<b>Postmile</b>	SBT, SR 152, PM 60.08
<b>GPS location</b>	Latitude: 36.94805 Longitude: -121.51211
<b>Dimensions</b>	Moderate-sized bridge where Pajaro River runs under SR 25. Bridge is 20'+ tall directly over the river.
<b>Direction</b>	Northeast - southwest. Direction is based on the alignment of Pajaro River.
<b>Visibility</b>	Yes. High visibility under the bridge from one side to the other.
<b>Substrate</b>	Substrate is primarily dirt/soil. No hardscape under the bridge.
<b>Habitat/land use</b>	Agricultural land adjacent to the riparian corridor.
<b>Wildlife track and sign</b>	Numerous tracks from several species present including bobcat, coyote ( <i>Canis latrans</i> ), and black-tailed deer ( <i>Odocoileus hemionus ssp. columbianus</i> ).
<b>Track and sign transects</b>	The substrate under the bridge is highly suitable for tracking transects.

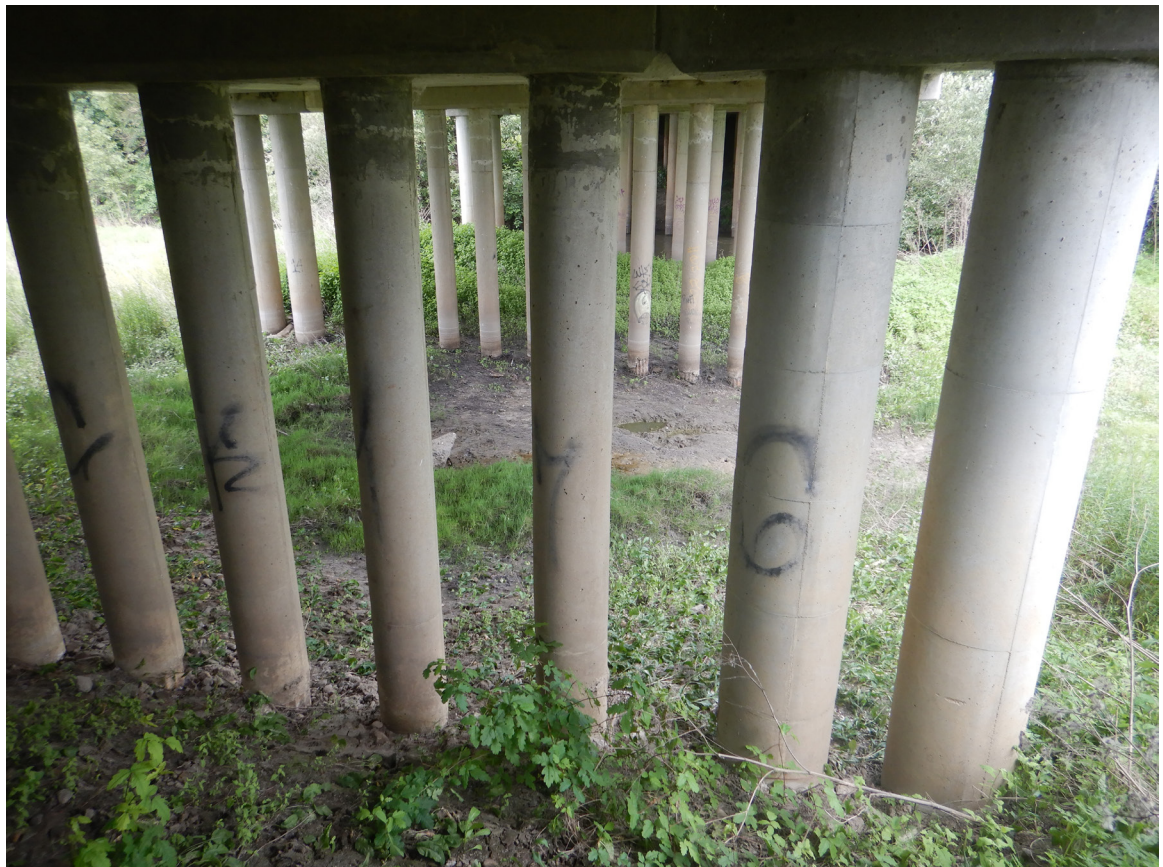
SR 25 Site 2 Pajaro River Bridge. Photo from west bank faces southeast towards the east bank.

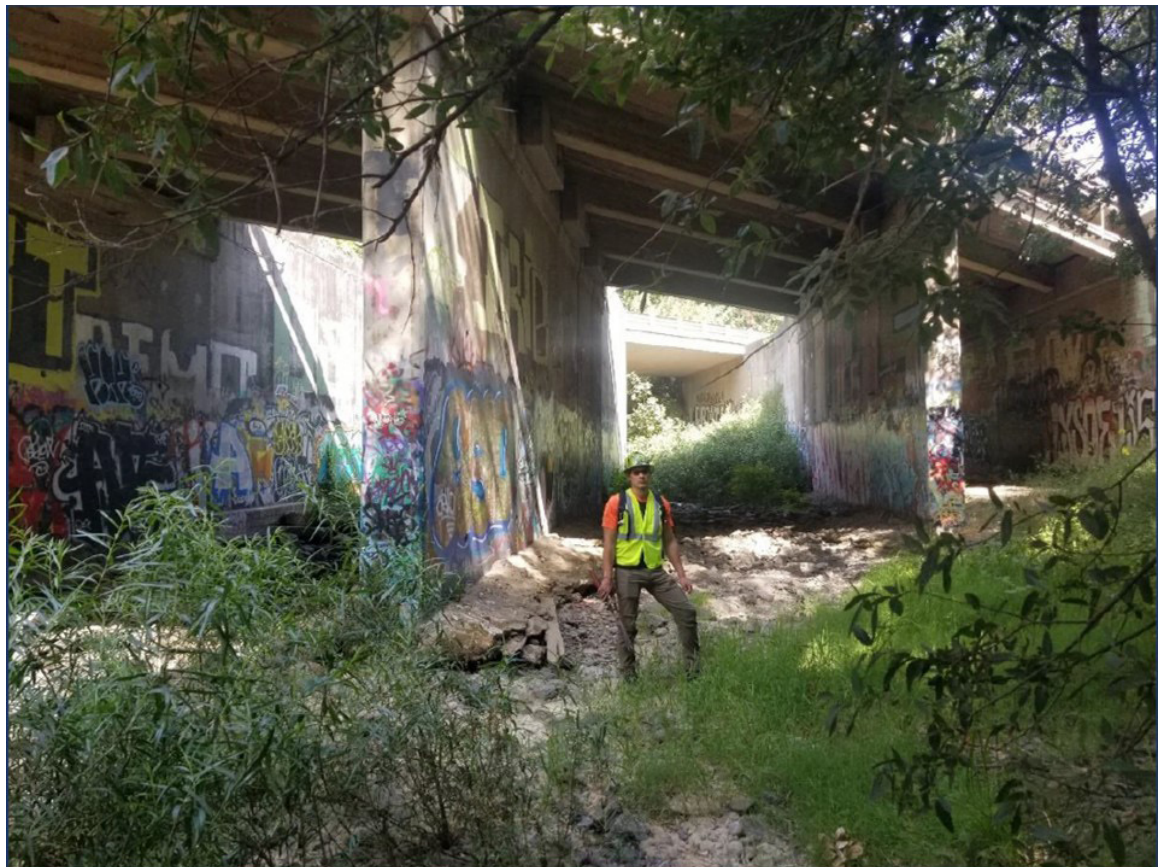
US 101 Site 1 Carnadero Creek Bridge. Photo faces northwest from the east side of the bridge.

US 101 SITE 1 CARNADERO CREEK BRIDGE	
<b>Postmile</b>	SCL, US 101, PM 4.21
<b>GPS location</b>	Latitude: 36.97637 Longitude: -121.55564
<b>Dimensions</b>	Large bridge where Carnadero Creek (also known as Uvas-Carnadero Creek) runs under US 101. Bridge is 20'+ tall directly over the creek. Bridge consists of two separate spans, one for southbound lanes and one for northbound lanes; these spans are connected by a single set of continuous piers.
<b>Direction</b>	Northwest - southeast. Direction is based on the alignment of Carnadero Creek.
<b>Visibility</b>	Yes. Visibility under the bridge from one side to the other.
<b>Substrate</b>	Mix of soils, cobbles, and boulders.
<b>Habitat/land use</b>	Riparian corridor with adjacent row crop agricultural and commercial land uses.
<b>Wildlife track and sign</b>	No notes taken.
<b>Track and sign transects</b>	The substrate under the bridge is suitable for tracking transects.

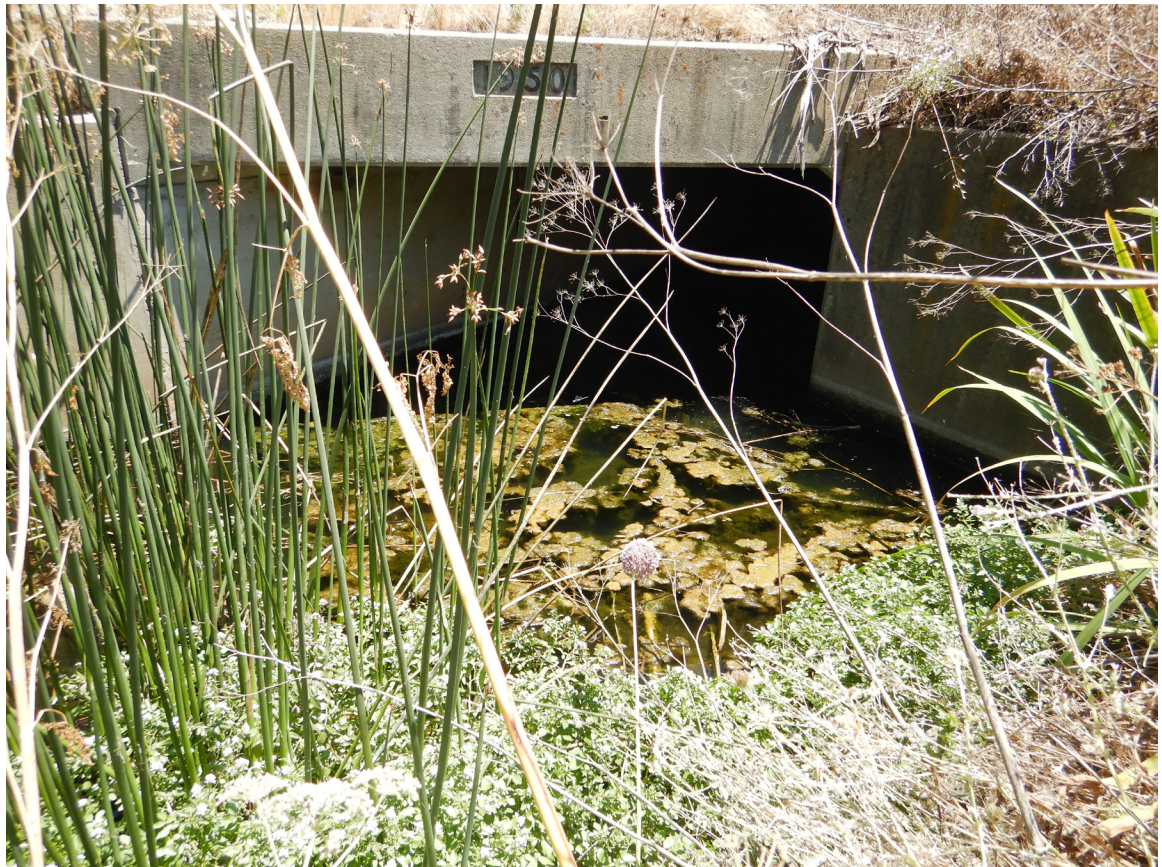
US 101 Site 2 Gavilan Creek culvert. Photo faces southeast towards the culvert entrance on the southbound side of US 101.

<b>Postmile</b>	SCL, US 101, PM 3.17
<b>GPS location</b>	Latitude: 36.96145 Longitude: -121.55131
<b>Dimensions</b>	Single box culvert approximately 12' wide by 6' tall.
<b>Direction</b>	Northwest - southeast
<b>Visibility</b>	Yes. Visibility from one side to the other.
<b>Substrate</b>	Culvert likely has a concrete bottom throughout culvert; however, at least 1' of sediment has deposited on top of it. Ponding water was present during inspection, and it is presumed that ponding is present most of if not all of the year.
<b>Habitat/land use</b>	Private residence on west side of crossing and row crop agriculture on east side.
<b>Wildlife track and sign</b>	None
<b>Track and sign transects</b>	Due to ponding water, site is not suitable for tracking transects.

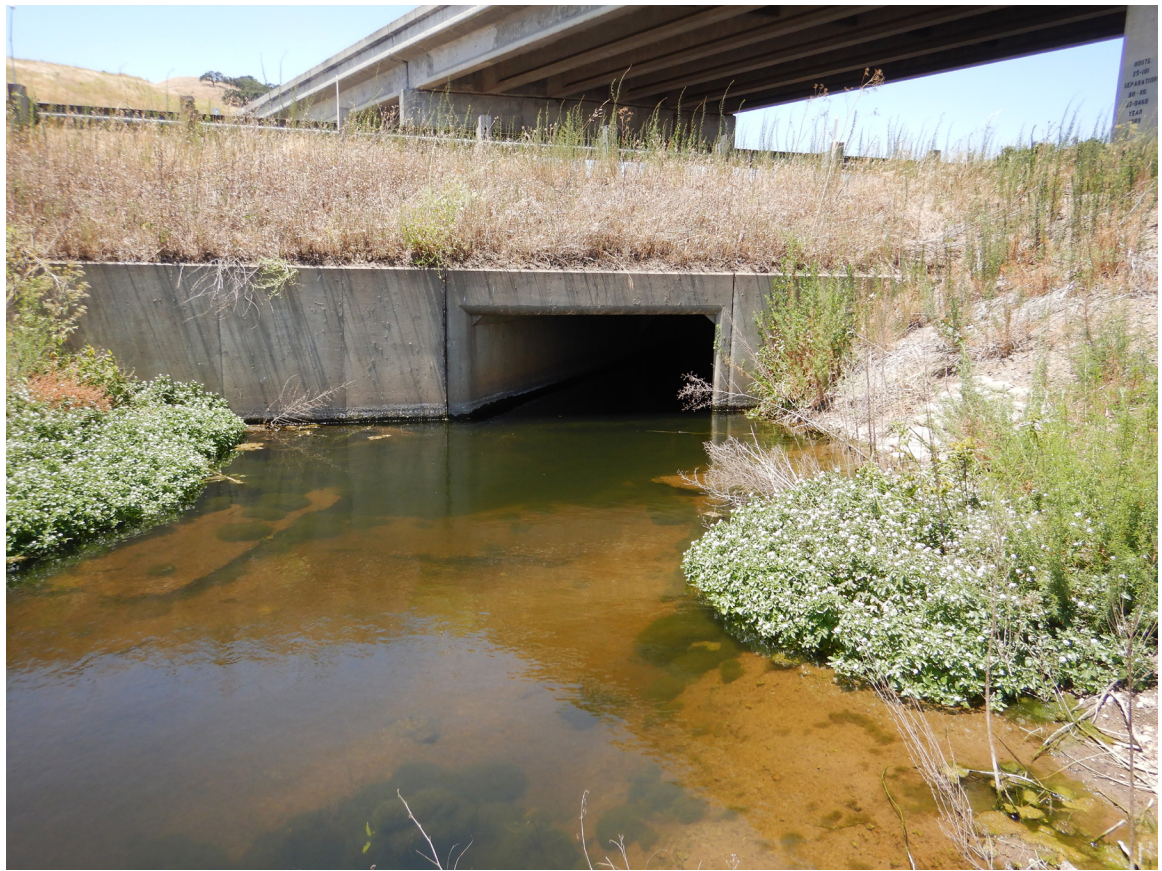
US 101 Site 2 Gavilan Creek culvert. Photo faces northwest towards the culvert entrance on the northbound side of US 101.
