# Enhancing ecological connectivity and safe passage for wildlife on highways between the southern Santa Cruz Mountains, Gabilan Range, and Diablo Range in California

Diamond, TD, A Sandoval, NP Sharma, ME Vernon, PD Cowan, AP Clevenger, and SC Lockwood. 2022. *Enhancing ecological connectivity and safe passage for wildlife on highways between the southern Santa Cruz Mountains, Gabilan Range, and Diablo Range in California*. Pathways for Wildlife and Peninsula Open Space Trust, Palo Alto, CA.

AUGUST 2022

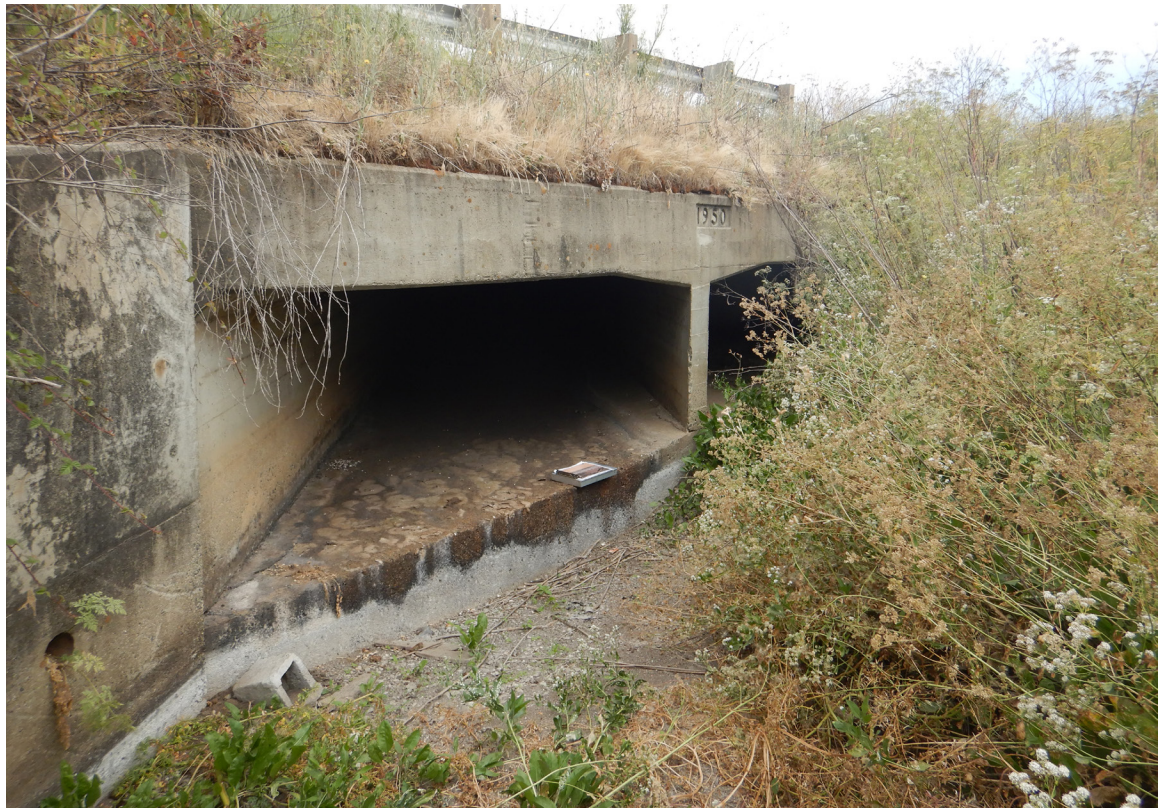
US 101 Site 3 Tick Creek culvert. Photo faces northwest towards the culvert entrance on the northbound side of US 101.

US 101 SITE 3 TICK CREEK CULVERT	
<b>Postmile</b>	SCL, US 101, PM 1.90
<b>GPS location</b>	Latitude: 36.94274 Longitude: -121.55243
<b>Dimensions</b>	Double box culvert with each box approximately 11' wide by 3' 4" tall.
<b>Direction</b>	Northwest - southeast
<b>Visibility</b>	Yes. Visibility from one side to the other.
<b>Substrate</b>	Culvert bottom is concrete, but sediment has deposited throughout most of the culvert.
<b>Habitat/land use</b>	High-quality habitat on both sides of the culvert — riparian on east side and grasslands, wetlands, and woodlands to the west.
<b>Wildlife track and sign</b>	Numerous tracks observed throughout the culvert.
<b>Track and sign transects</b>	The substrate throughout the culvert is suitable for a wildlife tracking transect.

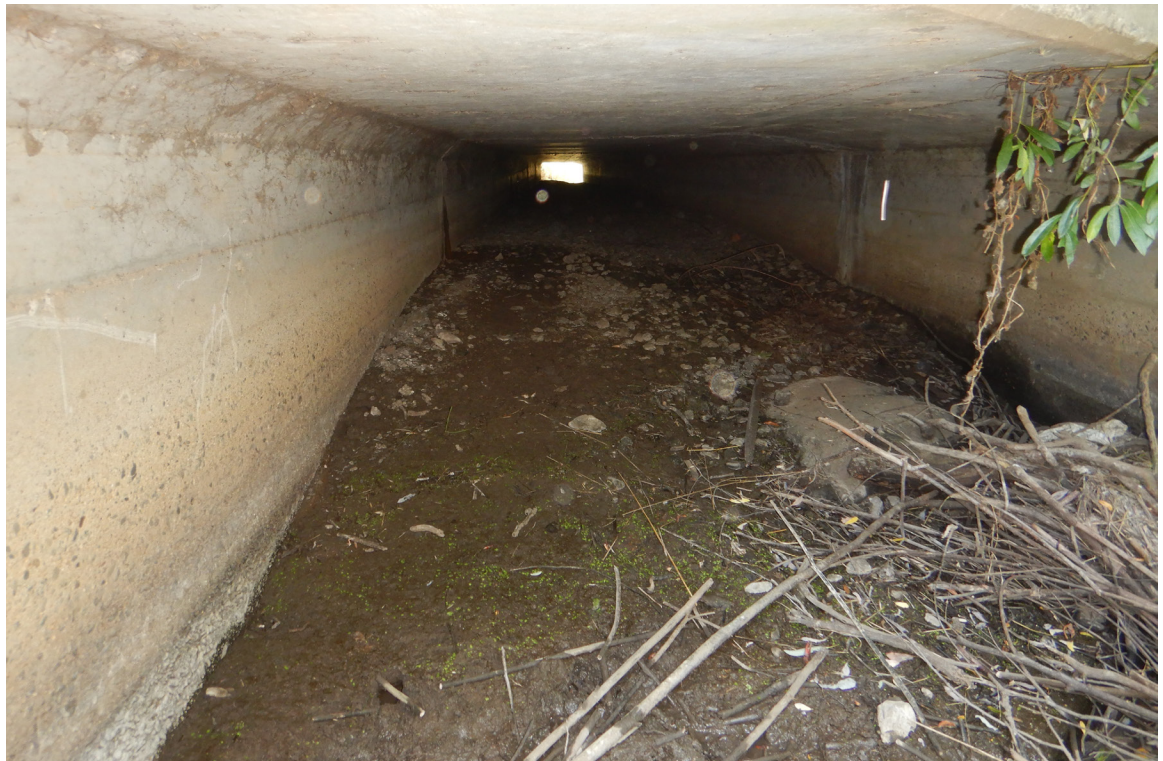
US 101 Site 3 Tick Creek culvert. Photo from the southbound side of US 101 faces southeast through the northern box.

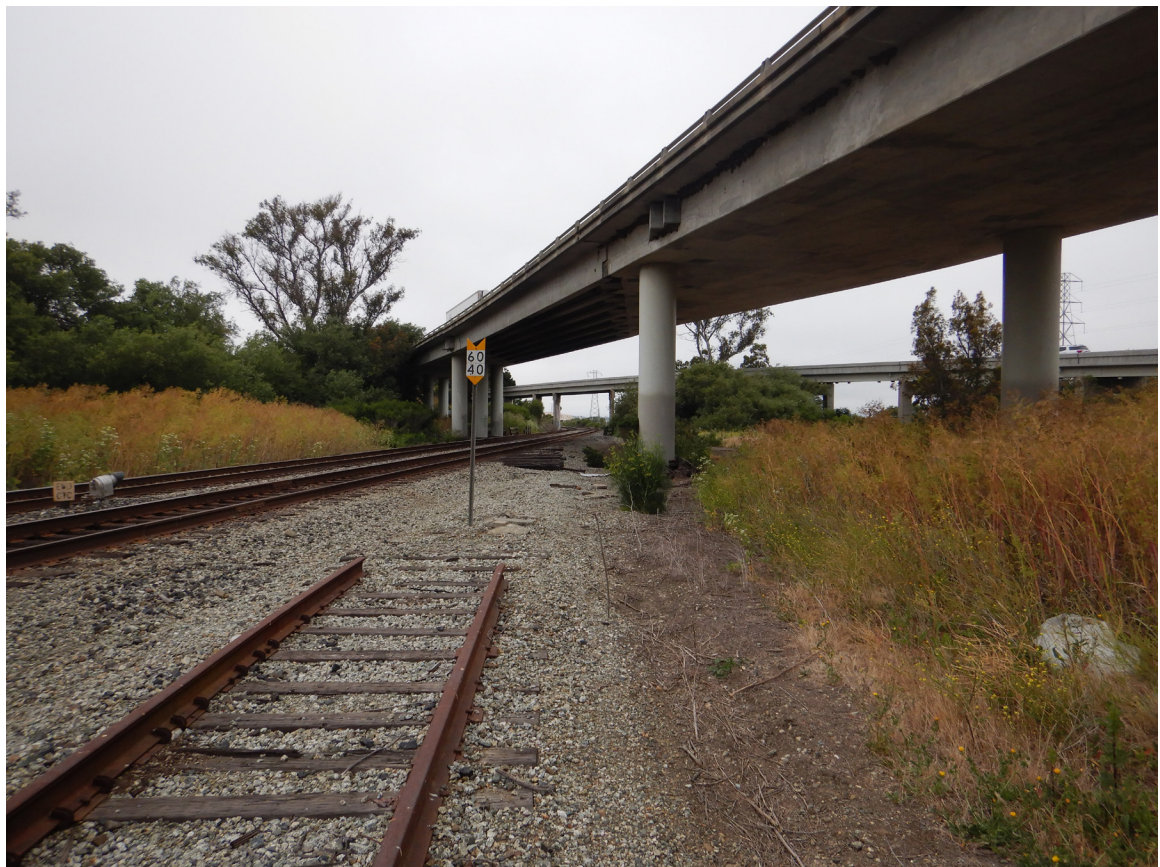
US 101 Site 4 Tar Creek Overpass. Photo faces east from west side of US 101 southbound.

<b>Postmile</b>	SCL, US 101, PM 0.84
<b>GPS location</b>	Latitude: 36.9289 Longitude: -121.54797
<b>Dimensions</b>	Large bridge where Tar Creek, the railroad, and a private road runs under US 101. Bridge is 20'+ tall directly over the creek. Bridge consists of two separate spans, one for southbound lanes and one for northbound lanes.
<b>Direction</b>	West - east. Direction is based on the alignment of Tar Creek.
<b>Visibility</b>	Yes. High visibility from one side to the other.
<b>Substrate</b>	Various substrates are present, both disturbed and undisturbed.
<b>Habitat/land use</b>	Residence on west side, includes train tracks, high-quality habitat on both sides other than those elements.
<b>Wildlife track and sign</b>	Numerous tracks observed under the bridge.
<b>Track and sign transects</b>	The substrate under the bridge is suitable for tracking transects.

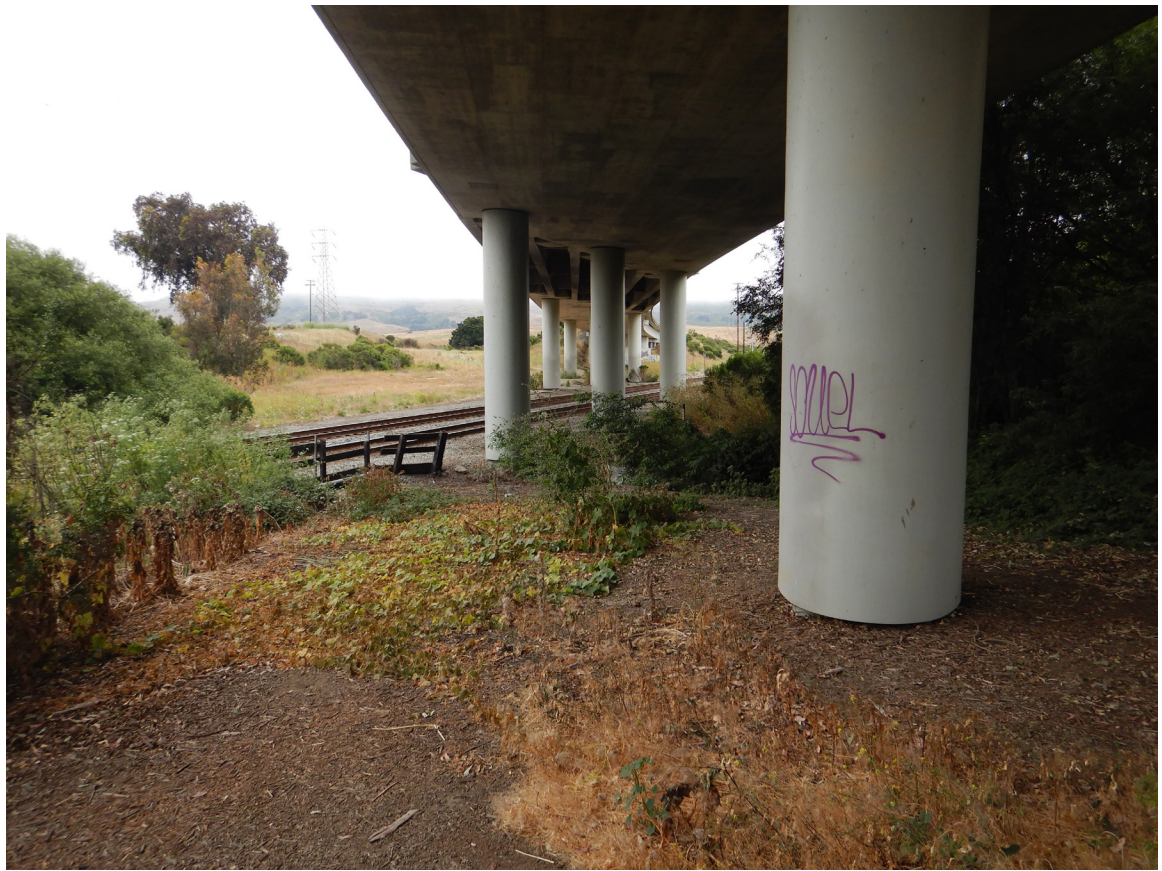
US 101 Site 4 Tar Creek overpass. Photo faces south/southwest from under northbound US 101.

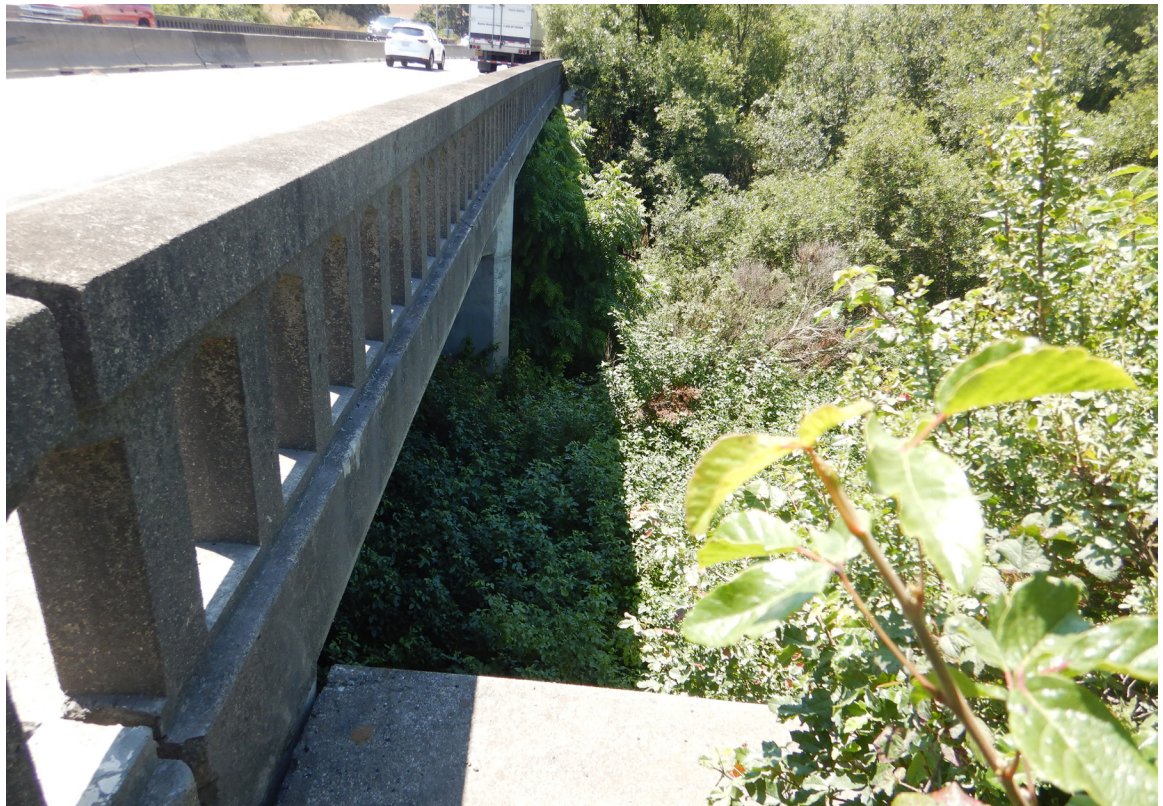
US 101 Site 5 Pajaro River Bridge. Photo taken from north side Pajaro River on west side of US 101 southbound looking south.

US 101 Site 5. Within northwestern opening, showing the corroded bottom of the culvert.

US 101 SITE 5 PAJARO RIVER BRIDGE	
<b>Postmile</b>	SCL, US 101, PM 0.00
<b>GPS location</b>	Latitude: 36.91745 Longitude: -121.54797
<b>Dimensions</b>	Large bridge where Pajaro River runs under US 101. Bridge is 20'+ tall directly over the river.
<b>Direction</b>	West - east. Direction is based on the alignment of Pajaro River.
<b>Visibility</b>	Yes. High visibility from one side to the other.
<b>Substrate</b>	Undisturbed soils are present and hardscape bottom is absent.
<b>Habitat/land use</b>	Wide riparian corridor with high-quality habitat.
<b>Wildlife track and sign</b>	Numerous tracks observed under the bridge.
<b>Track and sign transects</b>	The substrate under the bridge is suitable for tracking transects.

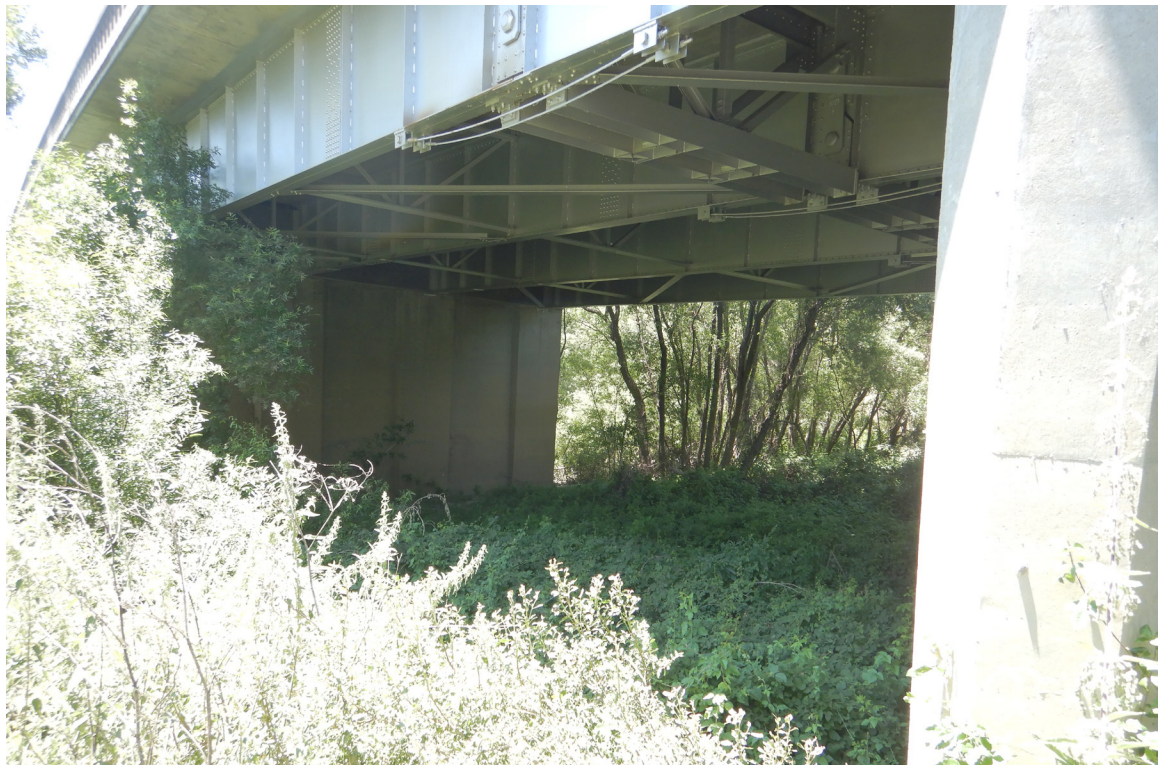
US 101 Site 5 Pajaro River Bridge. Photo from south side of Pajaro River faces west under the bridge.

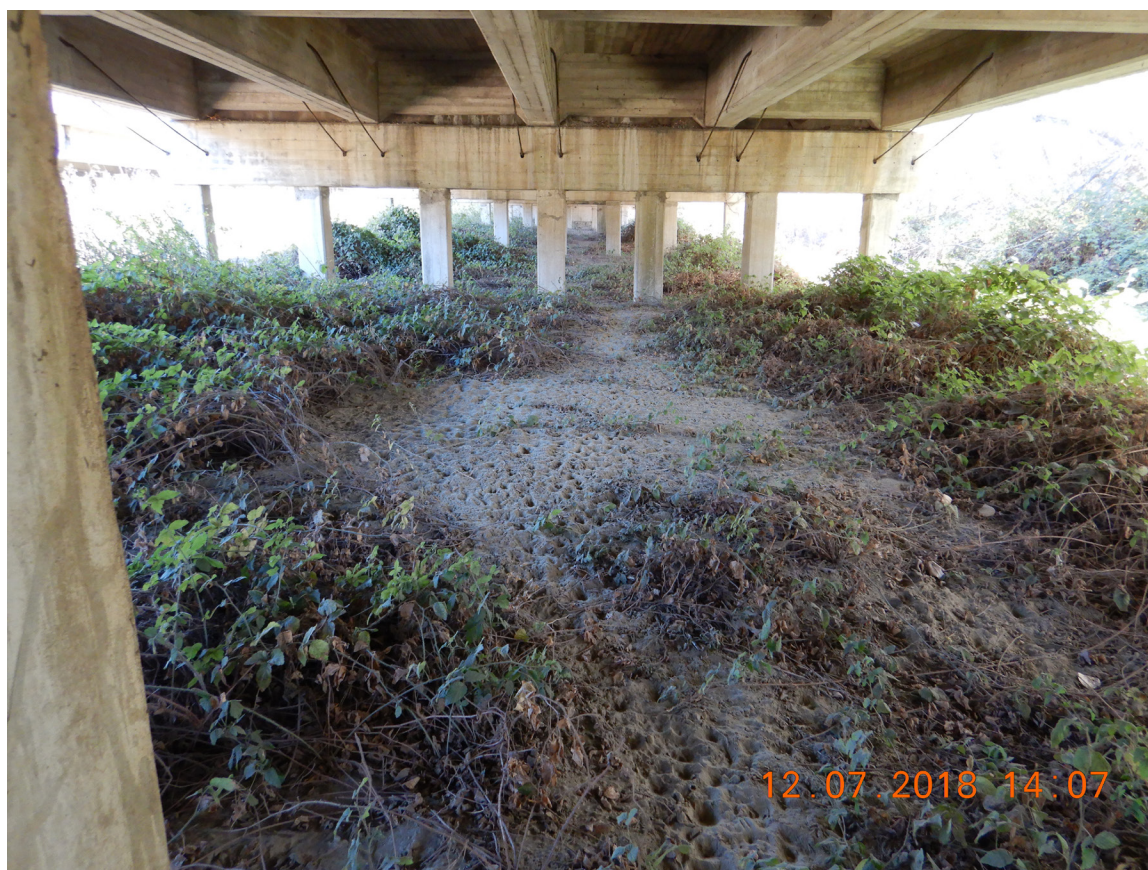
US 101 Site 6 San Benito River Bridge. Photo faces south from north side of San Benito River under US 101 southbound.

<b>Postmile</b>	SBT, US 101, PM 5.25
<b>GPS location</b>	Latitude: 36.88724 Longitude: -121.55888
<b>Dimensions</b>	Large bridge over the San Benito River. Bridge is 20'+ tall directly over the river. Bridge consists of two separate spans, one for southbound lanes and one for the northbound lanes.
<b>Direction</b>	Northwest - southeast. Direction is based on the alignment of San Benito River.
<b>Visibility</b>	Yes. High visibility from one side to the other.
<b>Substrate</b>	Undisturbed soils are present and hardscape bottom is absent.
<b>Habitat/land use</b>	Wide riparian corridor with high-quality habitat.
<b>Wildlife track and sign</b>	Numerous tracks of numerous species were present under the bridge.
<b>Track and sign transects</b>	Fine substrates under the bridge are highly suitable for tracking transects.

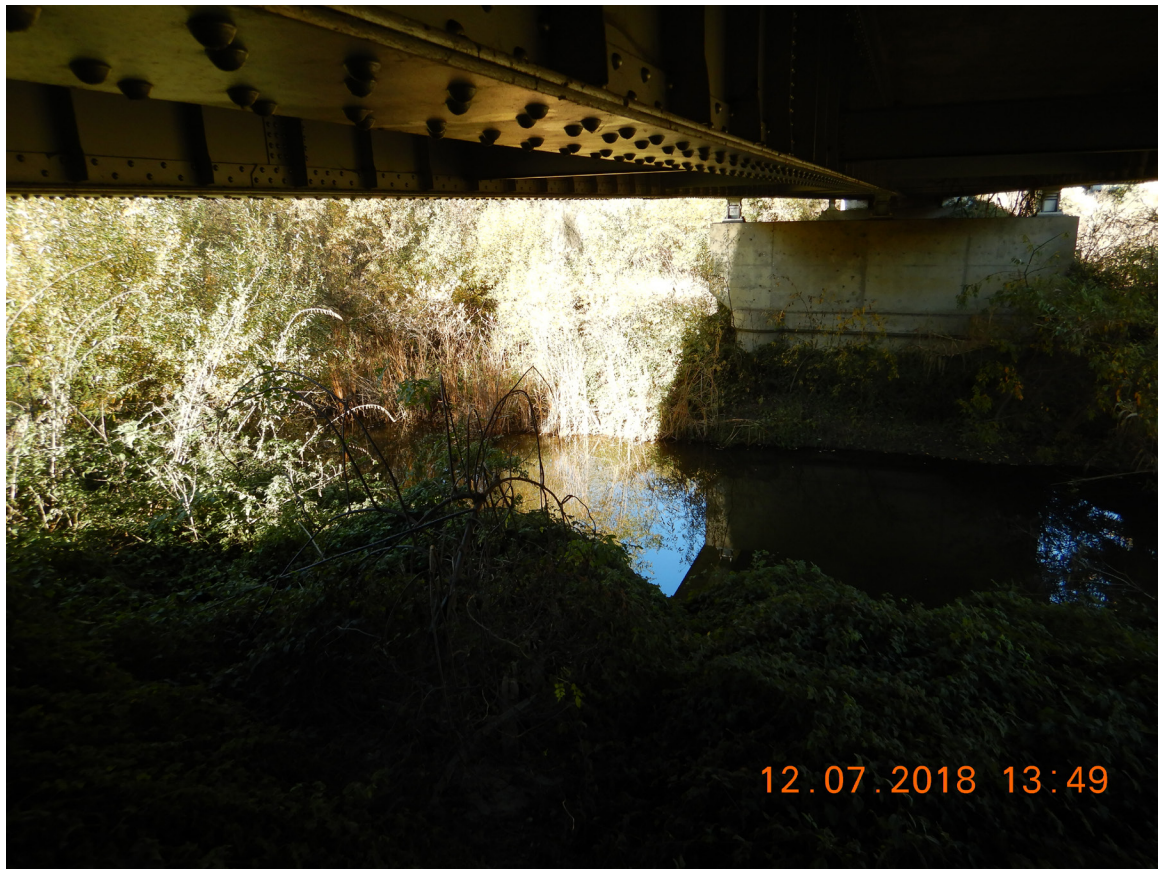
US 101 Site 6 San Benito River Bridge. Photo faces south taken from north side of San Benito River under US 101 northbound.

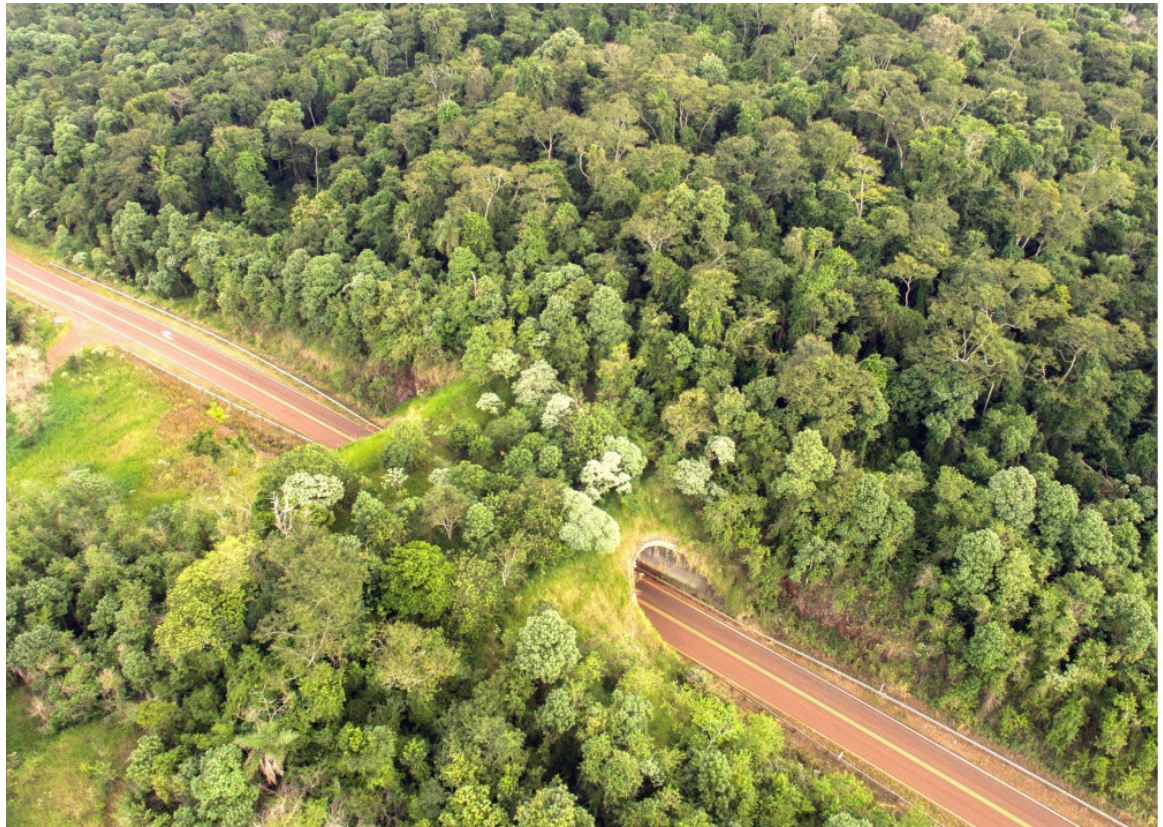
A wildlife overpass is one of the largest crossing structures to span highways. It is primarily intended to move wide-ranging large mammals.

Wildlife overpasses are vegetated, typically with native plants. If habitat elements are provided on the overpass, small mammals, medium-sized low-mobility mammals, and reptiles will also utilize these structures; with proper vegetation design, these crossings can also encourage use by bats and birds.

Example of a wildlife overpass near Iguazu, Argentina. Photo by Limba-Film Drone Project.

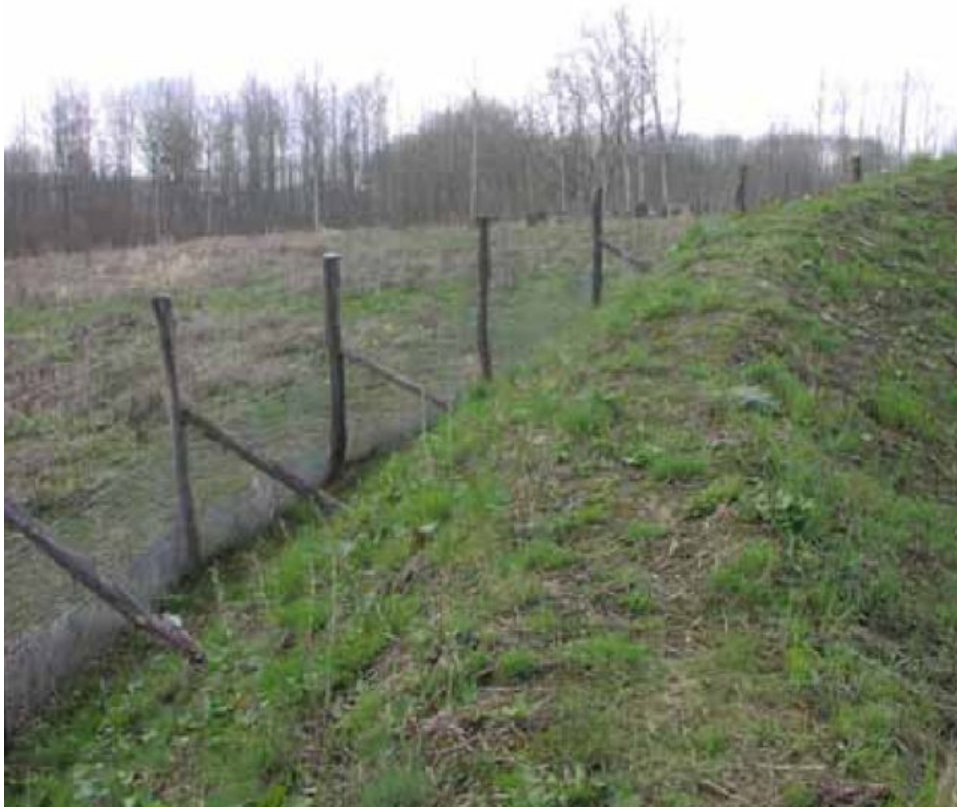
- Wildlife overpasses should be situated in areas with high landscape permeability, in known wildlife travel corridors, and with minimal human disturbance.
- Soils on and adjacent to the wildlife overpass should be as continuous as possible. Avoid importation of soils from outside the project area.
- Earth berms, solid walls, dense vegetation, or a combination of these should be used on the sides (lateral edges) of the overpass to reduce light and noise from vehicles (see photo).
- Wildlife overpasses should be closed to the public, with human use/activities prohibited.

A berm on the side of a wildlife overpass. Photo by Tony Clevenger.

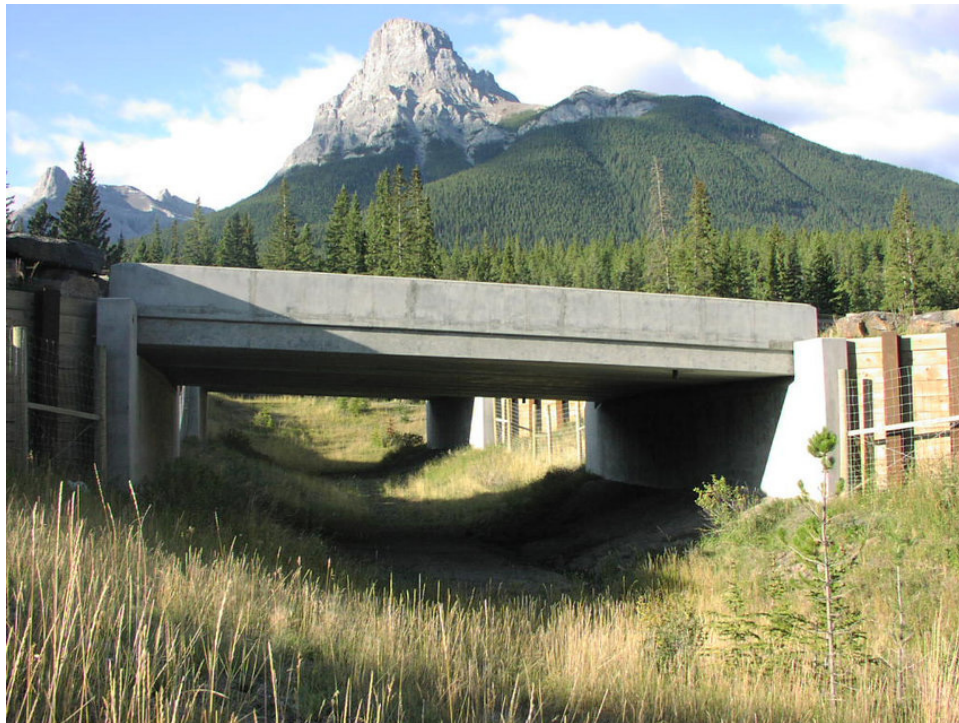
Wildlife underpass. Photo by AP Clevenger.

<b>Width</b>	Minimum: 7m Recommended: <12m
<b>Height</b>	Minimum: 4m Recommended: >4.5m

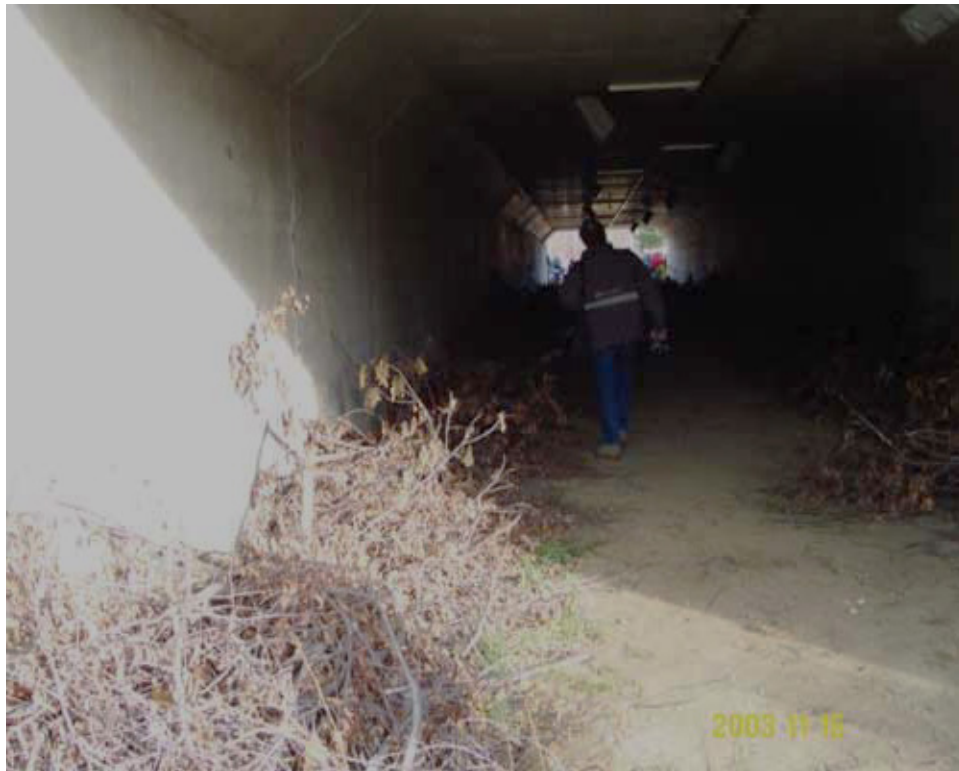
Brush and root wads along the edges of the undercrossing wall provide cover for mammals Photo by Nancy Newhouse.

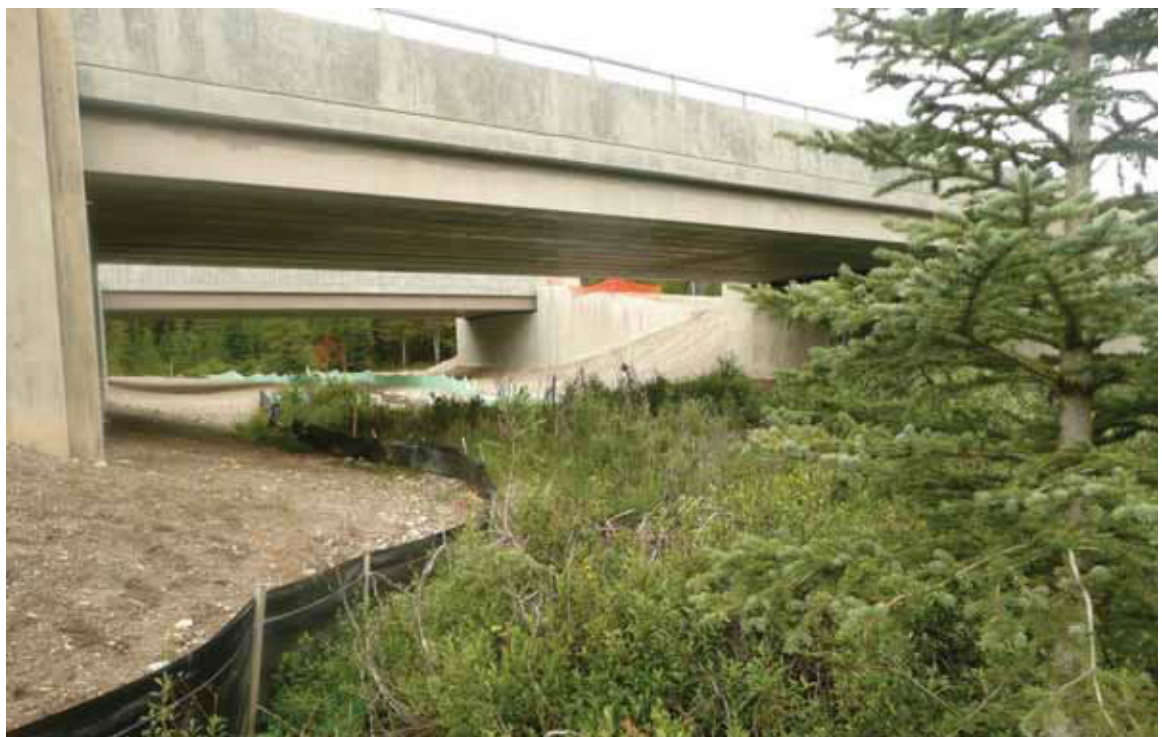
This is an undercrossing structure designed to accommodate dual needs of moving water and wildlife (see photo). Structures are generally located in wildlife movement corridors given their association with riparian habitats; however, some may be only marginally important. Structures aimed at restoring proper function and connection of aquatic and terrestrial habitats should be situated in areas with high landscape permeability, that are known wildlife travel corridors and that experience only minimal human disturbance. These undercrossing structures are frequently used by several large mammal species; use by some large mammals will depend on whether it is adapted for their specific crossing requirements. Small- and medium-sized mammals (including carnivores) generally utilize these structures, particularly if riparian habitat is retained or cover is provided along walls of the undercrossing by using logs, brush, or root wads. These undercrossing structures can be readily adapted for amphibians, semi-aquatic and semi-arboreal species.

Example of a wildlife undercrossing designed to accommodate water flow. Photo by Tony Clevenger.

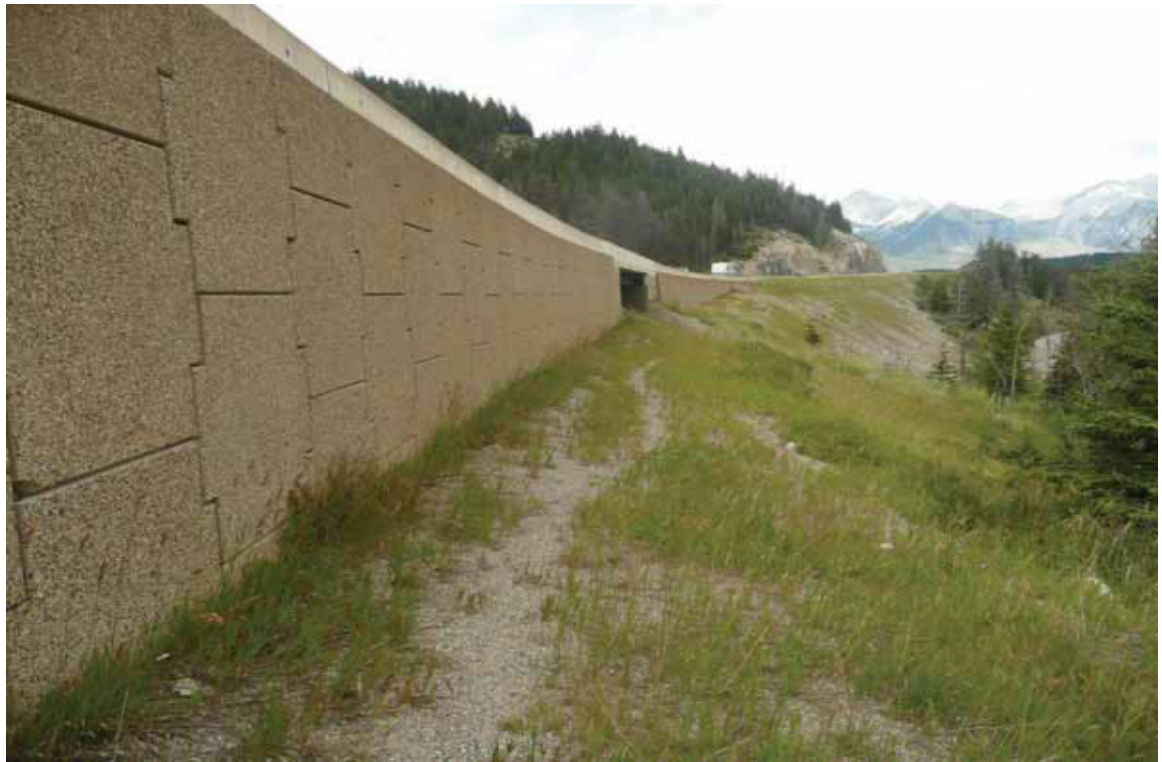
Mechanically stabilized earth wall serving as wildlife exclusion “fence.” Photo by Tony Clevenger.

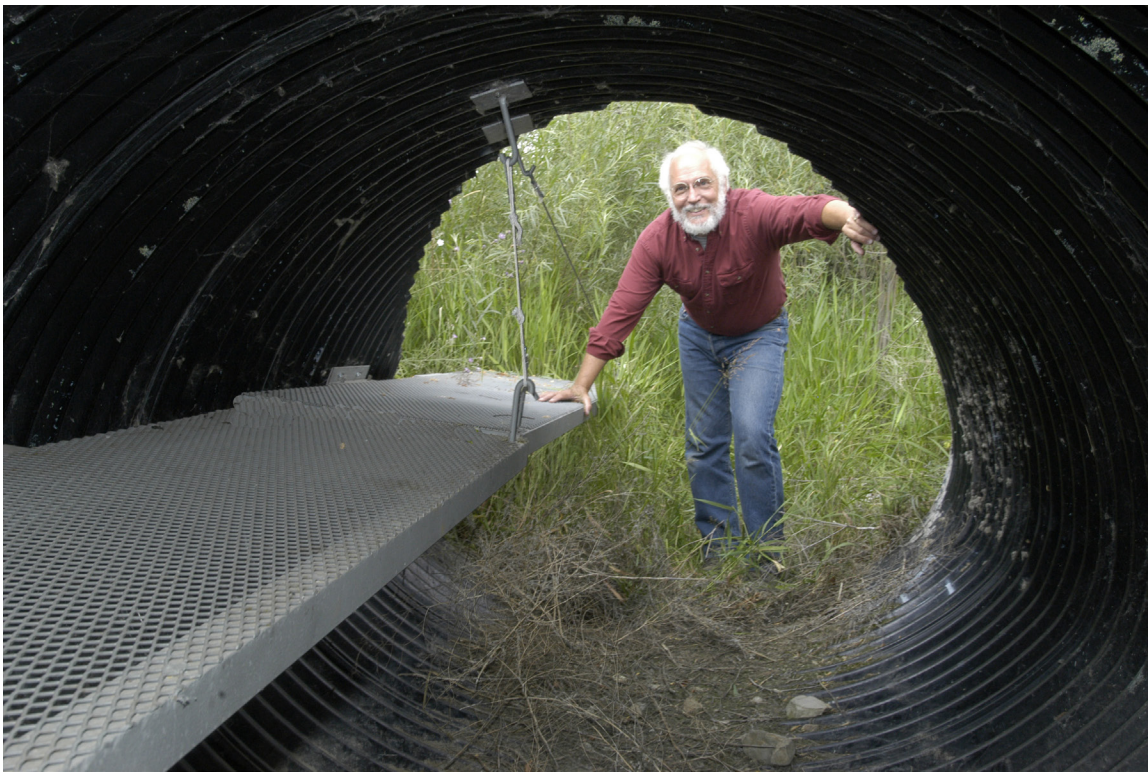
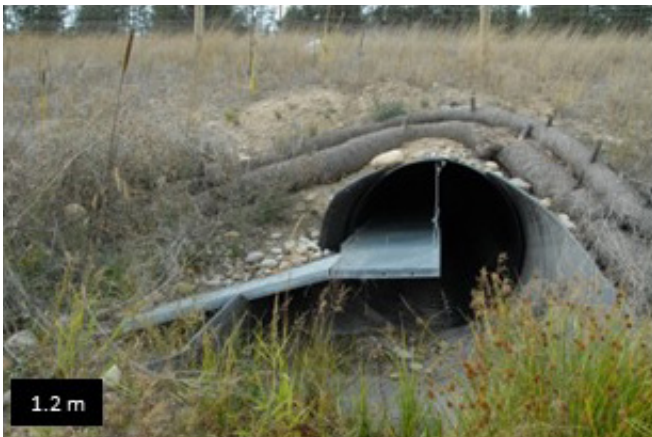
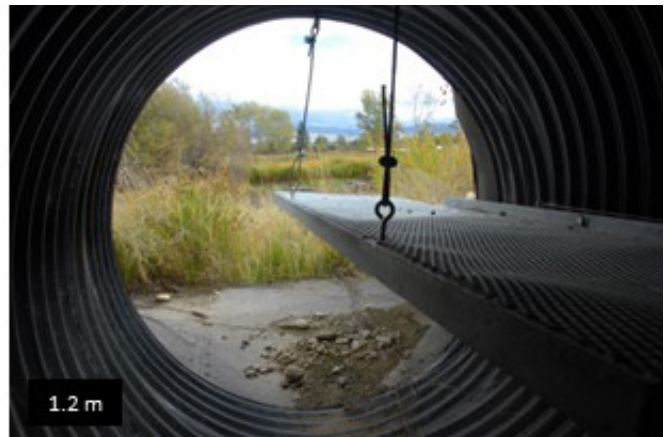
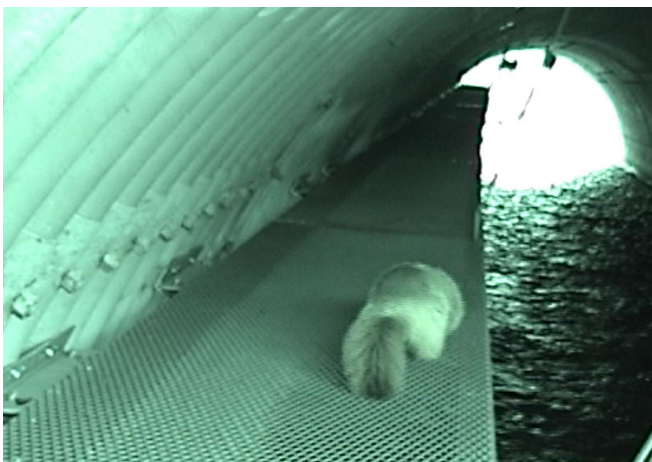
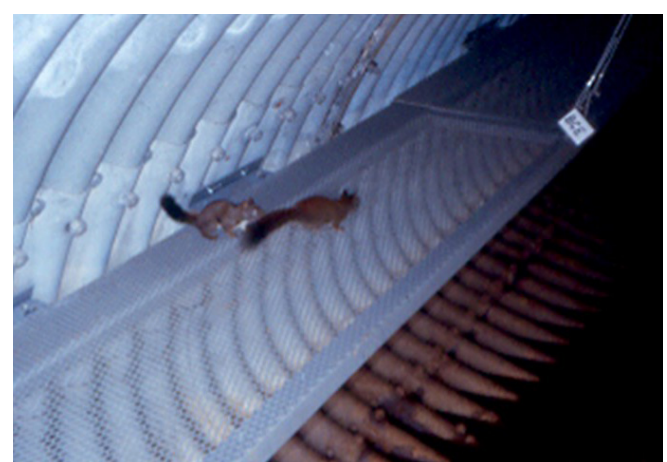
Metal shelving such as the units made by Critter-Crossing allow animals passage through flooded culverts and undercrossings. At top, Professor Kerry Foresman of Critter-Crossing Technology in Montana; middle photos show shelving in a 1.2m wide culvert; lower camera trap photos show small- and medium-sized mammals using the shelving during flooding. Photos courtesy Kerry Foresman.

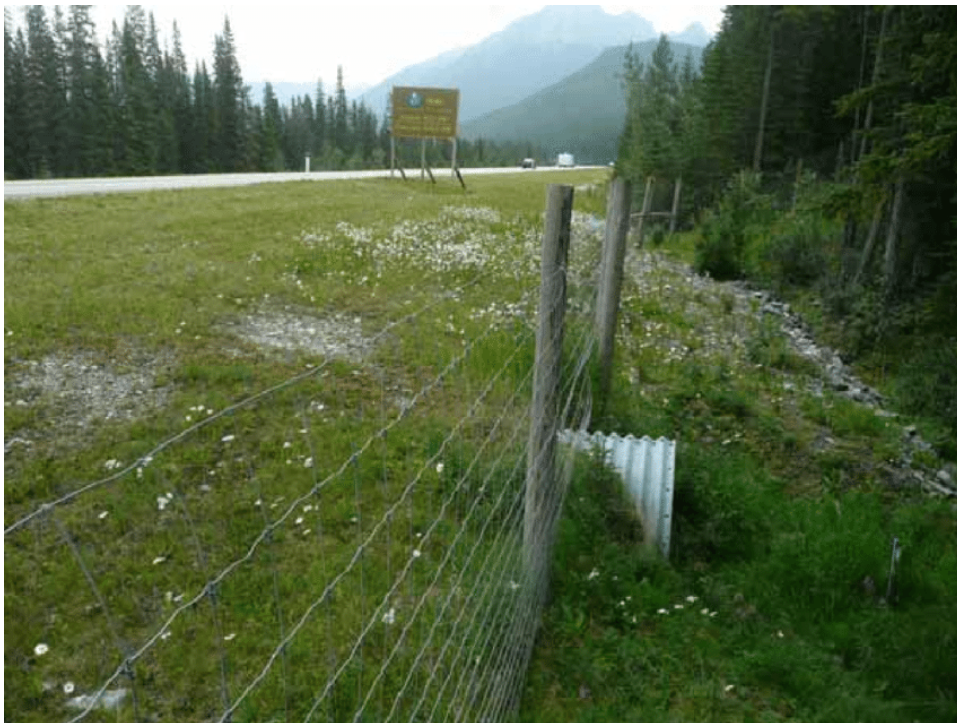
Fences can keep animals away from roadways and lead them to wildlife crossings where they can travel safely under or above the highway. Fencing is one part of a two-part strategy — fencing and wildlife crossing structures.

Wildlife exclusion fencing and culvert undercrossing. Photo by Tony Clevenger.

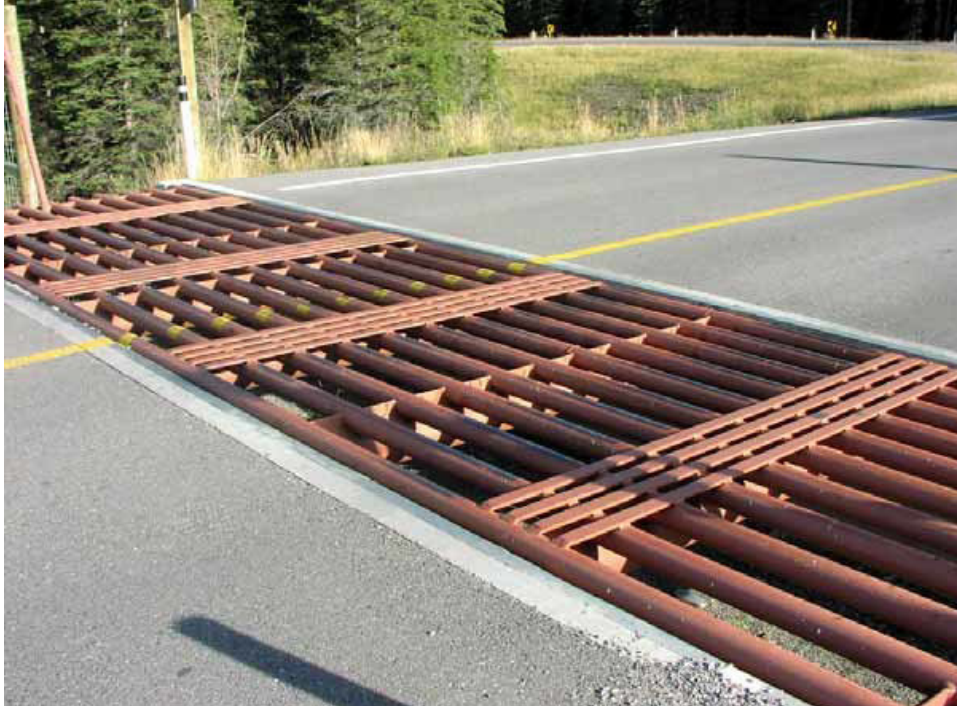
Few designs have been tested for their effectiveness with wildlife. However, a recently-developed grate pattern is 95% effective in blocking movement of Key deer and is safe for pedestrians and cyclists (Peterson et al 2003). Work by Allen et al. (2013) on

fenced sections of US 93 in Montana showed that Texas gates were more than 85% effective in keeping deer from accessing the road, and that 93.5% of deer used the crossing structure instead of the adjacent wildlife guard when crossing the road. The gates were less effective in keeping black bear and coyote from accessing the road (33–55%). However, all black bears and 94.7% of coyotes used the crossing structure instead of the adjacent wildlife guard when crossing

Cattle guard (Texas gate) in road. Photo by Tony Clevenger.

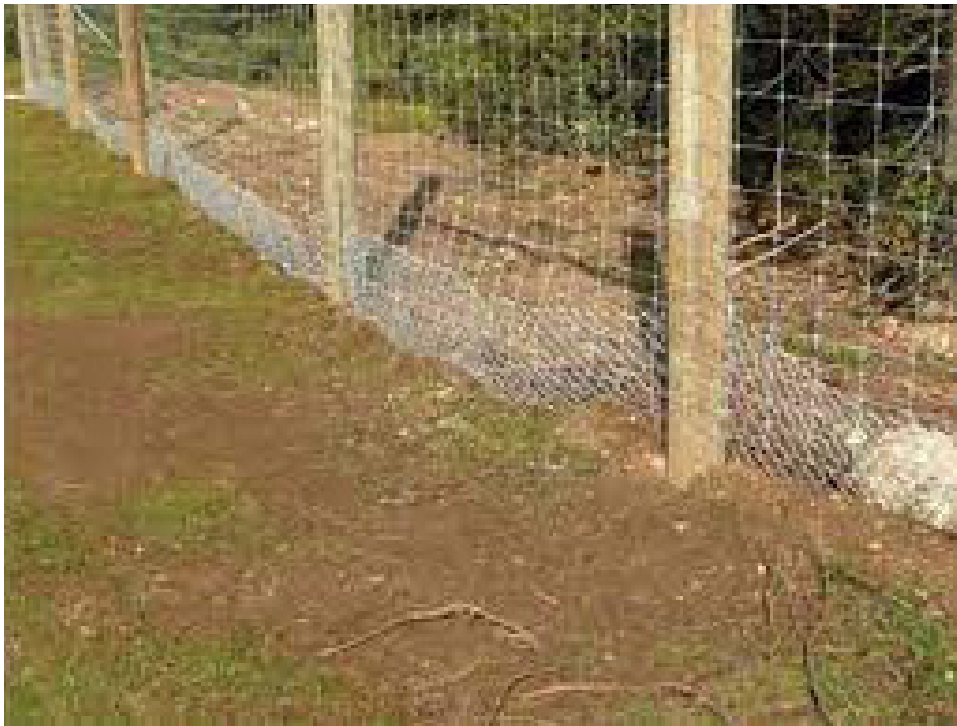
Wildlife exclusion fence with buried apron. Photo by Tony Clevenger.

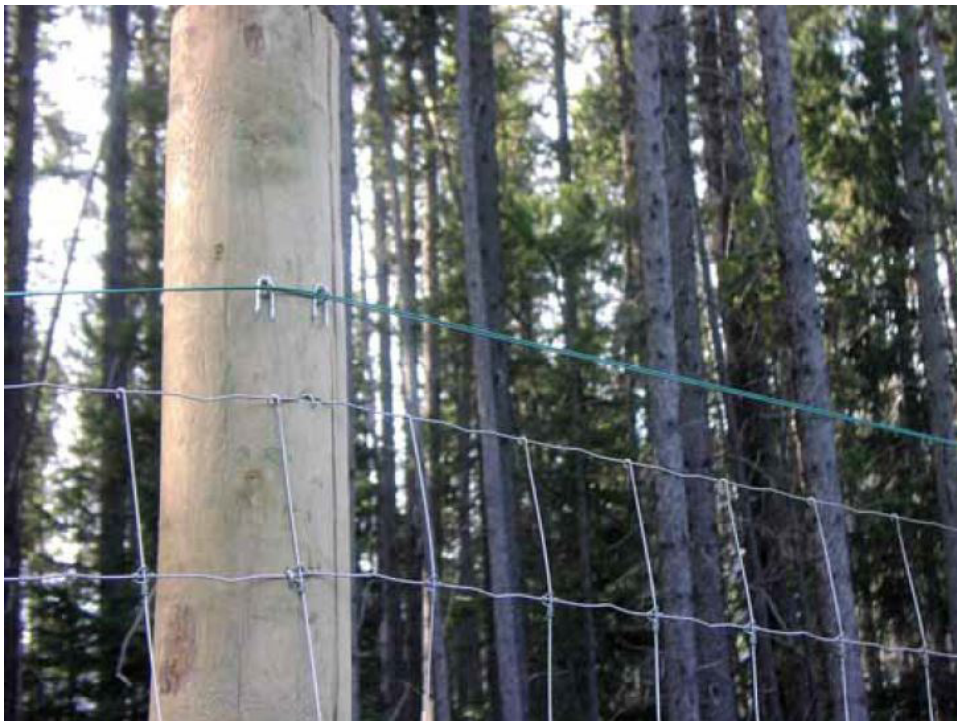
3. A protective high-tensile cable strung on top of fence posts can help break the fall of trees onto fencing. Such falls can provide openings for wildlife, and use of a protective cable should minimize fence damage, repair costs, and maintenance time (see photo).

High tensile cable designed to break fall of trees onto fence material. Photo by Tony Clevenger.

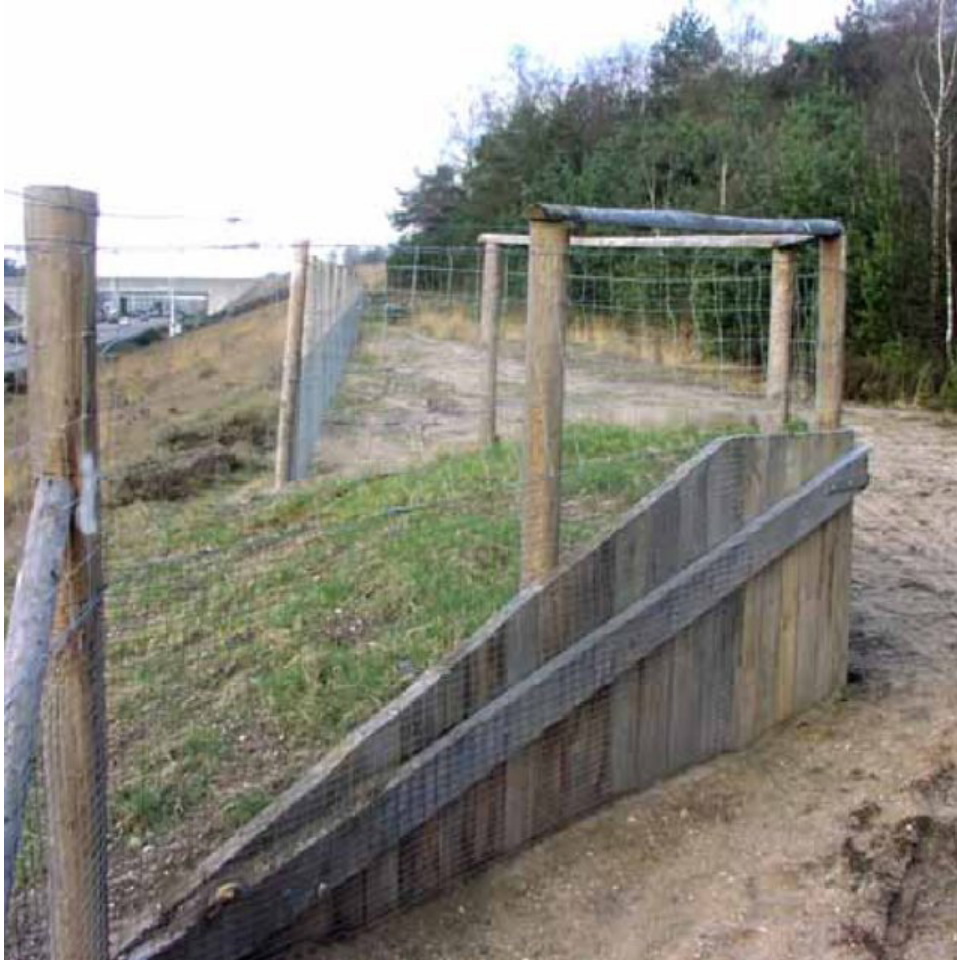
An animal that becomes trapped inside a fenced area needs to be able to safely exit. The most effective way to allow such escape is through a steel swing gate or an earthen escape ramp, also called a jump-out (see photo). The number, type and location of escape structures will depend on the target species, terrain, and habitat adjacent to the fence.

Wildlife escape ramp (jump-out). Photo by Tony Clevenger.

3. The outside wall height and materials should be designed with consideration for the behavior and ecology of native wildlife. The landing spot must consist of loose soil or other soft material to prevent injury to jumping animals. The outside walls must be smooth to prevent animals from climbing up.

4. Escape ramps should be positioned in a setback in the fence, and ideally would be protected with vegetative cover so that panicked animals can calm down before deciding to use the jump-out or continue walking along the fence. A right-angle jog in the fence is recommended for positioning the escape ramp.

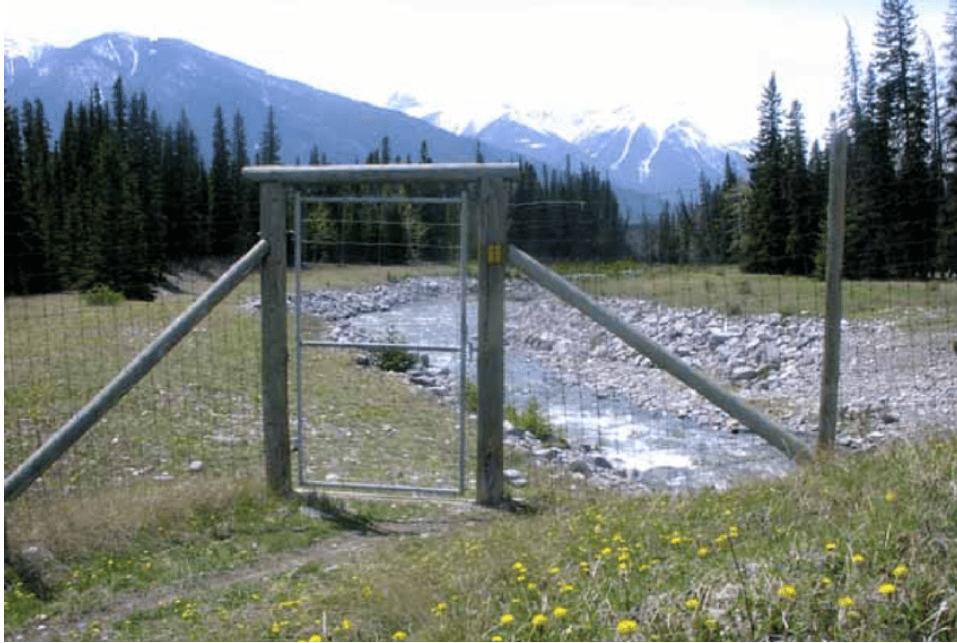
Single swing gate on a wildlife exclusion fence. Photo by Tony Clevenger.

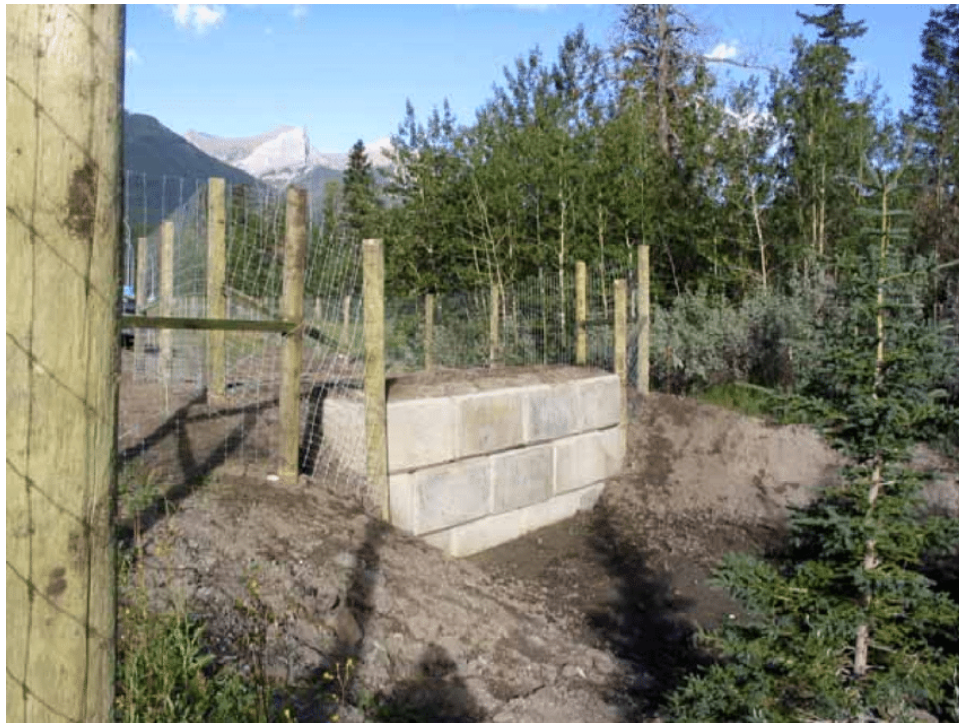
Escape ramp (jump-out) for wildlife trapped inside highway right-of-way. Photo by Tony Clevenger.
