# Enhancing ecological connectivity and safe passage for wildlife on highways between the southern Santa Cruz Mountains, Gabilan Range, and Diablo Range in California

Diamond, TD, A Sandoval, NP Sharma, ME Vernon, PD Cowan, AP Clevenger, and SC Lockwood. 2022. *Enhancing ecological connectivity and safe passage for wildlife on highways between the southern Santa Cruz Mountains, Gabilan Range, and Diablo Range in California*. Pathways for Wildlife and Peninsula Open Space Trust, Palo Alto, CA.

AUGUST 2022

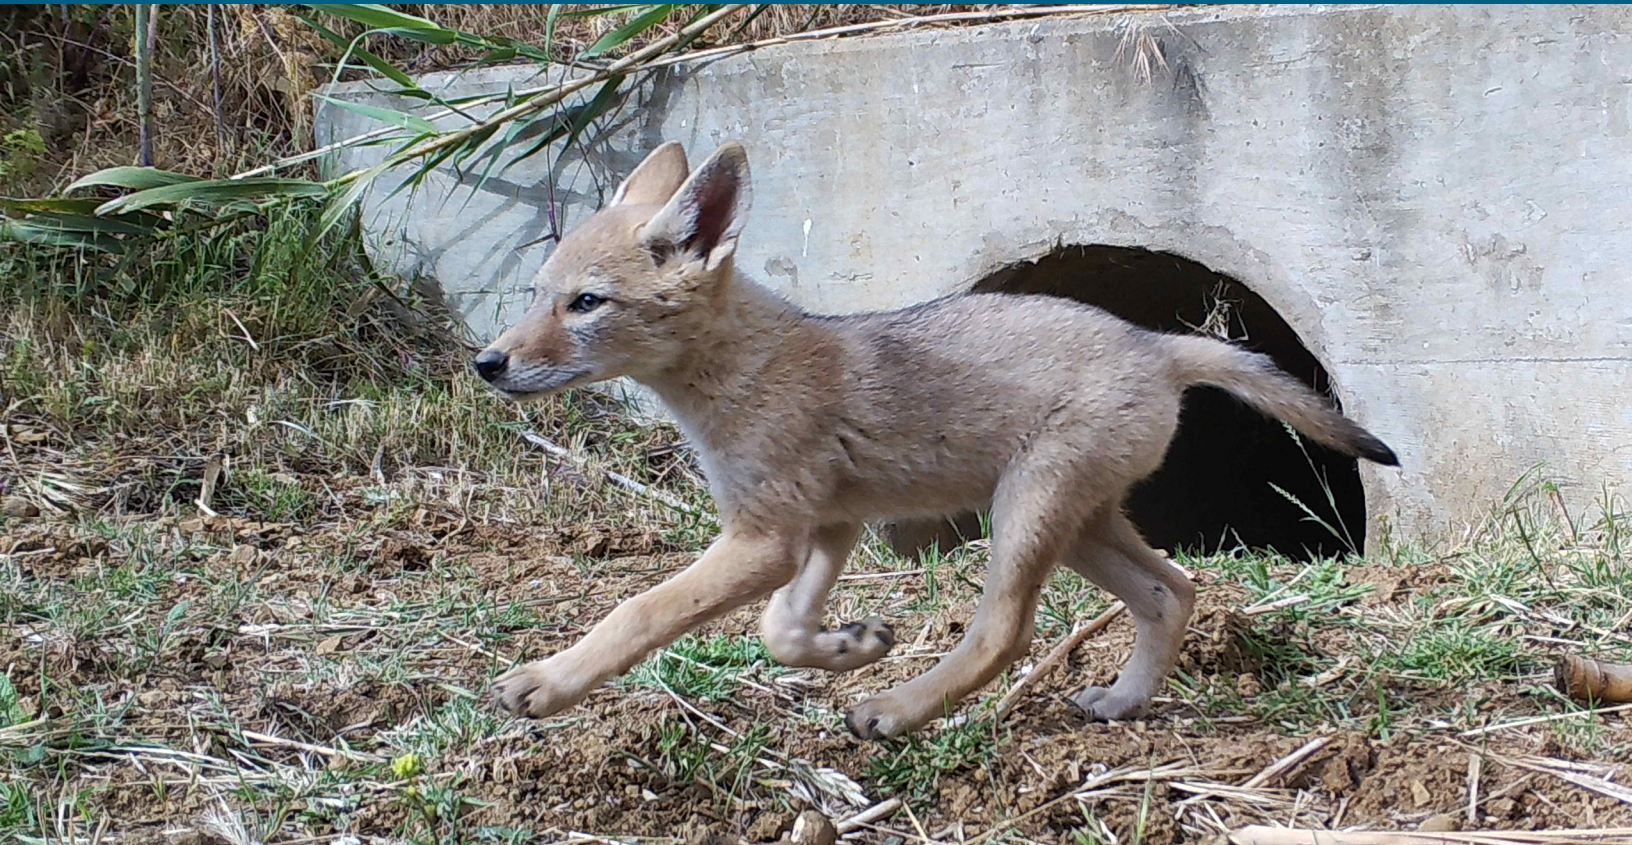
DESCRIPTION	NOTES
<b>Postmile SCL 3.17</b> <b>Lat/Long: 36.96145, -121.55131</b>	
<b>Existing infrastructure:</b> Culvert	
<b>Mean score: 1.0</b> Regional connectivity: <b>1</b> Local connectivity: <b>1</b> Land-use security: <b>1</b>	
<b>TARGET SPECIES FOR CONNECTIVITY ENHANCEMENTS</b>	
<b>Conservation and connectivity:</b> Multiple species	
<b>WILDLIFE OBJECTIVES</b>	
<ul style="list-style-type: none"><li>Enhance function as safe passage for wildlife under the highway.</li></ul>	
<b>LAND-USE SECURITY</b>	
<ul style="list-style-type: none"><li>Developed land on both sides of highway.</li><li>Intensive agriculture with little habitat value on the east side of the highway.</li></ul>	
<b>RECOMMENDATIONS</b>	
<b>Near- and long-term</b> <ul style="list-style-type: none"><li>Work with adjacent landowners to reduce the use of the culvert by domestic animals.</li><li>Add critter shelves to allow species passage when the culvert experiences ponded water.</li><li>Incorporate mix of vegetation/refugia and open conditions to encourage wildlife use.</li><li>Attention/interventions would likely be more effective/impactful at CES further south on Highway 101, absent of comprehensive habitat restoration actions in the vicinity of this structure.</li></ul>
