Highway 17 Wildlife Connectivity Project: Lexington Study Area.

Prepared for
Midpeninsula
Regional Open Space
District (MROSD) and
Peninsula Open
Space Trust (POST)
by Pathways for
Wildlife.

12/31/2016

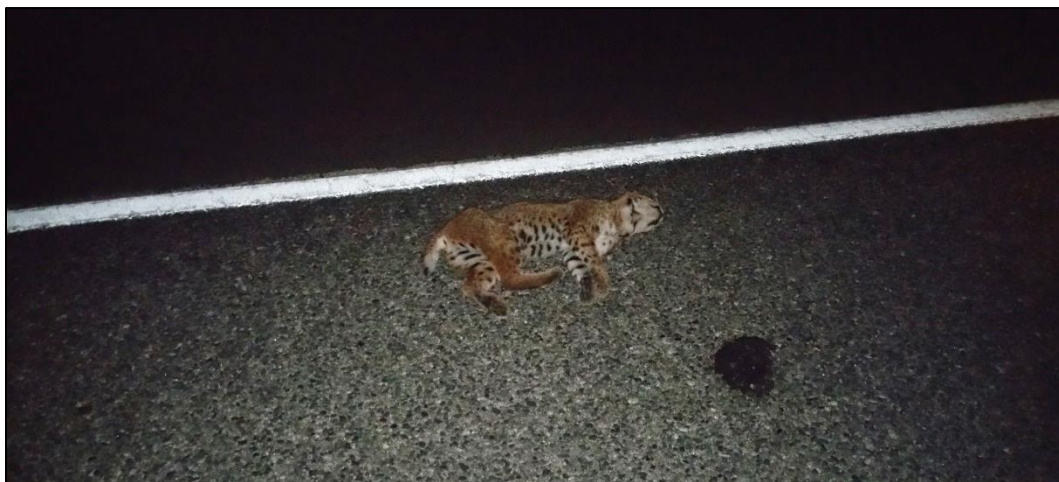
Figure 7: Juvenile bobcat hit at Trout Creek, southbound, on 9-28-2016.

Juveniles of all species have consistently been recorded hit on Highway 17 throughout the study during late fall and winter. For example a juvenile mountain lion was hit on 12-23-2015 (Figure 6), while a juvenile bobcat was hit on 9-28-2016 (Figure 7). These juveniles might have been dispersing out of their parental home range in attempting to establish their own. Of note, many of these juveniles, were hit on southbound lanes attempting to cross east towards the Sierra Azul Range.

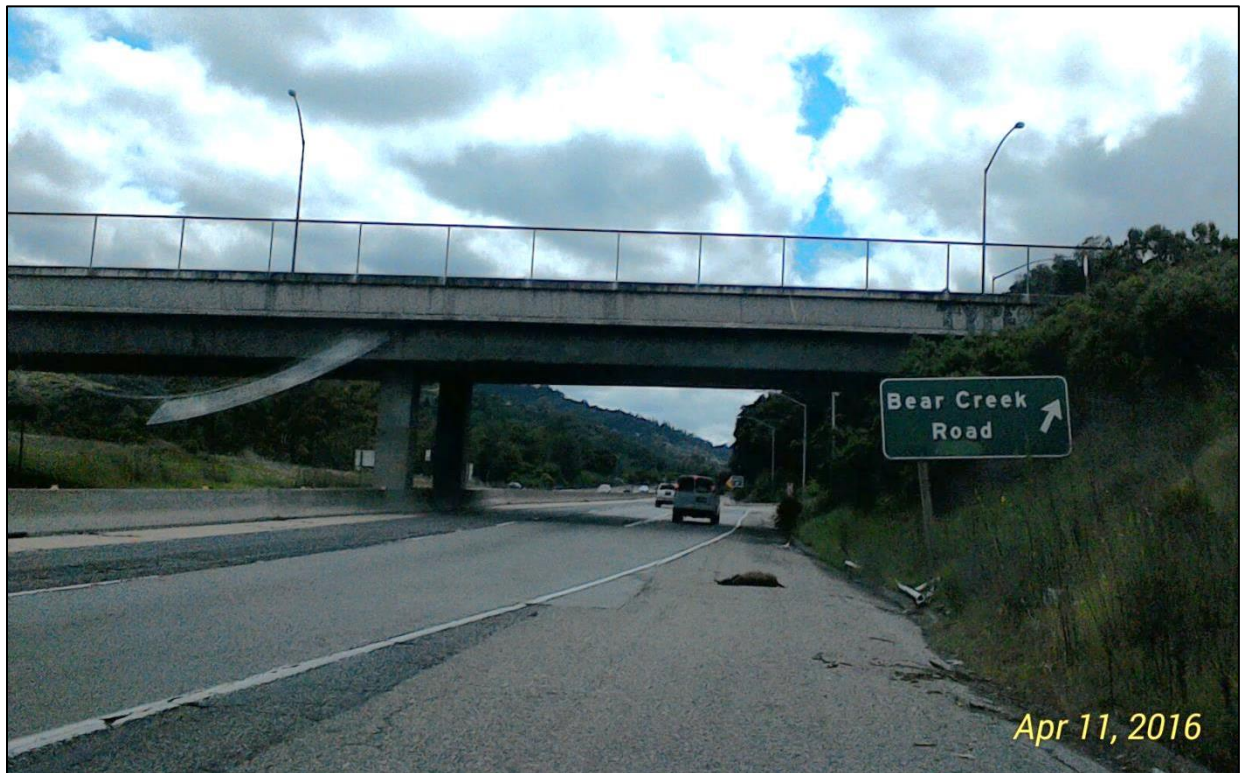
Figure 8: Deer hit on Highway 17 at the Bear Creek exit, southbound 4-11-2016.

During the month of April 2016, there had been a substantial increase in the number of deer recorded hit by Alma Bridge on Highway 17 at the Bear Creek exit, southbound (Figures 8 & 9).

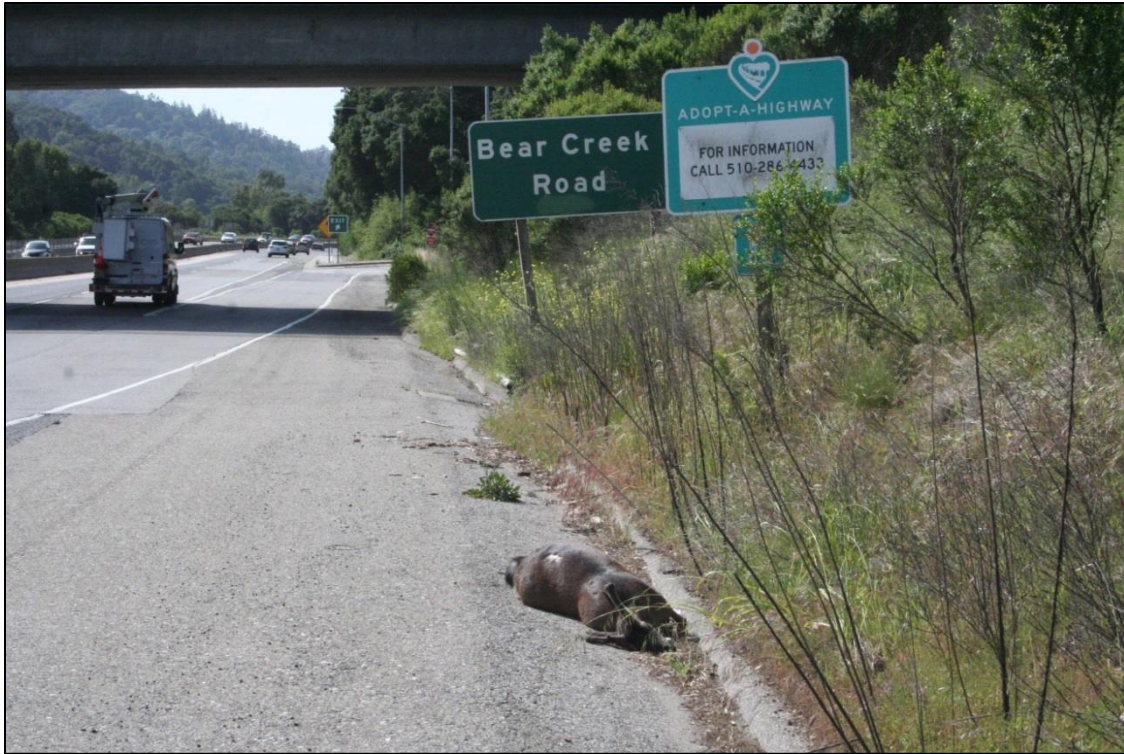
Figure 9: Male deer hit on Highway 17 at the Bear Creek exit, southbound 4-26-2016.

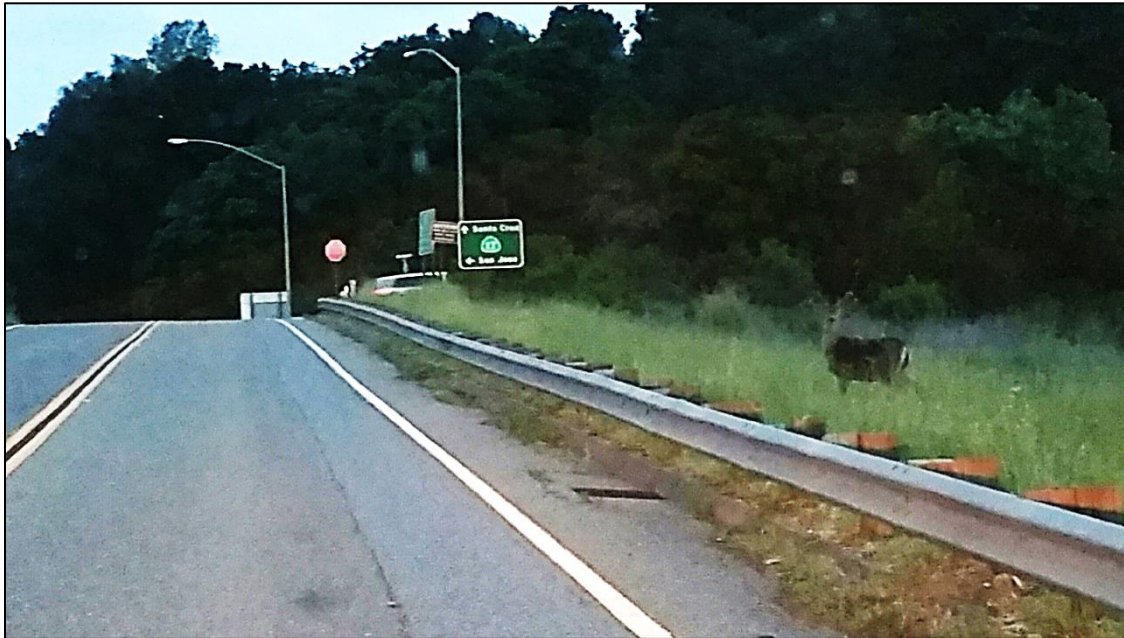
Figure 10: Male deer walking towards Montevina Road by the Bear Creek exit at the Alma Bridge.

On the west side of where the deer have been hit, is a ravine in which deer have often been observed grazing. On 4-27-2016, a male deer was recorded approaching Montevina Road, which runs parallel to Hwy 17 at the Bear Creek exit (Figure 10). Deer are walking up the ravine, across Montevina Road, and then onto the highway at this location.

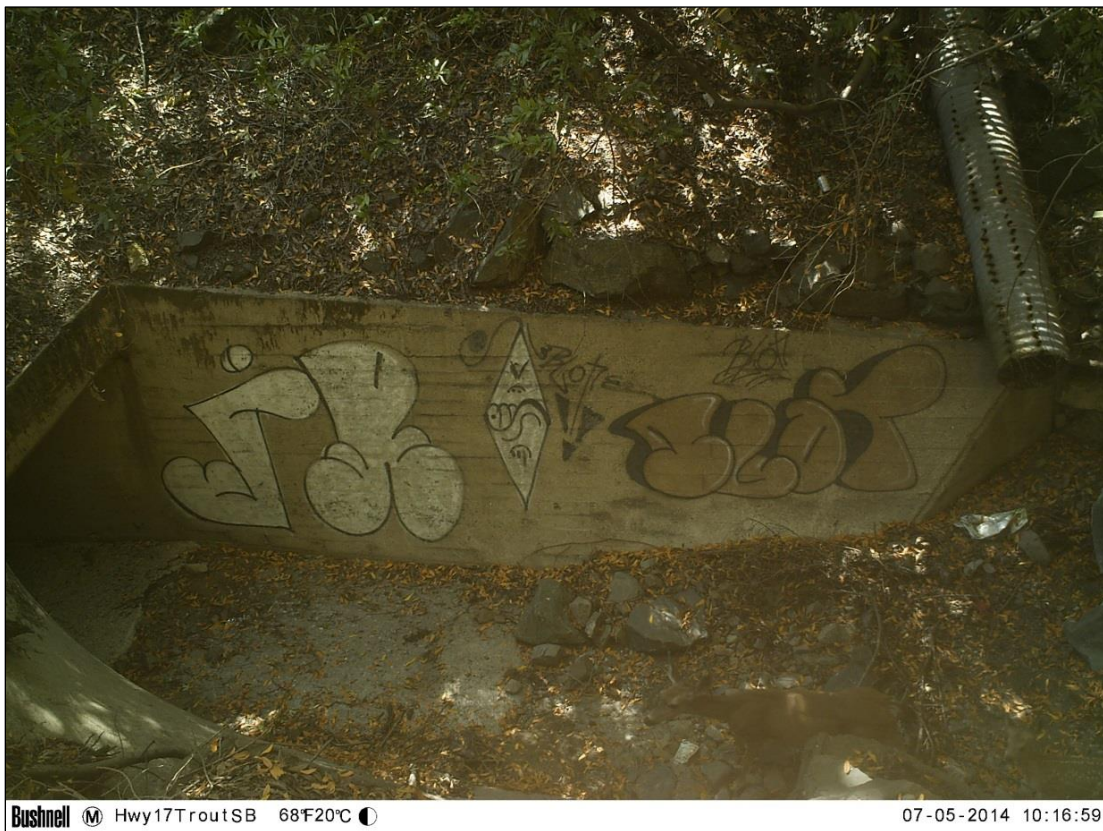
Figure 11: Deer at Trout Creek Culvert 7/5/2014.

In comparing the data collected from 2013-2015 to 2013-2016, there is a consistency in the species recorded along with the percentages of species visiting the culvert. The majority of species recorded is deer, raccoon, and gray fox in both the 2013-2015 to 2013-2016 data sets (Charts 8 & 9). **The majority of deer and gray fox consistently investigated the culvert, then turned back, and walked away from it (Figure 11 & Appendix A).**

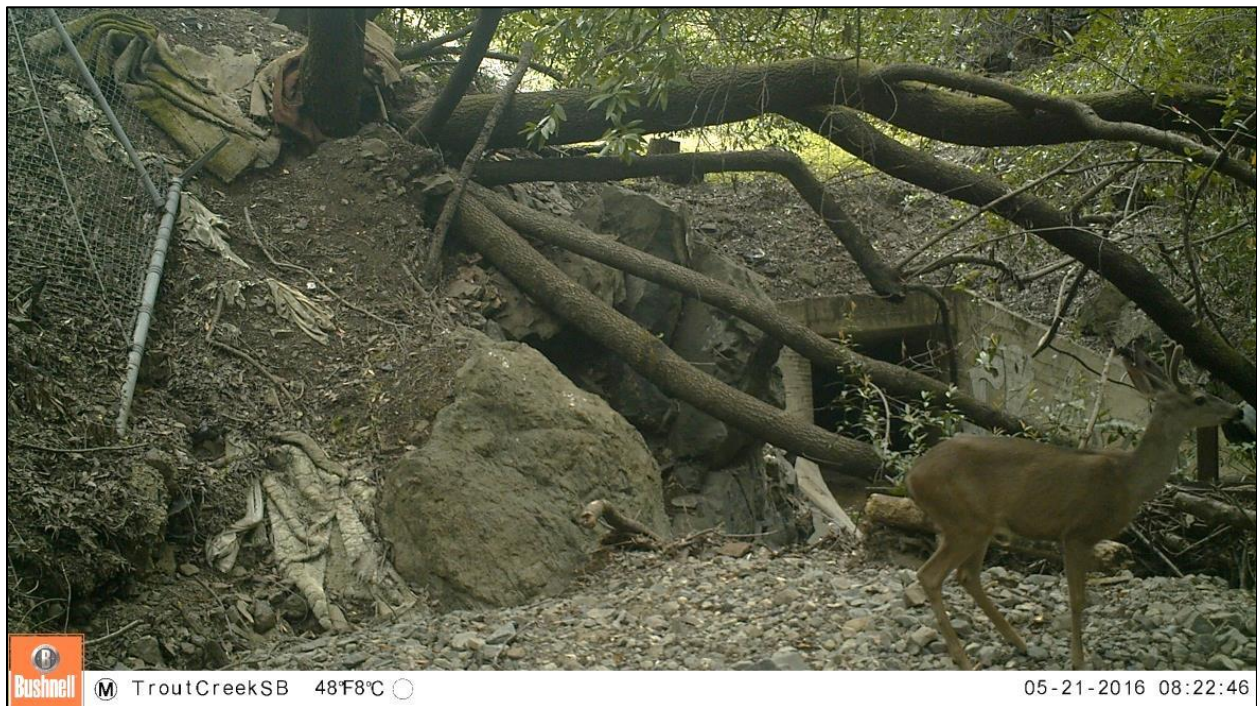
Figure 14: Deer at Trout Creek Culvert 5/21/2016.

In May 2016, a second camera station was added to the Trout Creek Culvert southbound site on the west side of the highway, to gather information about what species of wildlife might be traveling around the vicinity of the culvert, along with how animals are accessing the culvert, and potential movement patterns. Multiple individuals of deer were recorded traveling in the habitat adjacent to the culvert entrance (Table 8, Figures 14-16).

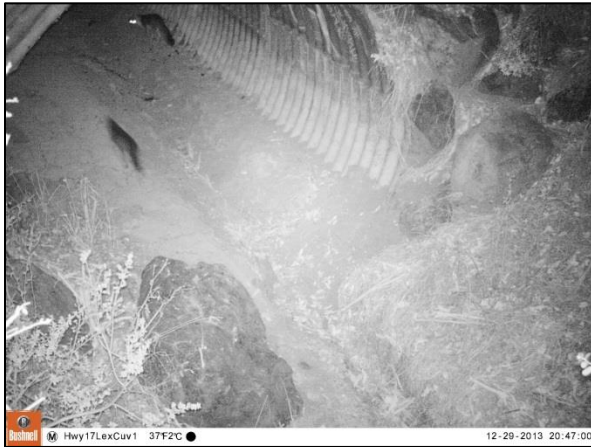
Figure 18: Two Gray fox using Lexington Culvert

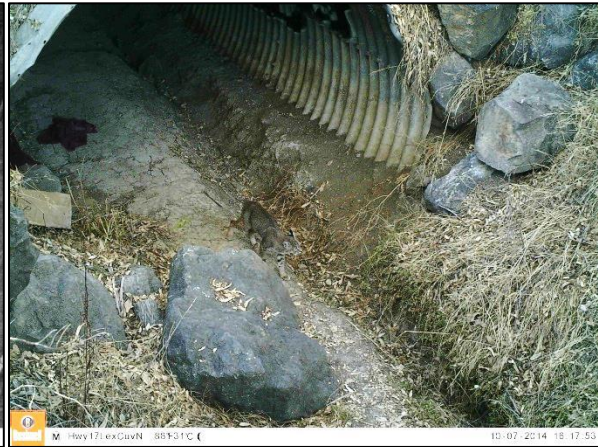
Figure 19: Bobcat using Lexington Culvert

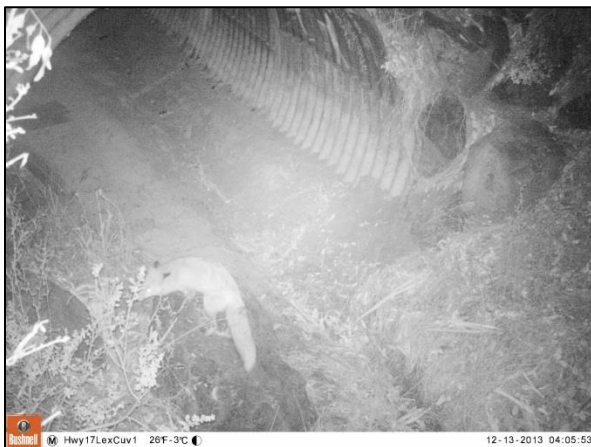
Figure 20: Red fox at Lexington Culvert

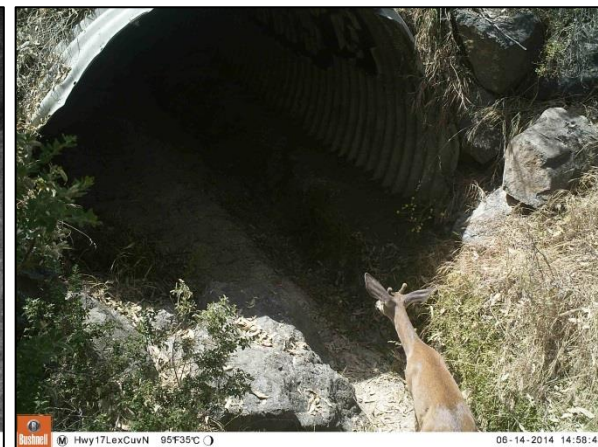
Figure 21: Deer investigating Lexington Culvert

A total of 1,298 animals have been recorded at the Lexington Culvert (Table 9). The majority of species detected were mesocarnivores, mid-sized animals, such as skunk (920), gray fox (517), raccoon (242) and bobcats (84) (Table 9). Nineteen deer approached the culvert but did not go through it (Figure 21). In comparing the data collected from 2013-2015 to 2013-2016, there is a consistency in the species recorded along with the percentages of species visiting the culvert. The majority of species recorded is skunk and gray fox in both the 2013-2015 to 2013-2016 data sets (Charts 13 & 14).

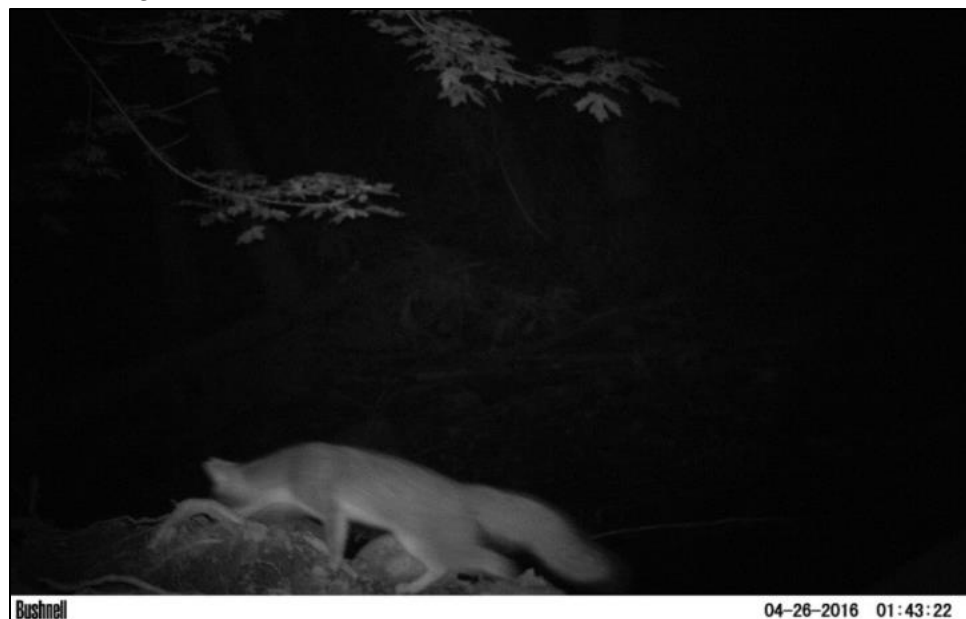
Figure 26: Aldercroft Culvert Northbound: Gray fox on 4-26-2016.

recording traveling along the banks of the pool of water (Figures 25 & 26). **Throughout the monitoring period, on a monthly basis, different deer individuals would walk into the base of the water pool, investigate the culvert but then walk away (Figures 27 & 28).**

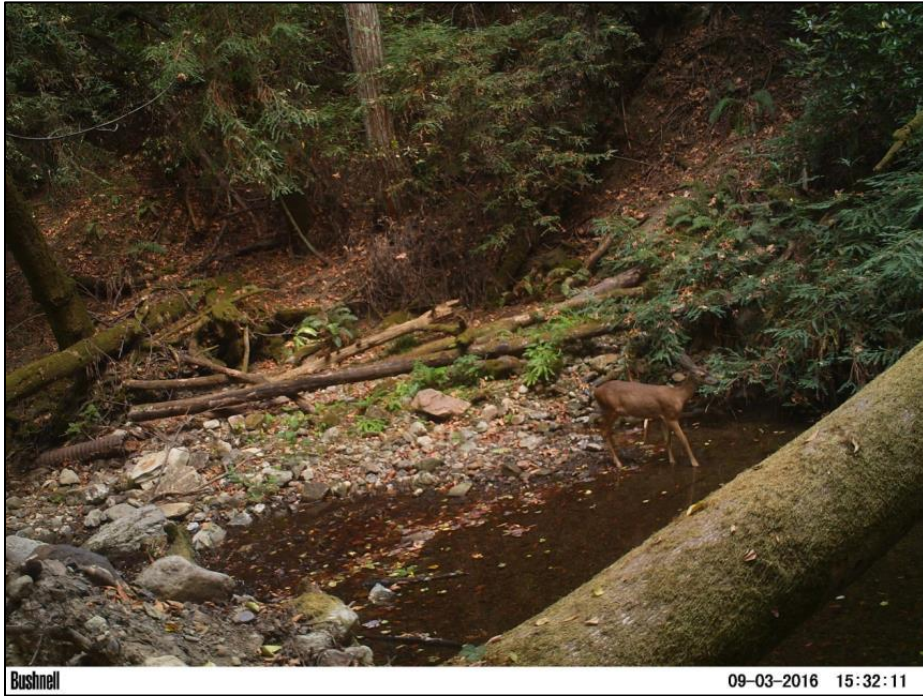
Figure 27: Aldercroft Culvert: Northbound (east side) Deer heading towards the culvert on 9-3-2016.

On the east side of the culvert, there is a large pool of water, which was consistently full throughout the summer months. Deer would often walk into the pool of water, looking at the culvert, but then walk away from it (Figures 27 & 28). The pool of water is deep at the mouth of the culvert, approximately 5-6 feet, which might be acting as a barrier for wildlife movement through the culvert, especially for species of mesocarnivores. **Recommendations include, managing the pool of water by including drainage improvements so that animals can access the culvert. Other improvements could include creating banks for animals to walk along to access the culvert. Lastly, adding in directional fencing on both sides of the culvert to guide animals to the culvert would be highly beneficial in keeping wildlife off the highway and possibly increasing animals using the culvert to cross through it.**

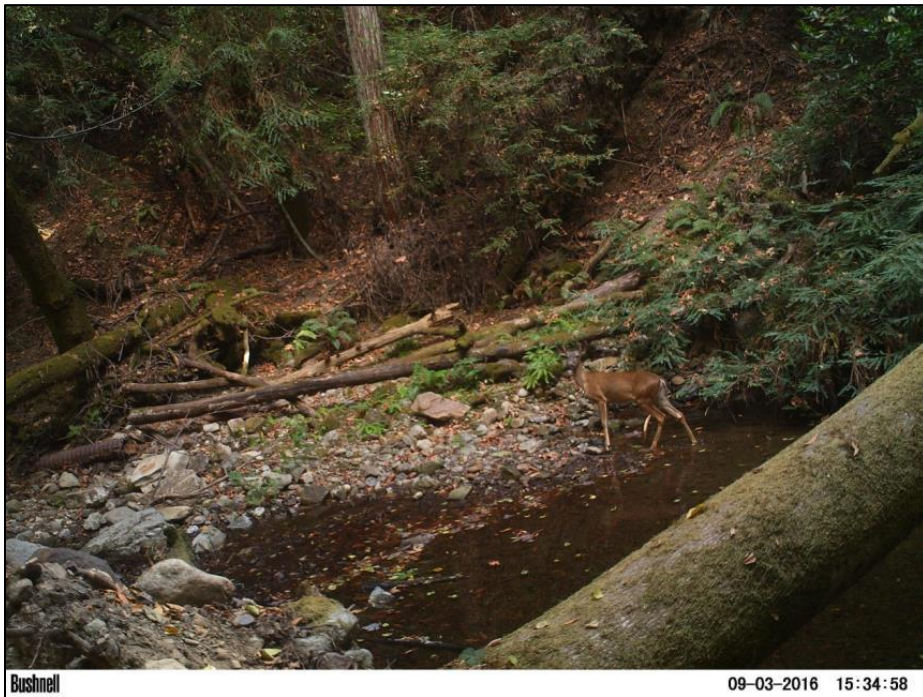
Figure 28: Aldercroft Culvert: Northbound (east side) Deer walking away from the culvert on 9-3-2016.

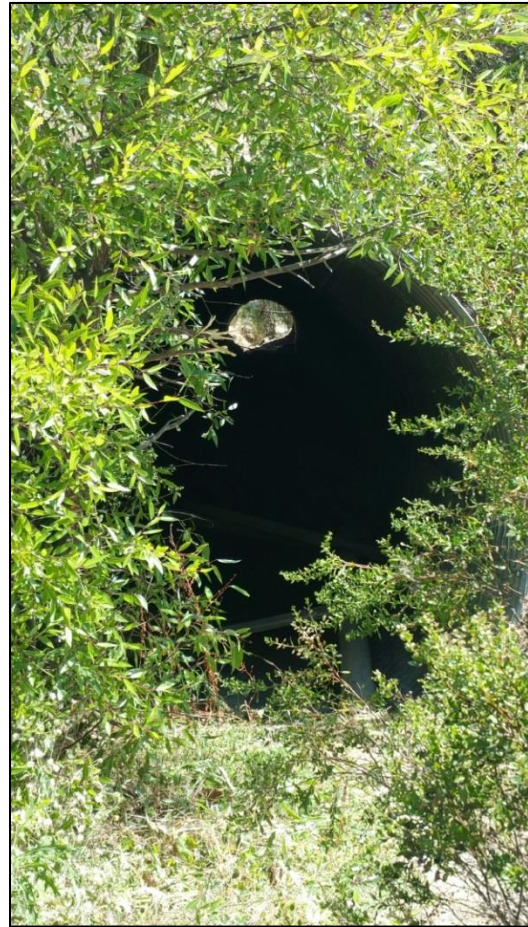
Figure 33: Vegetation Clearance.

In the month of September 2015, the vegetation in front of the west side of the Lexington Culvert had become overgrown, blocking visibility through the culvert (Figure 33). This resulted in a significant decrease of passages through the culvert by wildlife species such as; bobcat, gray fox, skunk, and raccoon, that were typically traveling through the culvert on a consistent monthly basis. Pathways for Wildlife cleared the overgrown vegetation in front of the culvert (Figure 34). After several weeks

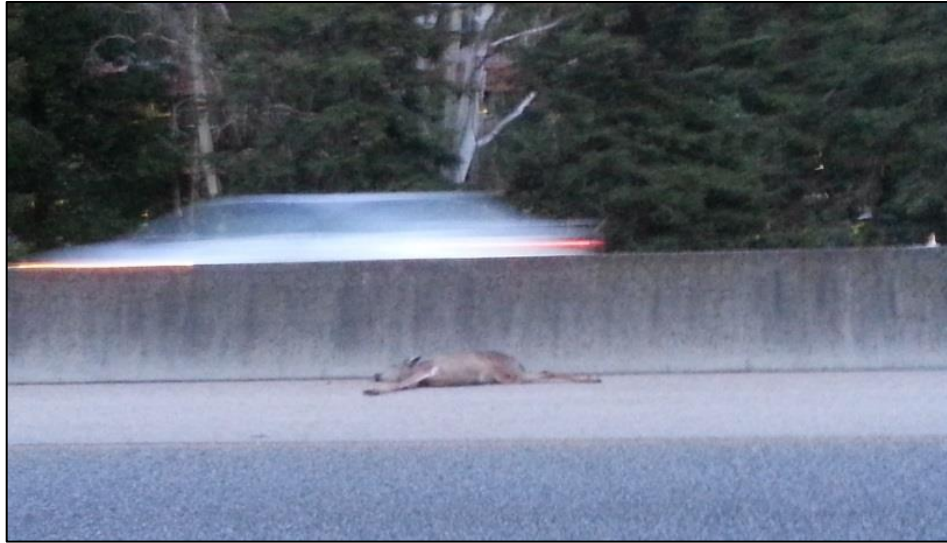
Figure 36: Deer hit on Highway 17 on 5-4-2010.

Medians, which have been installed to prevent head-on collisions between vehicles, also pose a problem for wildlife that have been attempting to cross the highway. Medians are a barrier to wildlife movement across roads as animals tend to become trapped at the median wall and have a high probability of becoming hit by a vehicle (Figures 35 & 36). **These medians increase the need for a wildlife crossing to make the highway permeable for wildlife movement by installing safe passages for them to travel across the road (Safe Passages, 2010).**

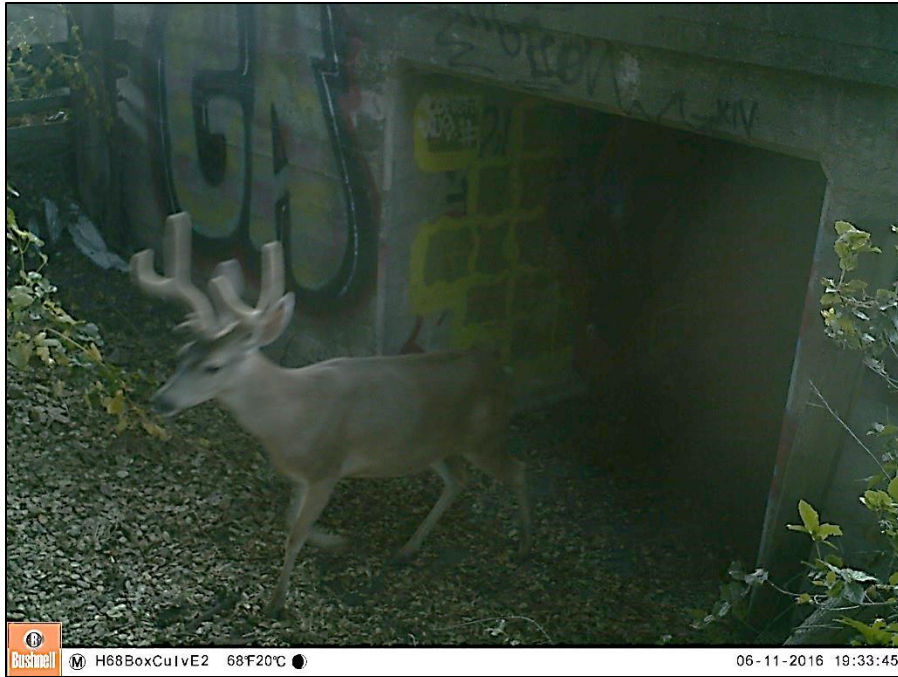
Figure 37: Deer traveling through Hwy 68 Box Culvert.

In the Bay Area, through several studies, deer have been documented to consistently travel through box culverts at Hwy 68 in Salinas, Monterey, and Hwy 116 in Sonoma (SR68 Wildlife Connectivity Study and Sonoma Land Trust Wildlife Connectivity Study) (Figure 37). Mountain lions have also been documented to travel through culverts in San Luis Obispo at Hwy 101 Cuesta Grade (Caltrans District 5, Nancy Siepel) (Figure 38).

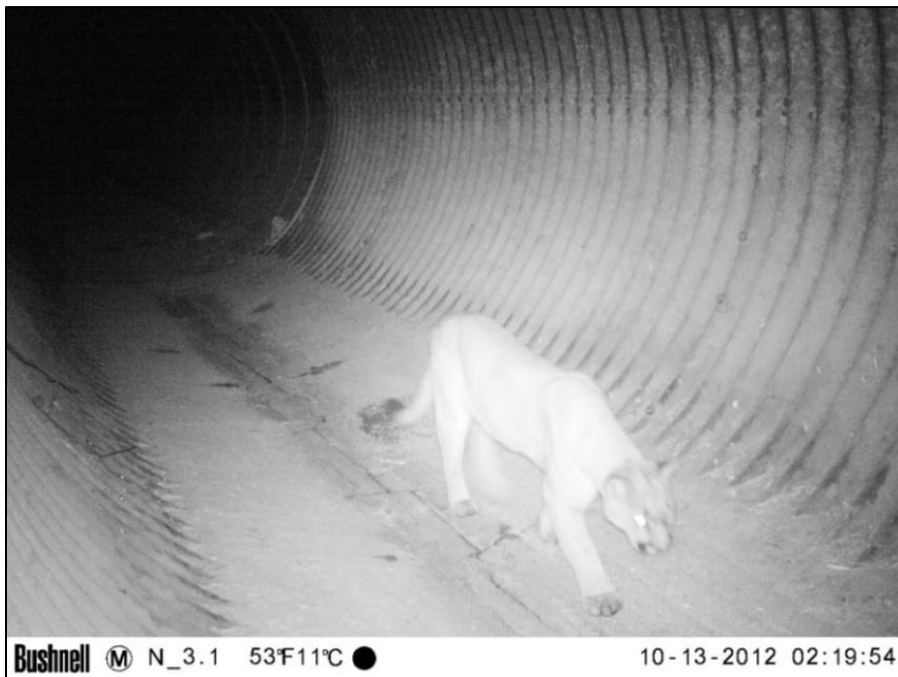
Figure 38: Mountain lion traveling through a Hwy 101 culvert at Cuesta Grade, San Luis Obispo, photo courtesy of Nancy Siepel, Caltrans District 5.

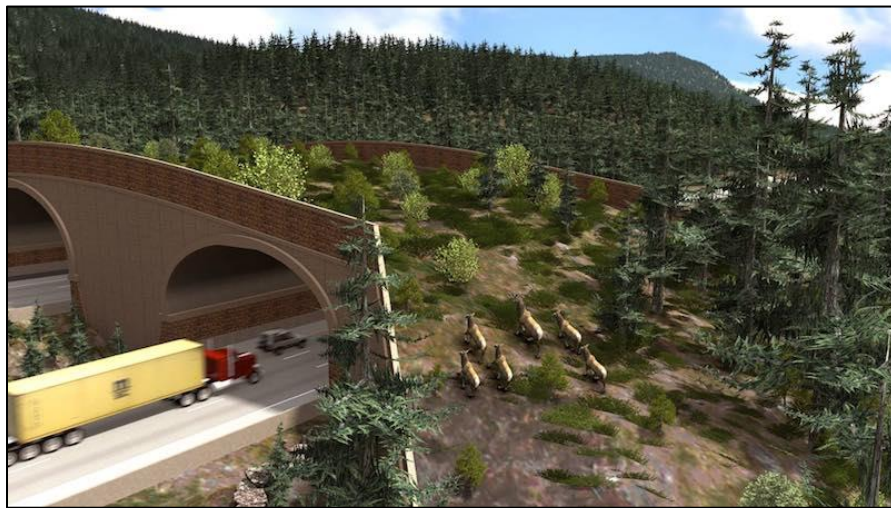
Figure 39: I-90 Landscaped wildlife bridge-Washington State Transportation Dept.

There have also been studies showing successful use of land bridges by large mammals in crossing over highways (Gloyne & Clevenger (2001). Land bridges extend from existing habitat on one side of the highway to the other and are vegetated so that animals perceive the extension of the bridge as part of the landscape they are walking on (Figures 39 & 40).

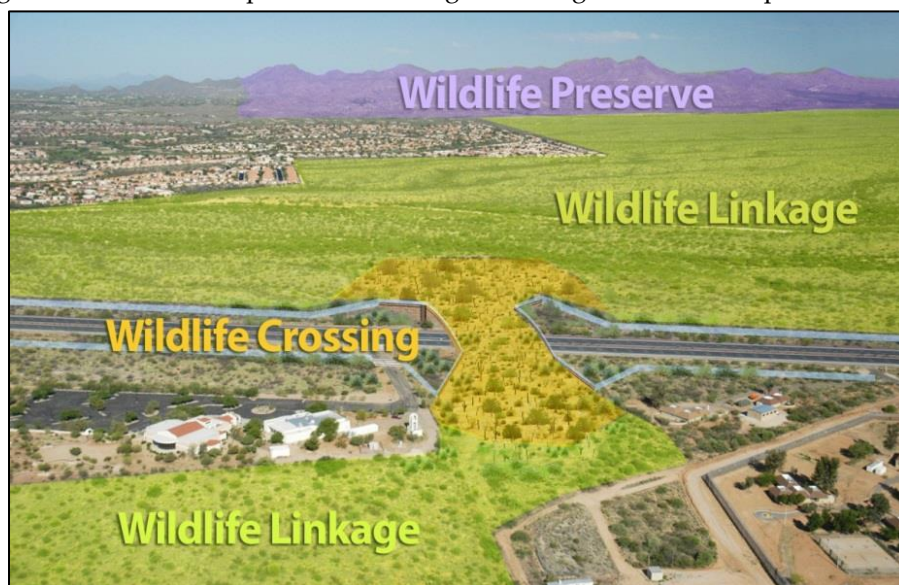
Figure 40: Land Bridge Visual Design: <http://www.sonorandesert.org>.
